The condition of the Greenstone-Kinloch Road has been examined, locals interviewed and recommendations for improvement proposed, in response to a request from Queenstown Lakes District Council (QLDC).

INTRODUCTION

1 HISTORY OF GREENSTONE-KINLOCH ROAD

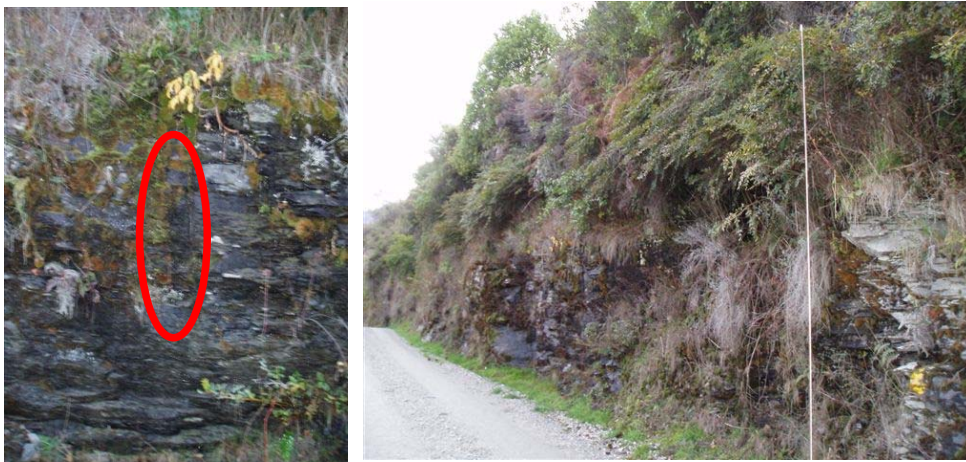
Figure 1: Rock Outcrop Formation

Figure 1 below shows the outcrop near the jetty, and the 2005 crash site. In the middle of the close-up photo can be seen a section (circled) through a hand-drilled hole in which a charge of gelignite was placed.

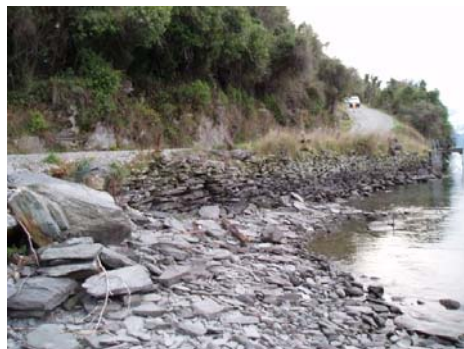
Figure 3: View Looking North from Greenstone End

The road in the vicinity of Greenstone Station was surveyed to assist this report, in May 2006. Figure 3 below shows the climb from Greenstone, the area of commencement of the survey.

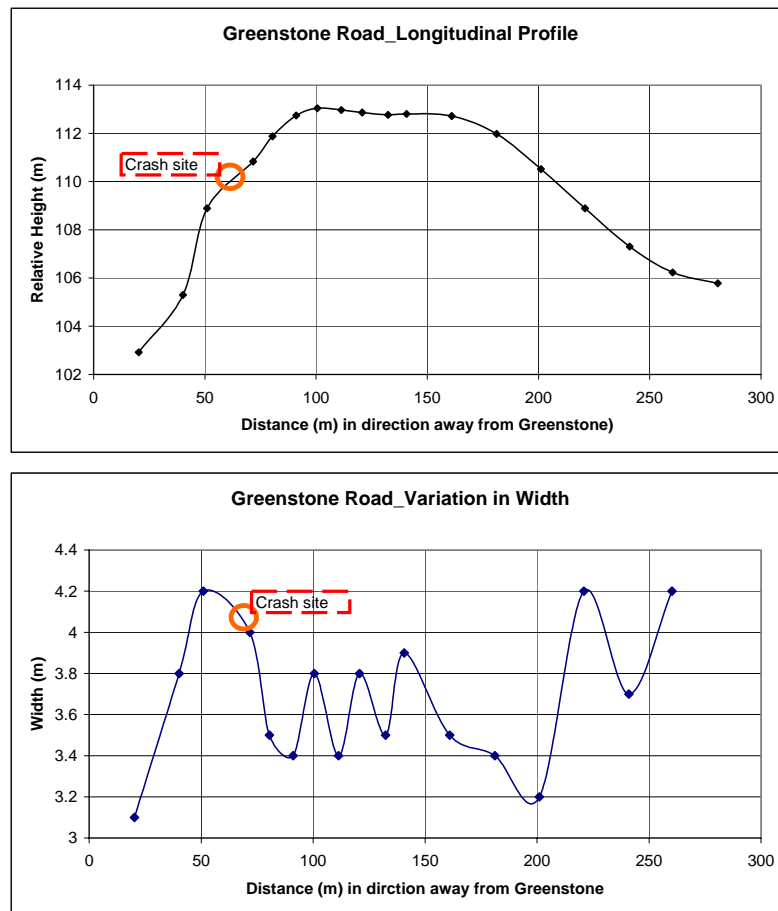
Figure 4: Longitudinal Profile and Width Variation of Road at Greenstone End

The base of the hill (see Figure 4) is 80 m from this marker, and gradients are as high as 1 in 3.

The dotted line shows a potential alteration to vertical alignment (a standard vertical curve) to ease gradients and rates of change of gradient. As drawn, this involves cuts of up to about 2 metres.

At the site of the crash, the road is relatively wide (4.1 m), although this is not a sufficient width for a two lane road.

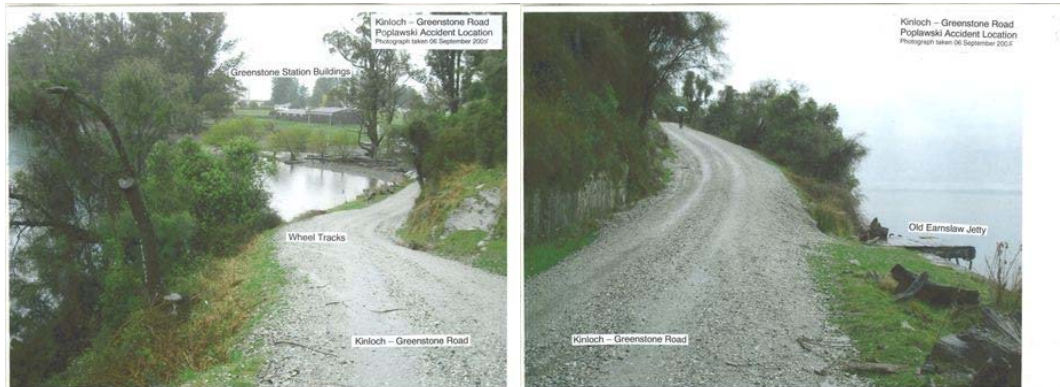
Figure 5: The Accident Scene Four Days after Crash (6 Sept 2005)

Photos taken 4 days after the crash (about 6 weeks after metalling) are shown in Figure 5 and indicate that the aggregate was in a reasonable state of compaction in the wheeltracks, but loose on the edges.

Sheep has been driven over the road on the day before the accident, and may have loosened the top surface.

Based on the photographs taken shortly after the time of the accident, the road surface was in a reasonably stable condition.

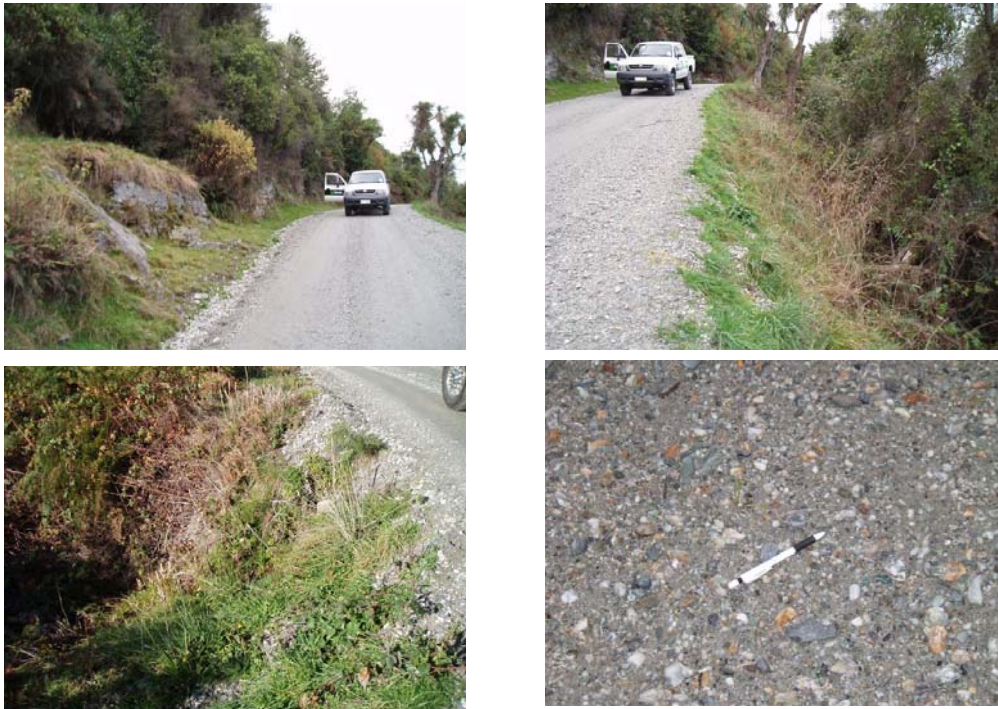
Figure 6: Greenstone End of Road in May 2006.

The photos in Figure 6 show the condition of the road surface material.

The road surface condition is not out of the ordinary for an unsealed road, with relatively low traffic volumes, as here. It is clear that there is loose metal at the edge of the roadway. However, it is not possible to compact this edge-of-road aggregate.

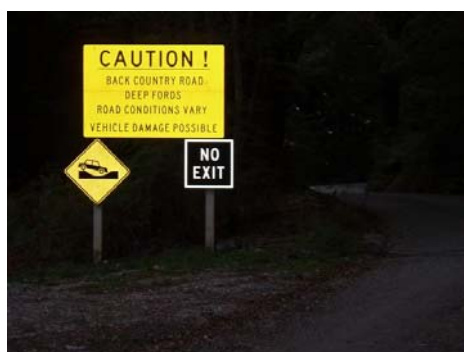
Figure 7: Warning Sign near Dart River Bridge on Road to Greenstone

A sign at the northern end of the road (Figure 7) gives a quite stark warning to motorists wishing to continue south.

The motor grading and metalling operation does not need change, except that signs warning of the presence of loose gravel should be put out at the north end and retained in place for about two week following grading. Grading and remetalling should be confined to periods when the road and available metal is damp.

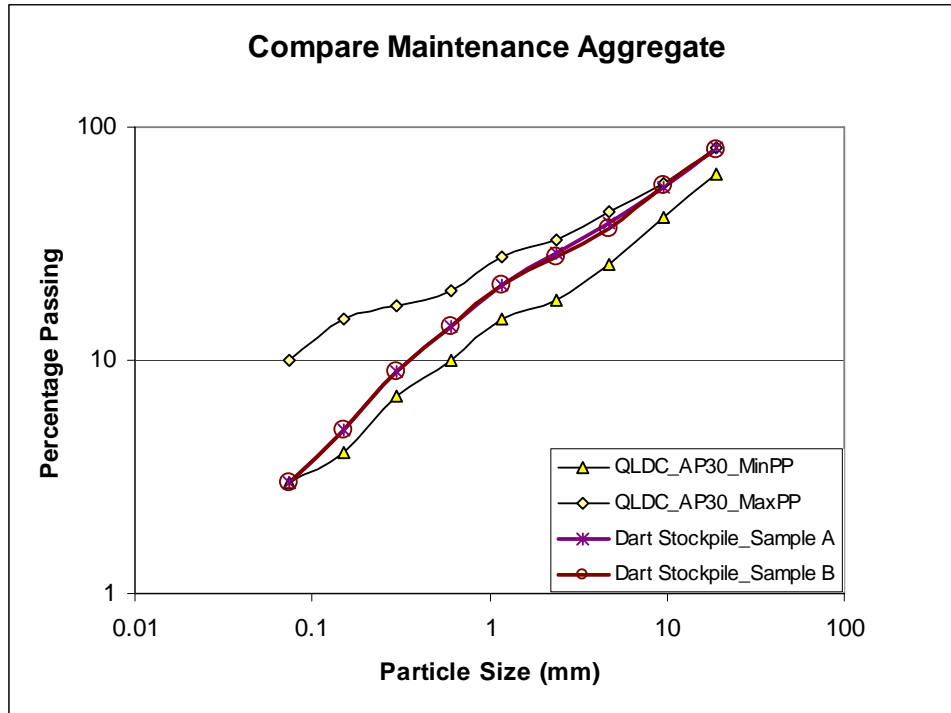
Figure 8: Comparison of Sampled Material with Specification

Figure 8 compares the specified maintenance metal with samples taken from the source stockpile for this road at the Dart River Bridge site.

The stockpile fits comfortably within the prescribed particle size gradation limits. The slope of the curve indicates a material with a smaller concentration of fine material.

Visual inspection of the material suggested the dominance of a coarse sand at the smaller end of particle size. The absence of cohesive clay material means that the metal will be unbound when it is dry, but the well graded nature of it suggests that it should pack together reasonably well. The absence of much silt means that the metal will not weave and rut under trafficking, even when very wet. The material is at its best condition when moist. Such was the case on the date of stockpile and road inspection.

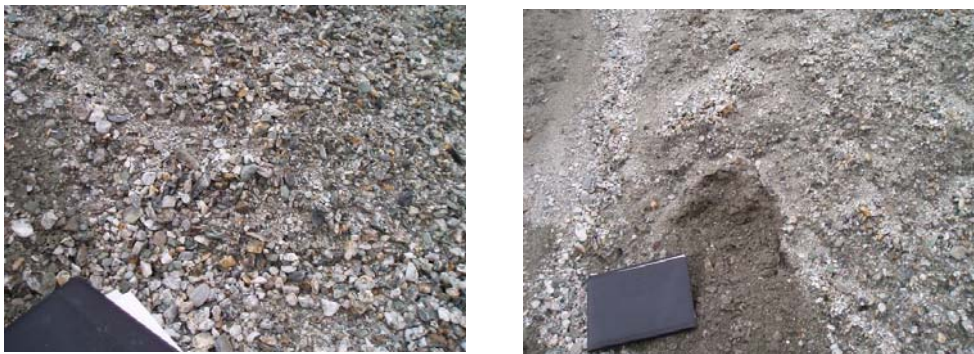
Figure 9: Stockpile of Maintenance Aggregate at Dart River Bridge Site

The photos below (Figure 9) show the stockpile of crushed metal from the Dart River.

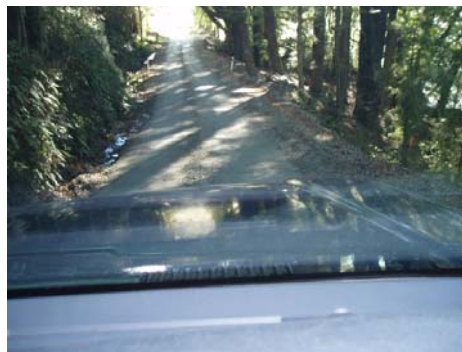
Figure 10: Natural Lighting Contrast in Glade

The bush glades pose a crash risk, through the sudden change of light, and worse, the dazzling effect of sunlight dancing between trees as the vehicle progresses. Figure 10 shows the sudden change of light (glare) for the driver emerging from the glade: the opposite effect, sudden adjustment to twilight as the driver enters, is more severe.

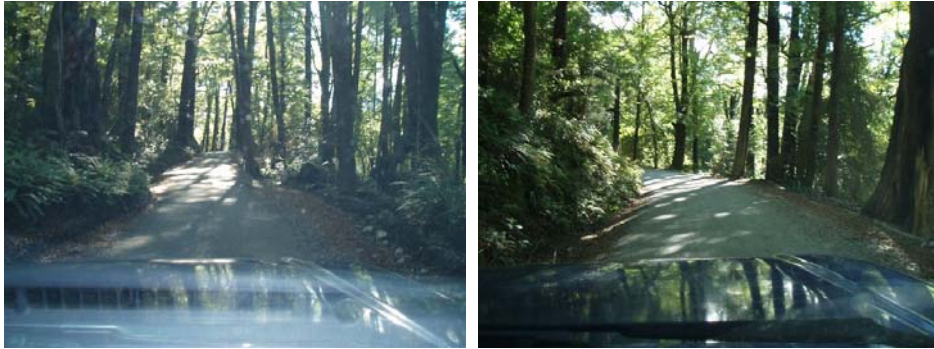
Figure 11: Small Sight Distance and Intruding Obstacles

Some beech trees near the road edge have clearly been struck by vehicles, shown by missing bark at point of impact. Figure 11 shows the sudden changes in carriageway alignment with a bank protruding at left. At right, the tree at right of the vehicle has been regularly struck by cars approaching a "blind" corner.

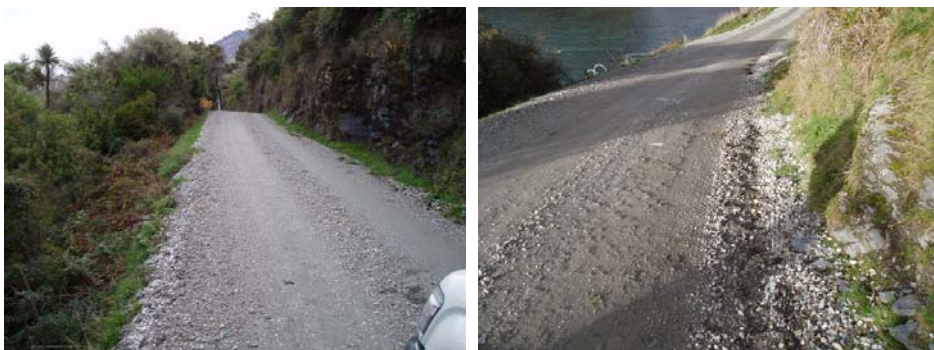
Figure 12: Views at Either Side of Crest at Greenstone Station End

The climb northbound from the jetty at Greenstone Station is “pretty steep.” For southbound traffic, there is a sudden and surprising dip after a crest. Both photos In Figure 12 look south: that at left is on the approach to the steep downgrade (not apparent to the driver at that point) while the right hand photo shows the bend immediately beyond the crest.

In the picture at right, above, it is apparent on site that a vehicle has skidded on the right side of the road. Although not clear in the picture, the vehicle has then turned towards the lake (near the shadow at upper mid section of photo). The involuntary change in direction results from the differential skid resistance between the loose gravel at the bank edge and the traffic-compacted gravel across most of the width.

The group noted that it was quite common for vehicles to hug the bank side of the road as they came south over the crest.

The rock face on the hill side of the road is not generally very high, and is part of a natural terrace. It would not therefore be difficult to widen the road by cutting back this face.

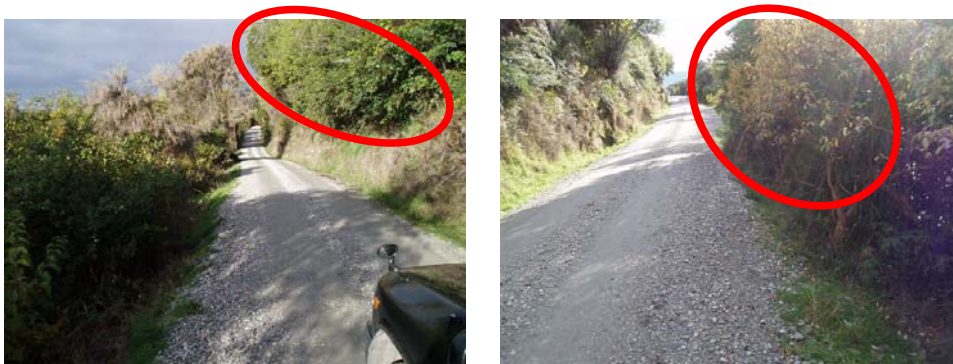
Figure 13: Encroaching Brush on Sides of Road

Weeds and brush at the roadway edge has to be controlled to help road users identify the edge. Bracken is intruding. Periodically, this was treated by mulching. Currently, a small mower is used instead: this equipment is not clearing high enough. It would be better to use spray⁴. Figure 13 shows general views of encroachment.

Often the bracken is capable of securing an errant vehicle, but there are critical locations where this does not happen.

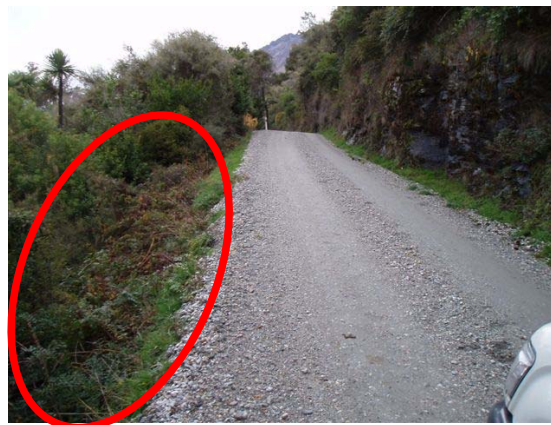
Figure 14: Imprint of Straying Vehicle on Roadside Scrub

Figure 14 shows the imprint of a vehicle that has left the road.

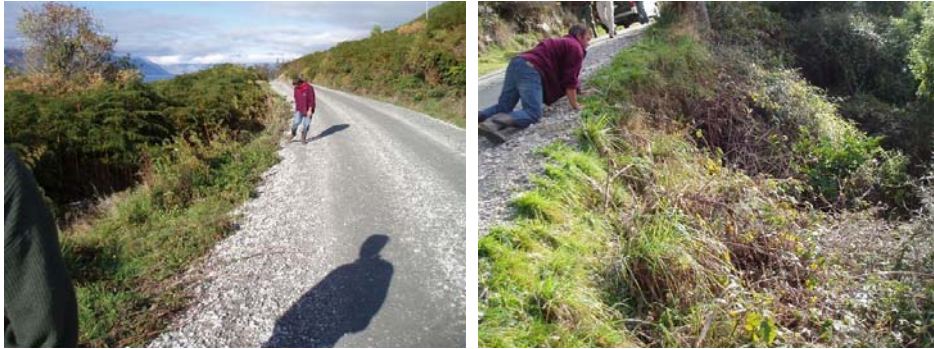
Figure 15: Absence of Verge at Lakeside Edge of Road

In places on the lake side, the road has no verge. The person in the photo at right, in Figure 15, is indicating one such drop-out.

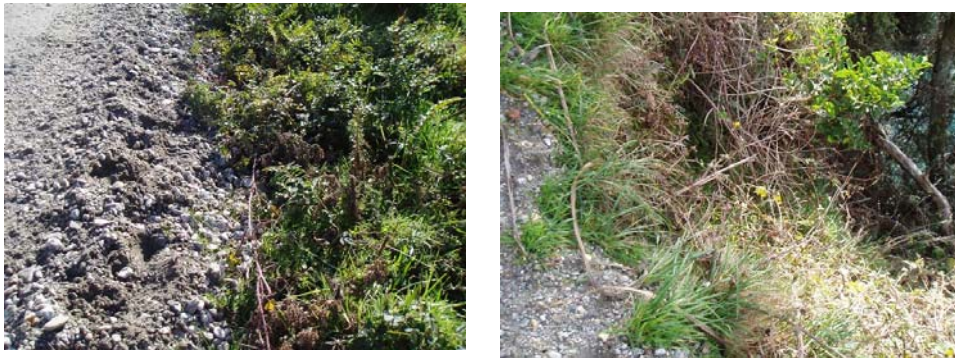
Figure 16: Unsupported Metal at Road Lakeside Edge

Maintenance metal at this unsupported edge is loose, where not bound by vegetation: two comparisons are shown in Figure 16.
