QLDC OFFICES AND LIBRARY

DETAILED SEISMIC ASSESSMENT

PHASES 1 & 2

QUEENSTOWN LAKES DISTRICT COUNCIL

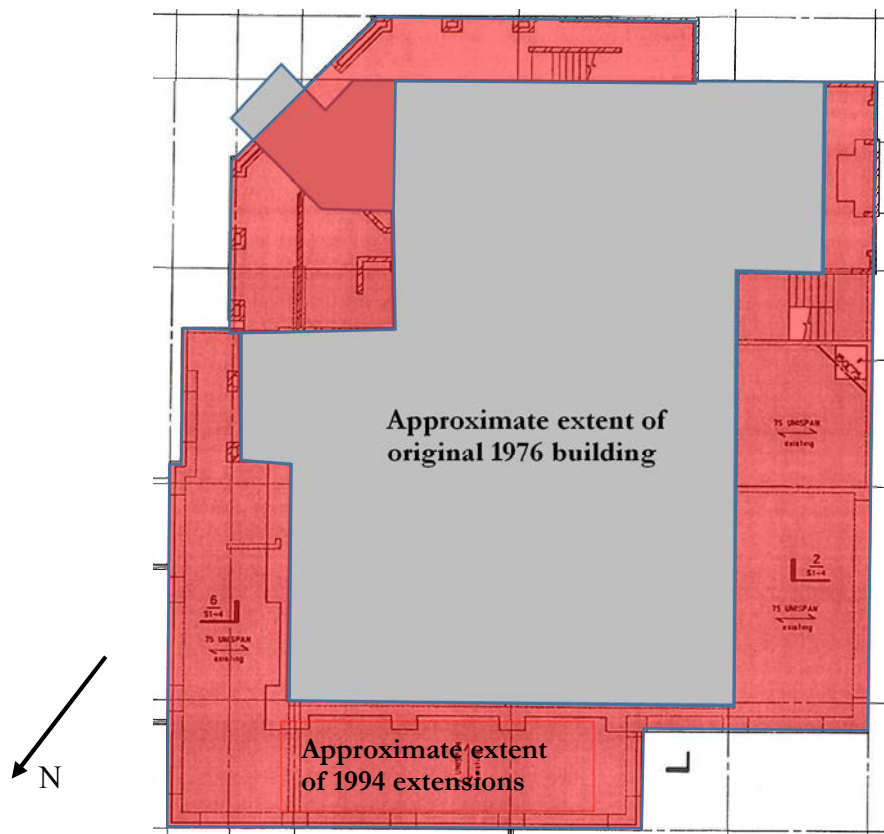
Figure 3-3: Approximate extent of first floor extension for Wakatipu Club (1994) (Inferred from 1998 drawings)

Figure 3-3 highlights the approximate magnitude of the first floor extension carried out in the 1994 alterations.

As part of these alterations, a substantial portion of the northern-most concrete blockwork wall at ground floor level appears to have been removed. Additional blockwork walls appear to have been constructed further north of this point, although it is not clear whether they were tied into the structure above, or constructed as non-structural partitions.

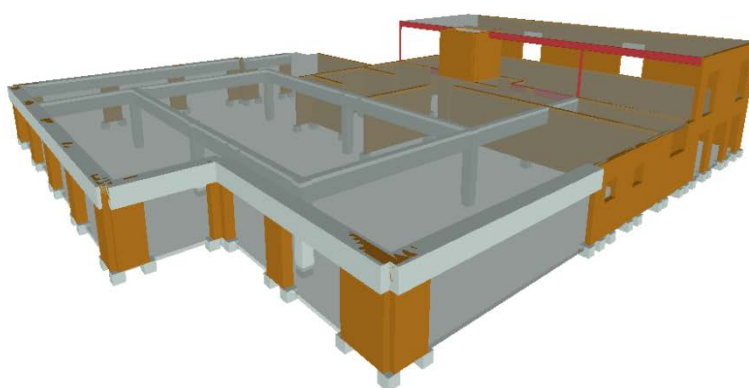
Figure 4-2: 8-10 Gorge Road – analysis model

Based on this analysis, the building is considered to have a capacity of 35% of the DBE for an Importance Level 2 building.

The capacity of the building is limited by the concrete masonry frames around the northern portion of the building. These frames reach their flexural capacity at 35% of the DBE and yielding of their foundation beams is expected to commence. The concrete masonry lift walls between first floor level and the council chambers also reach their capacity at this level of load.

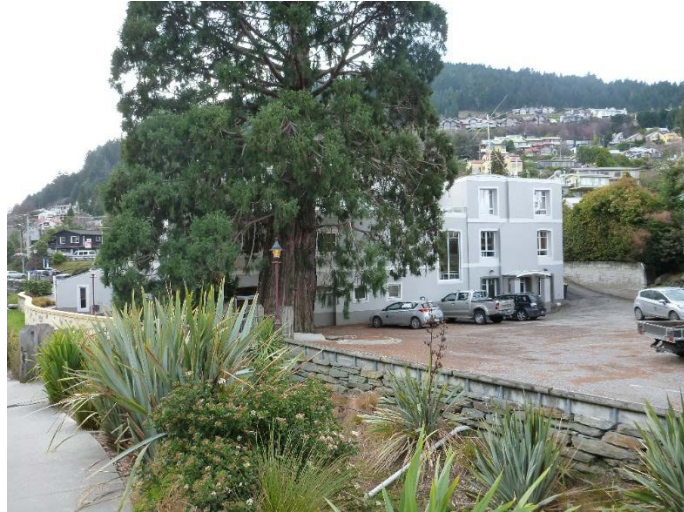
Figure 4-3: Large tree at the north-west corner of the building

A large tree is located in the north-west corner of the site. Noting that the site is subject to liquefaction in events exceeding 50% of current code as above, instability of the ground caused by loss of bearing capacity or lateral spreading towards Horne Creek could compromise the root system for this tree. Given the lightweight roof structure at 8-10 Gorge Road, the tree has the potential to cause a significant collapse if it were to fall on the building. We recommend others with appropriate expertise carry out an assessment of the tree.

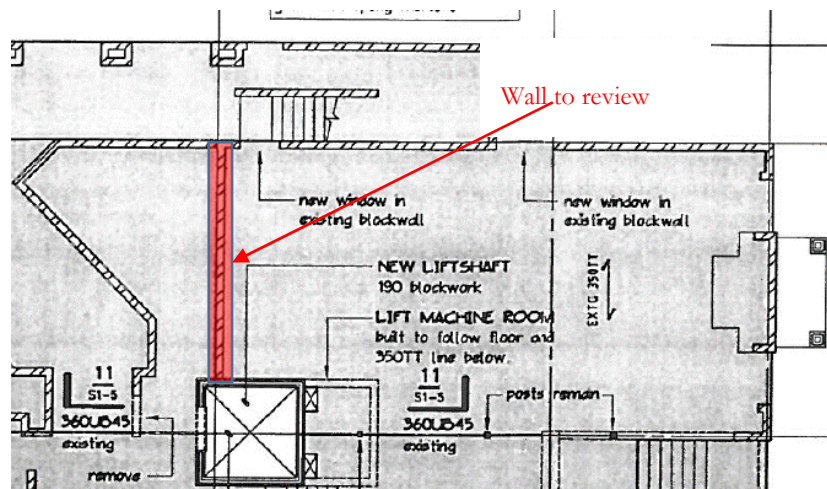
Figure 4-4: First Floor Wall

A wall between first and second floors has been assumed to resist much of the lateral loads from the floor of the council chambers. However, this wall appears to sit on the precast flooring units from level 1, and its connection to the lift core walls is unknown due to the construction sequence of these (refer to Figure 4-4). Given the importance of this loadpath, we recommend investigation of the connection of this wall to the exterior wall and the walls forming the lift shaft.

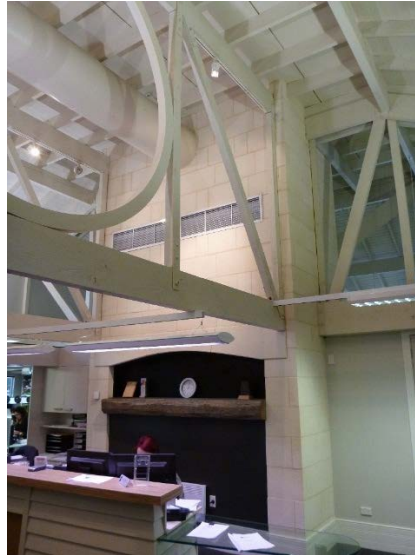
Figure 4-5: Fireplace with stone veneer

A double height fireplace extends from the QLDC reception area up to roof level as seen in Figure 4-5. We have no specific details of the fireplace construction, or fixing of the stone veneer to the concrete masonry units. Failure of the fireplace could cause localised collapse of the precast flooring and we therefore recommend further investigation of the construction of this fireplace.
