## Maxwell Place & Panorama Terrace Intersection – Tree Safety Assessment

Queenstown Lakes District Council, Parks Division, requested that Opus International Consultants complete a safety assessment of the trees near the intersection of Panorama Terrace and Maxwell Place.

A site visit was completed on 15 March 2017.

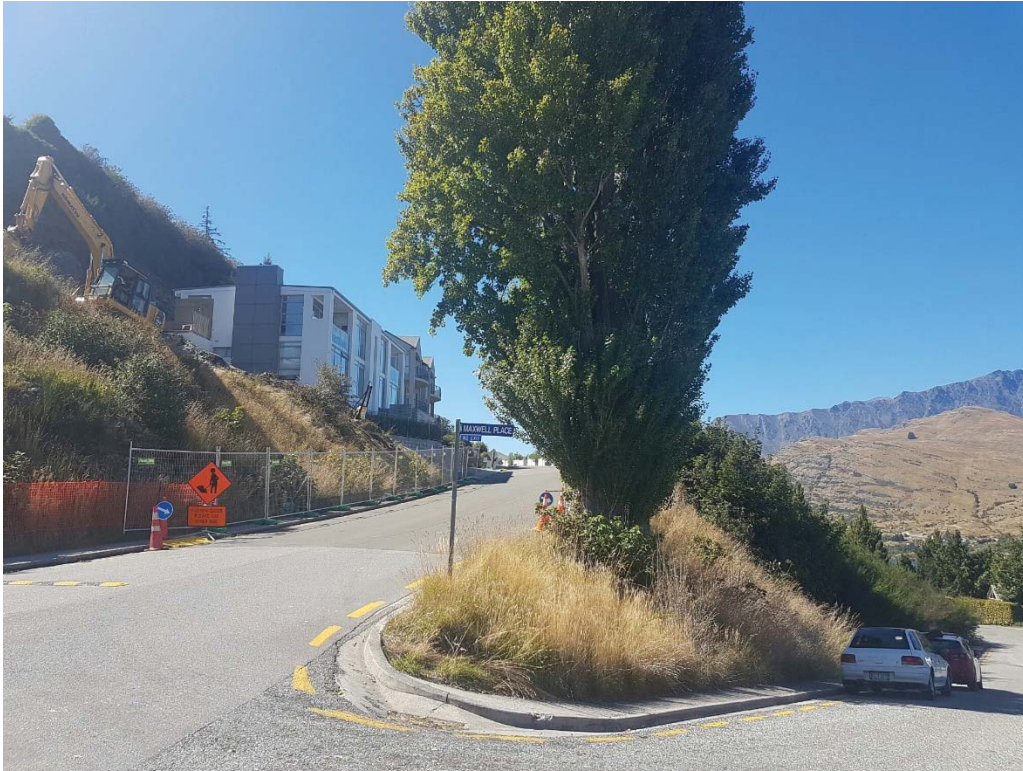
Figure 2: Trees inside corner of intersection

The trees currently pose a safety hazard by restricting sight lines at the intersection. In particular vehicles exiting Maxwell Place have poor sight distance to their right due to the trees blocking vision. This is of particular concern to cyclists as their smaller width and positioning on the road is likely to further reduce sight distance. Figure 2 shows the affected sightline, while Figure 3 shows the reverse angle.

It is recommended to remove both trees from the road reserve. The removal of the trees would be beneficial to user safety by improving sight distances, reducing the chance of icy surfaces, and removing the possibility of collision with the trees.

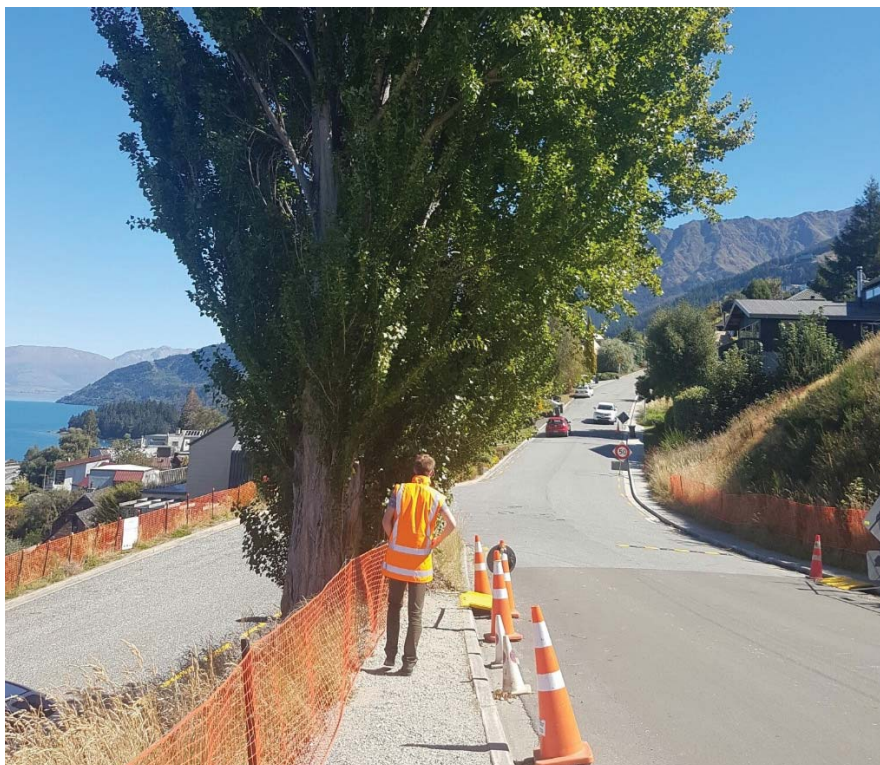
Figure 3: Trees impeding vision of intersection

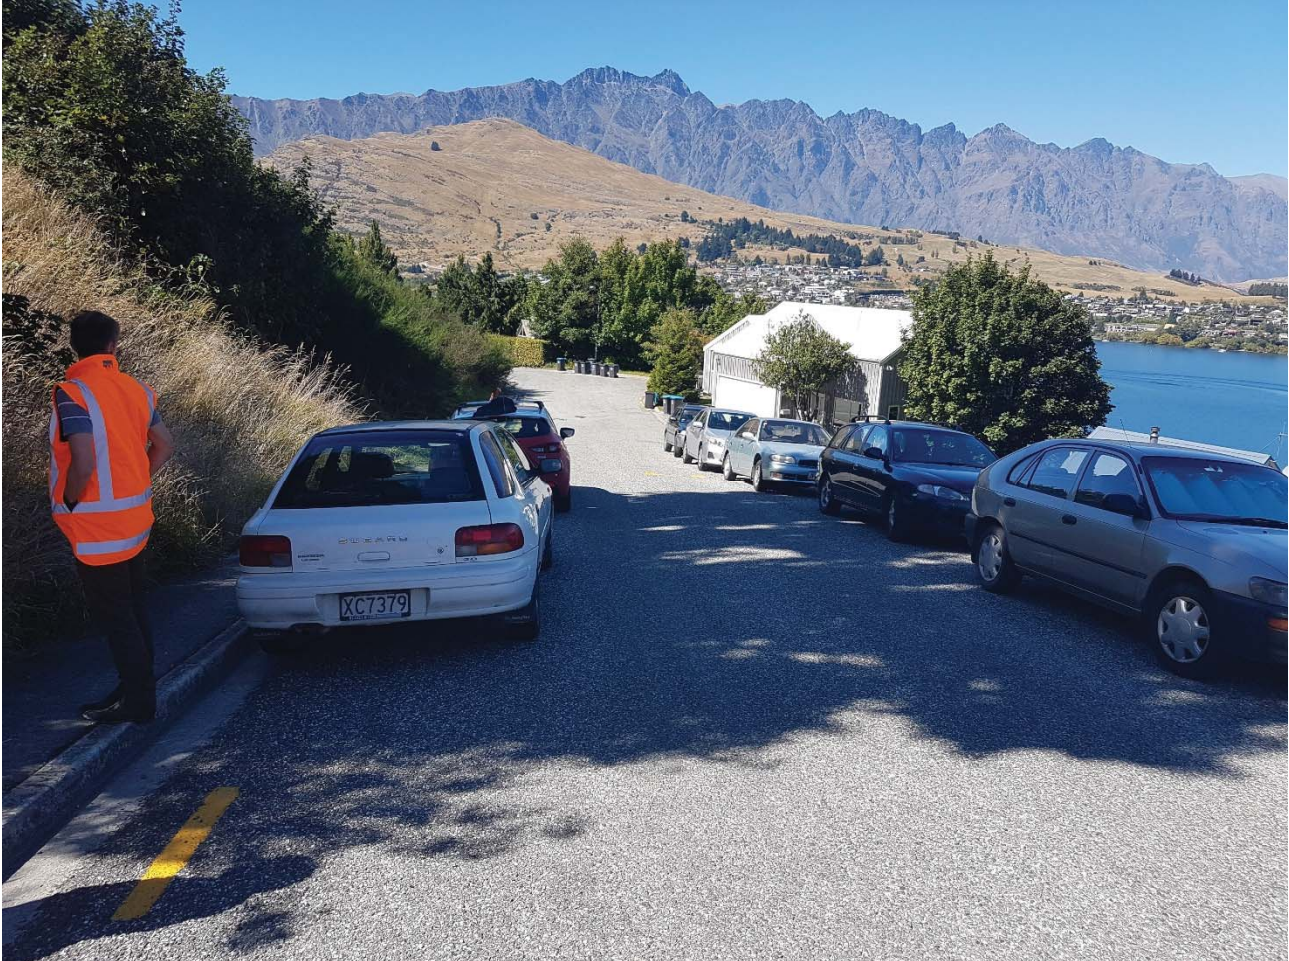
During the winter period, temperatures often reach below freezing. The shade created by the trees, figure 4, is likely to result in a dangerous icy surface near the intersection and partway down Maxwell Place as the sun cannot effectively warm the road surface.

*Figure 4: Shaded area on Maxwell Place*

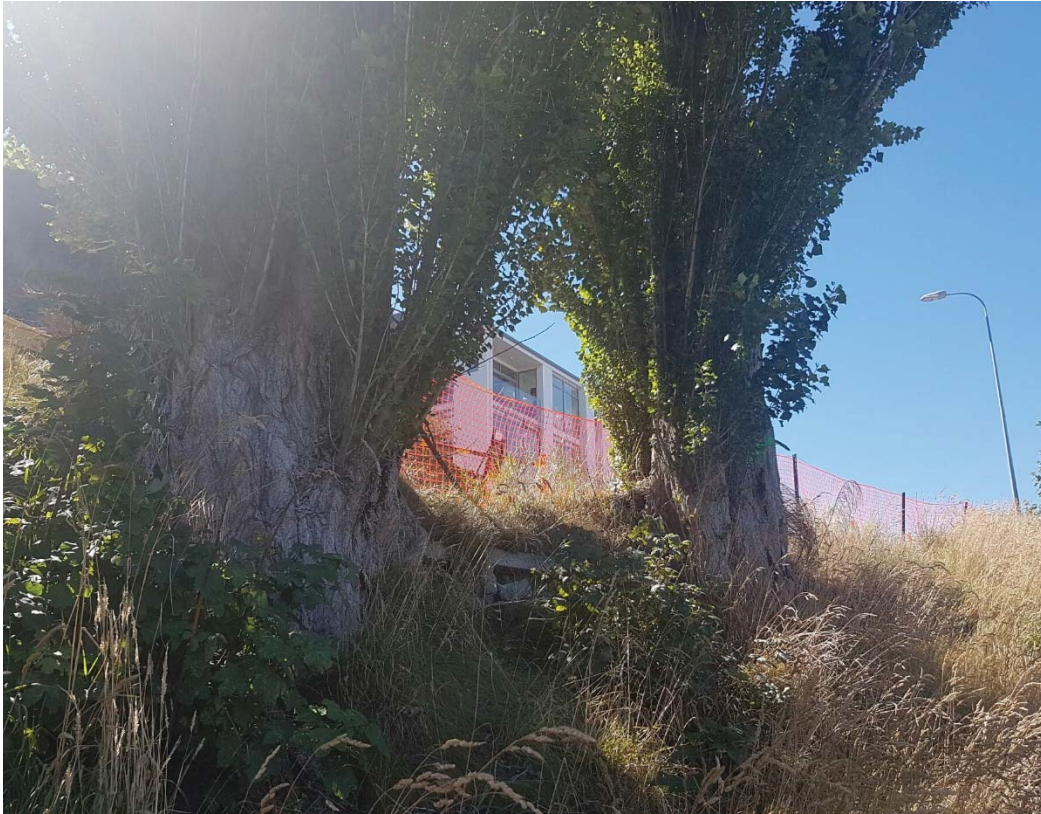
Figure 5 shows the concrete crib wall that is currently retaining the pavement shoulder of Panorama Terrace. While the trees have already undermined the existing wall in sections, the continued growth of the trees within the retaining wall is likely to damage the structure of the wall further.

There have been cases in Queenstown where Poplars have fallen over and the resulting root mass that is dislodged is substantial, thus potential damage to the carriageway and retaining wall could be significant.

*Figure 5: Retaining wall near trees, supporting Panorama Terrace*
