SINGLE STAGE BUSINESS CASE

BENNETTS BLUFF  
CAR PARK AND VIEWING AREA

3 November 2017

This report presents the results of a slope hazard assessment undertaken by GeoSolve Ltd for an area of Bennetts Bluff, Queenstown-Glenorchy Road.

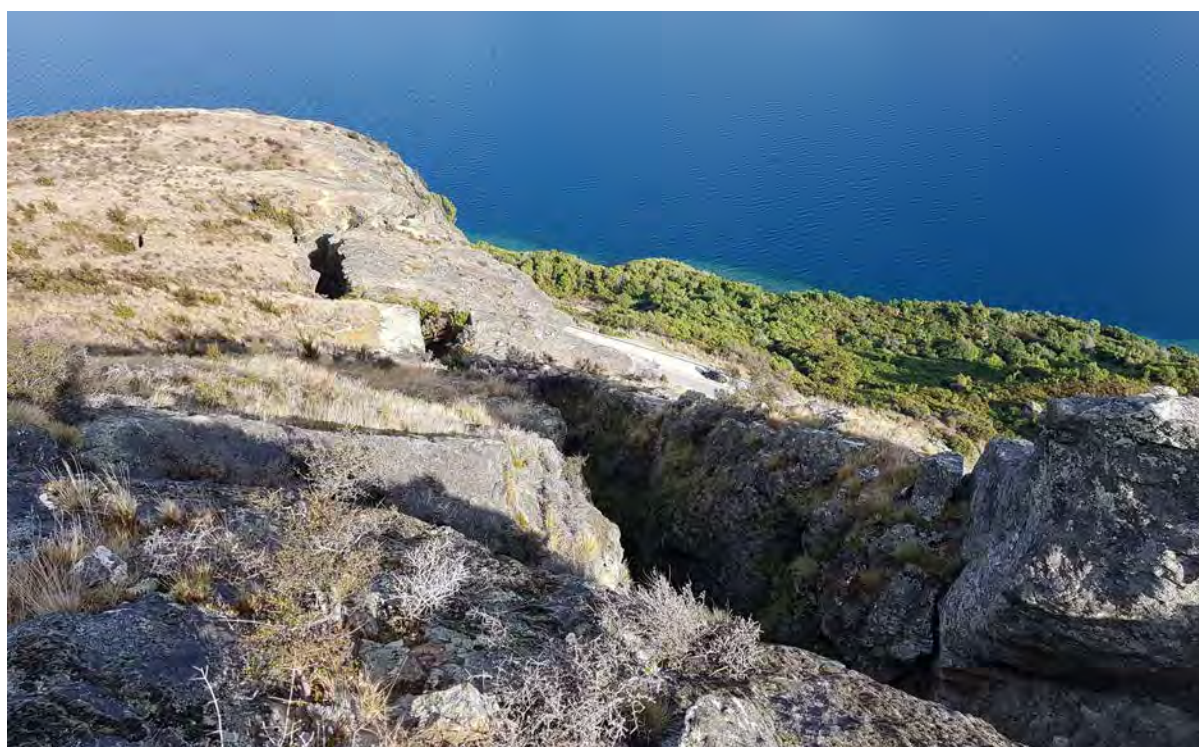
Photograph 1.1 – Showing the tension crack behind Bennetts Bluff with Queenstown-Glenorchy Road and Lake Wakatipu shown in the background.

This preliminary report identified large tension cracks, indicating significant ground movement, behind the crest of Bennetts Bluff and recommend that a detailed geotechnical assessment and ongoing survey monitoring be completed to determine the risk of future instability.

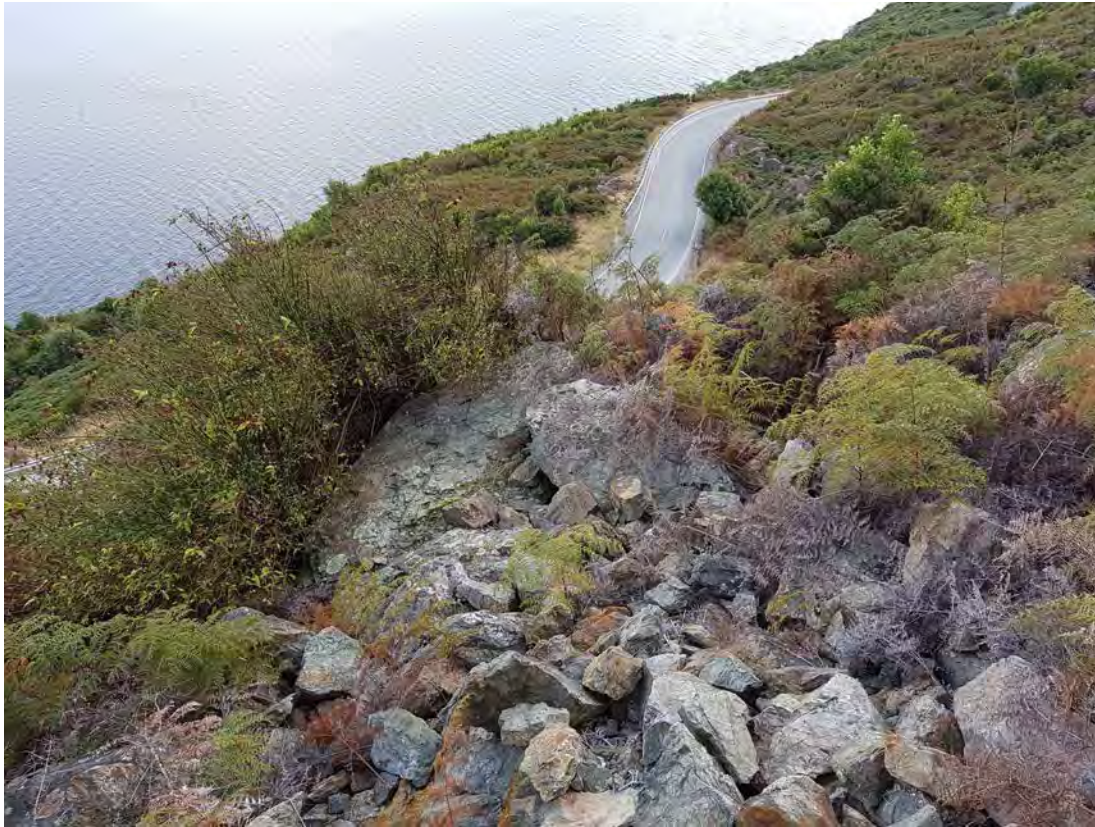
- There is significant evidence of historic and recent rock fall. Widespread rock debris is present on the slopes between the road and the bluff and comprises boulder sizes ranging from 0.1 – 3.0 m in diameter (see photograph 2.1 below). In many cases smaller boulders have come to rest against the small scrubs or larger boulders, suggesting recent failure. The debris on the surface is loose and close to angle of repose at 35 - 40 degrees;

Photograph 2.1 – Showing the rock fall debris on the slopes above the road and below the main tension crack and monitoring locations.

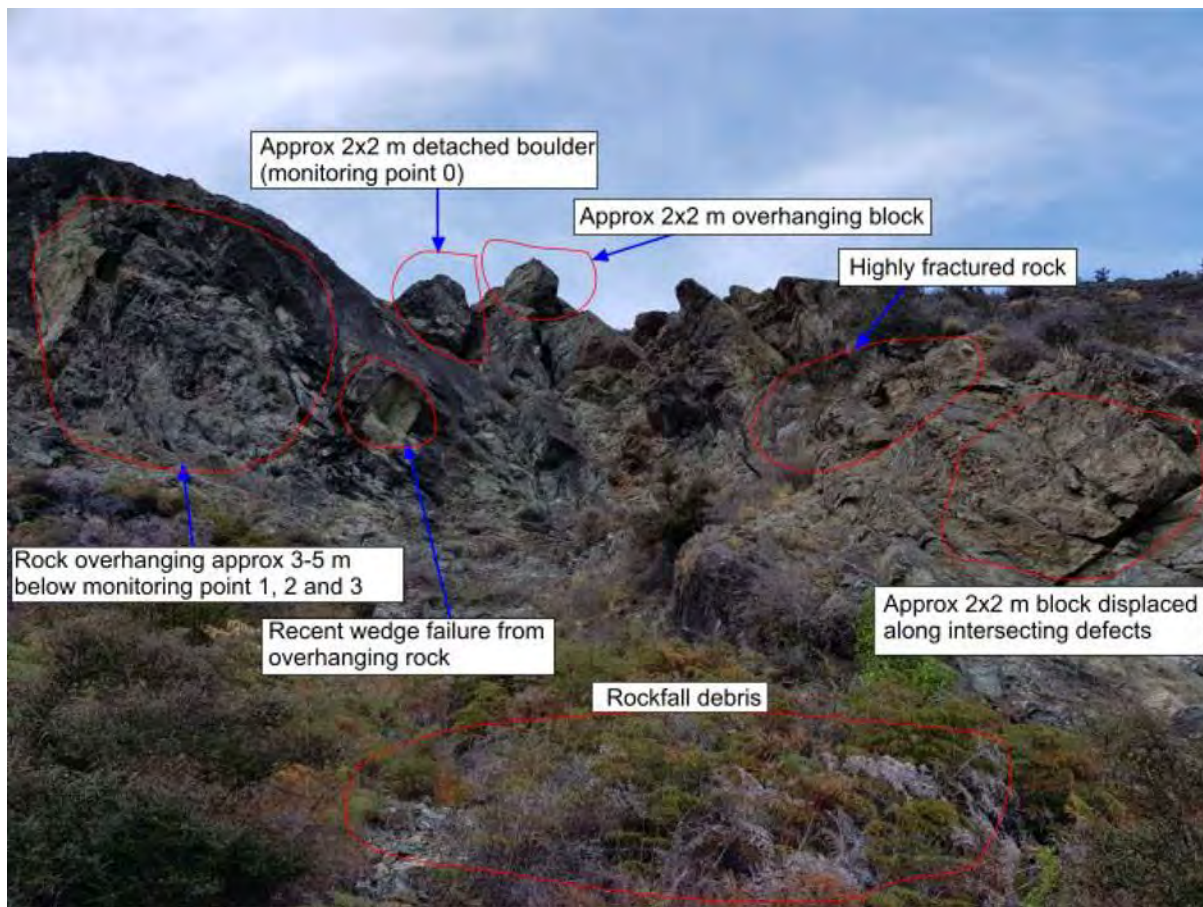
- A 'choke' of large boulders is present within the the main tension crack where it exists the face at the south western end. There is a large boulder, approx.  $8 \text{ m}^3$ , which has detached from the other boulders and sits precariously on the edge of the bluff in this location. Survey monitoring point 0 was set up on this boulder, see Photograph 2.2 below;

- The rock face is overhanging in several locations. The most significant rock overhang location is assessed to be below monitoring points 1, 2 and 3 as shown on Figure 1b, Appendix A, and Photograph 2.2 below. Here the rock appears to be overhanging by 3 - 5 m;
- In general the bluff face shows signs of ongoing rock fall and fretting with non-uniform weathering and colouring at locations where blocks have dislodged;
- The slopes beneath the bluff are expected to be a historic landslide. The bluffs themselves form the back-scar (up-slope extent) of the landslide movement. The landslide extends downslope from the bluffs, beneath the Glenorchy –Queenstown Road and to the lake below. The toe of the landslide is not well defined and may be below lake level.

Photograph 2.2 – Showing the location of the overhanging rock with other features.

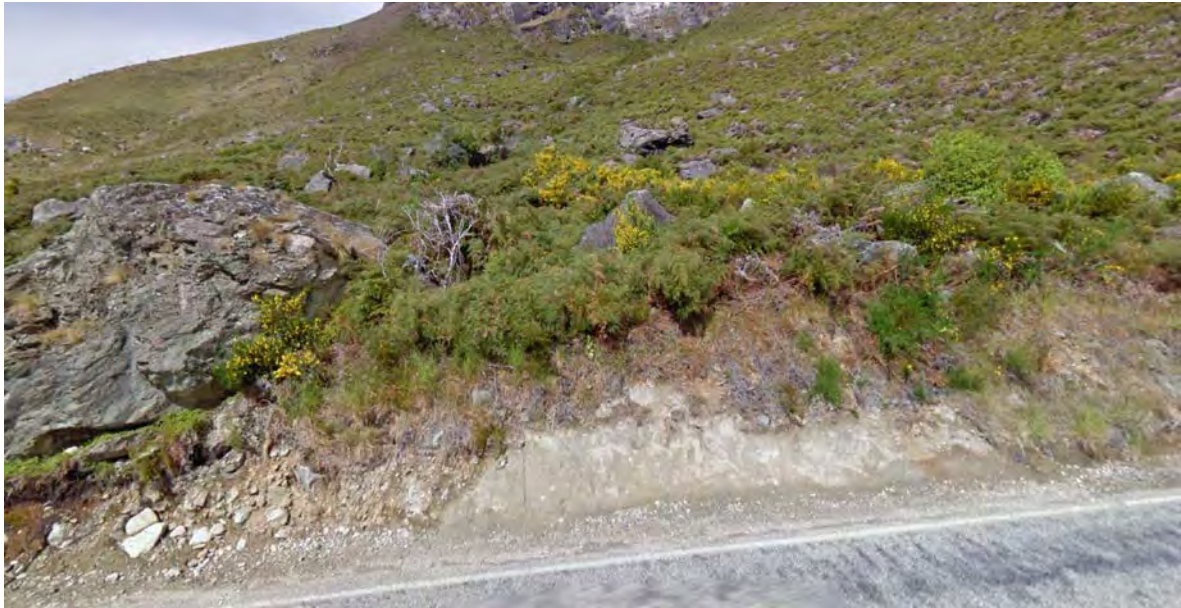
- The location and details of the identified tension cracks behind the crest of the bluff are shown on Figure 1a, Appendix A. Further inspection of the surrounding area identified a smaller tension crack extending further to the south of the main tension crack although these cracks have only displaced approximately 100 mm;
- Evidence of rock fall extending to the road and beyond is highly evident along the road length in this area as shown in photograph 2.3 below;

Photograph 2.3 – Showing many large boulders between 150-200 m away from the bluff adjacent to the road.

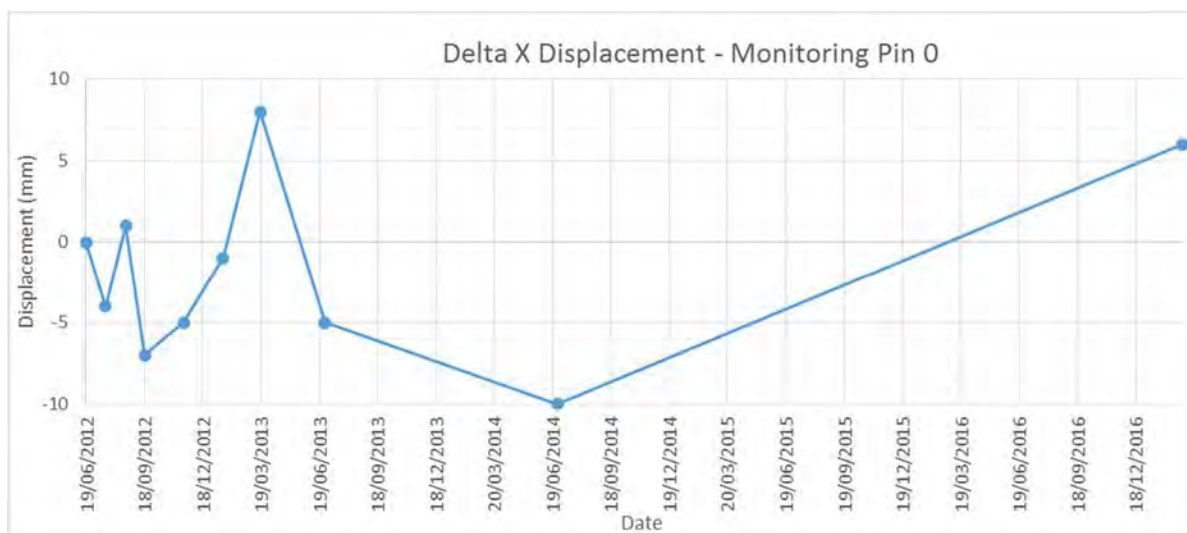
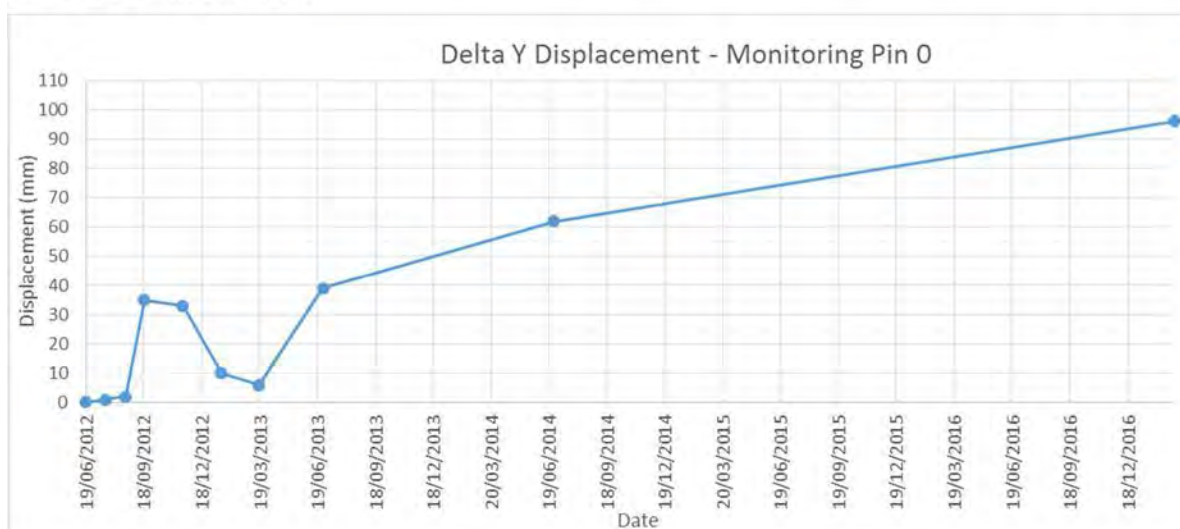
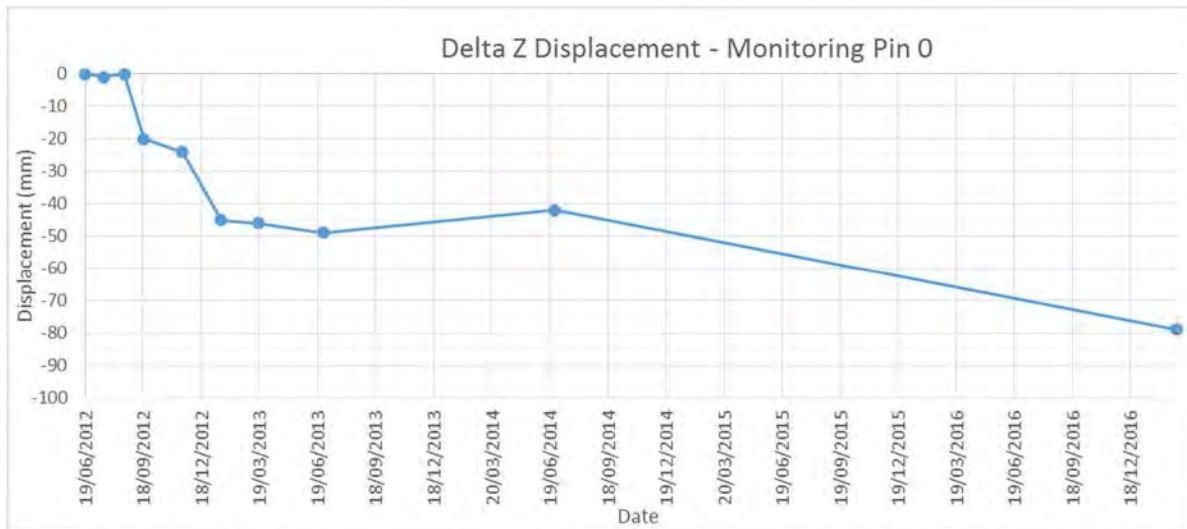
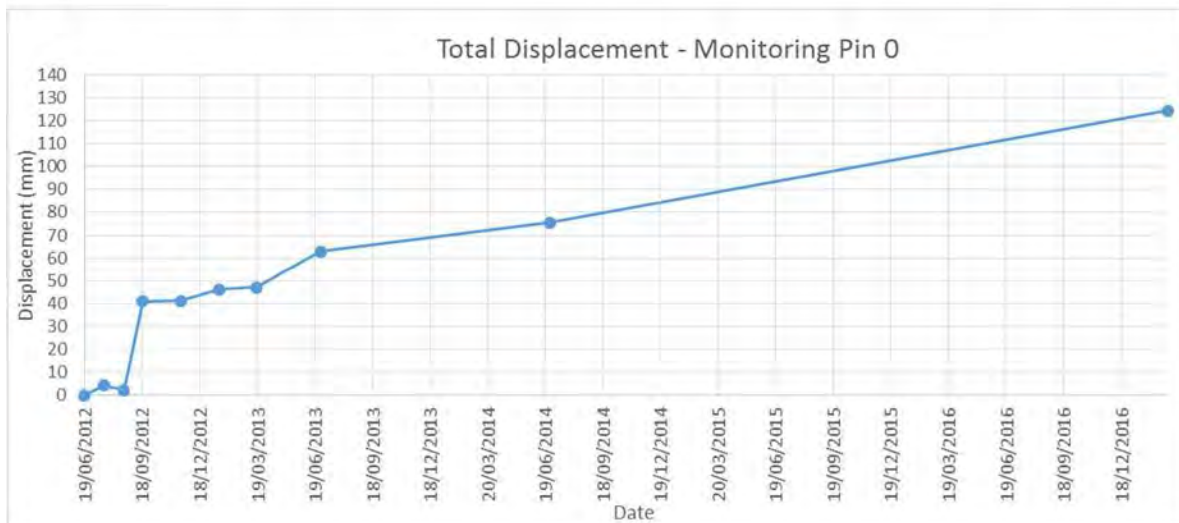
Monitoring point 0 is on a large detached boulder present at the south western end of the main tension crack. The results for monitoring point 0 are presented in Figures 2.1, 2.2, 2.3 and 2.4 below. The full tabulated results are presented in Appendix B.

In summary, there has been definitive movement of the boulder in a downhill direction with the monitoring point moving a total distance of 125 mm over the 5 year monitoring period.

- No significant movement, or trend of movement, has been identified for the main tension crack;
- The isolated boulder, present where the main tension crack exits the face at the south western end (Monitoring Point 0) exhibits clear movement both away from the face and in a downslope direction.

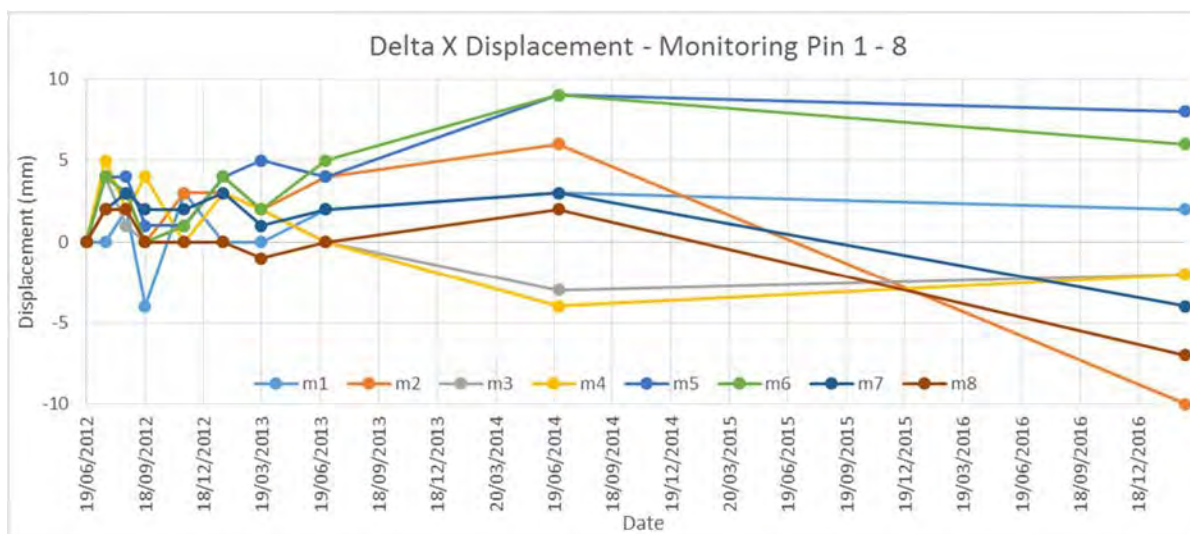
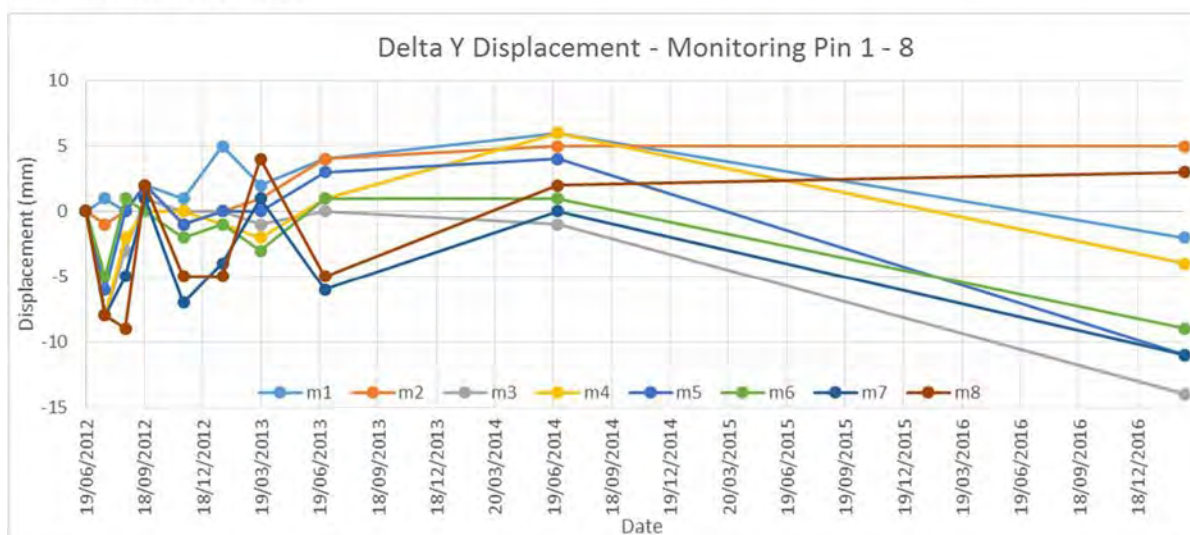
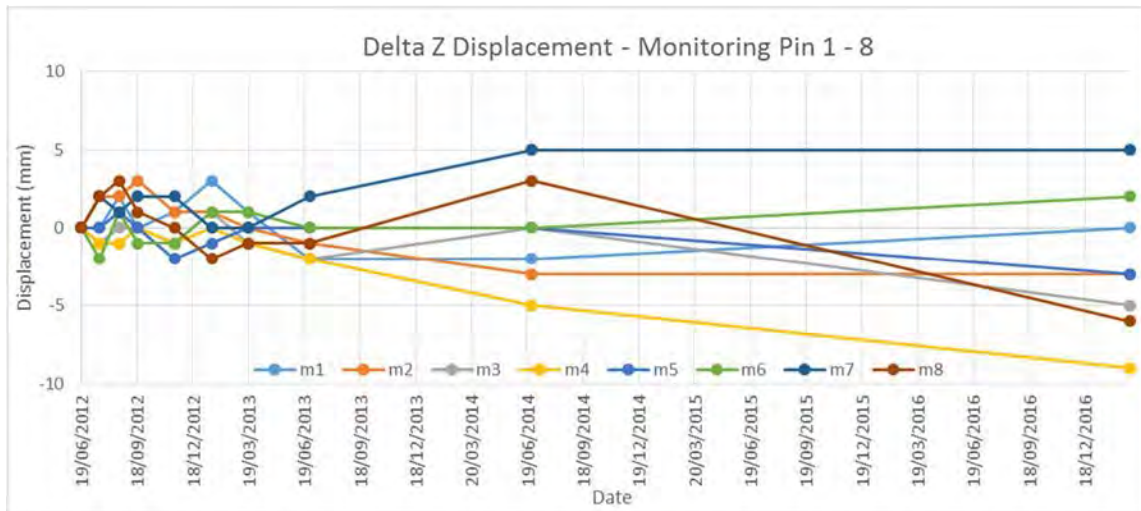
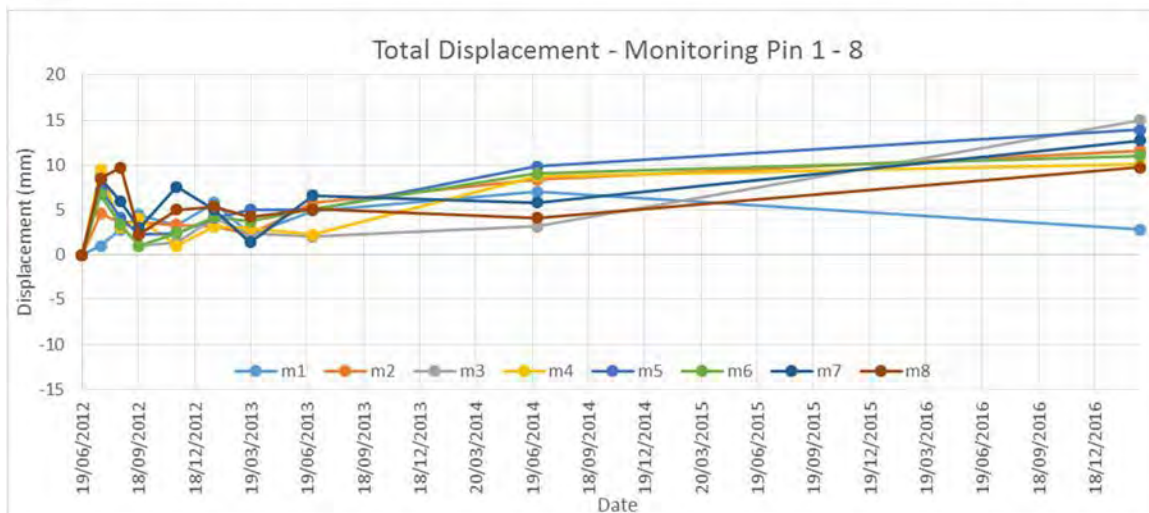
The results of the monitoring for monitoring points 1-8 are presented in Figures 2.5, 2.6, 2.7 and 2.8 below. The full tabulated results are presented in Appendix B.

In summary, the spread of the results within the first year of monitoring are within the accuracy of the survey equipment and therefore not conclusive. The total spread increases at the next survey completed a year later and then again nearly 3 years later. The direction of the movement for the monitoring pins does not generally remain consistent between the monitoring dates. A clear trend of movement cannot be interpreted from the results in any of the three orthogonal directions. Overall displacements are low (<15 mm) and the increase of the total spread overtime is assessed to result to a decay of the survey points and natural processes such as freeze-thaw etc.

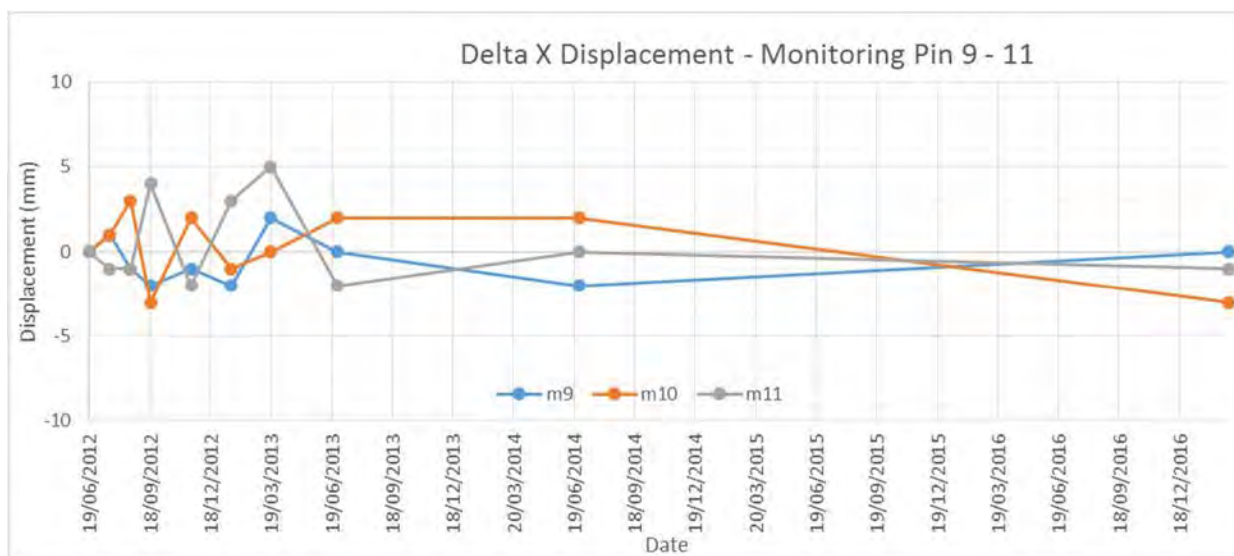
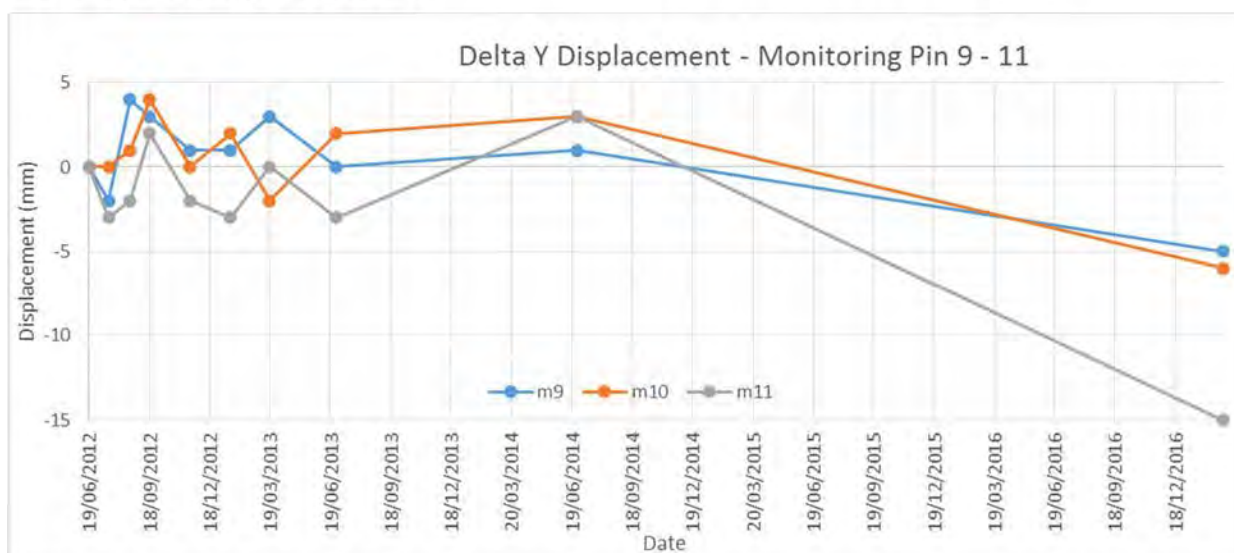
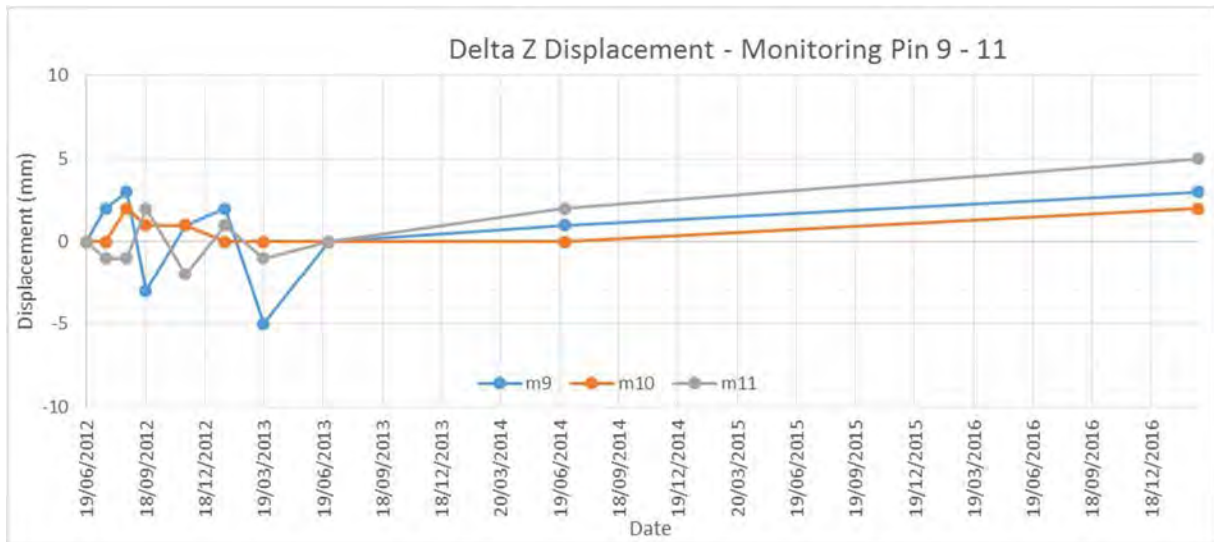
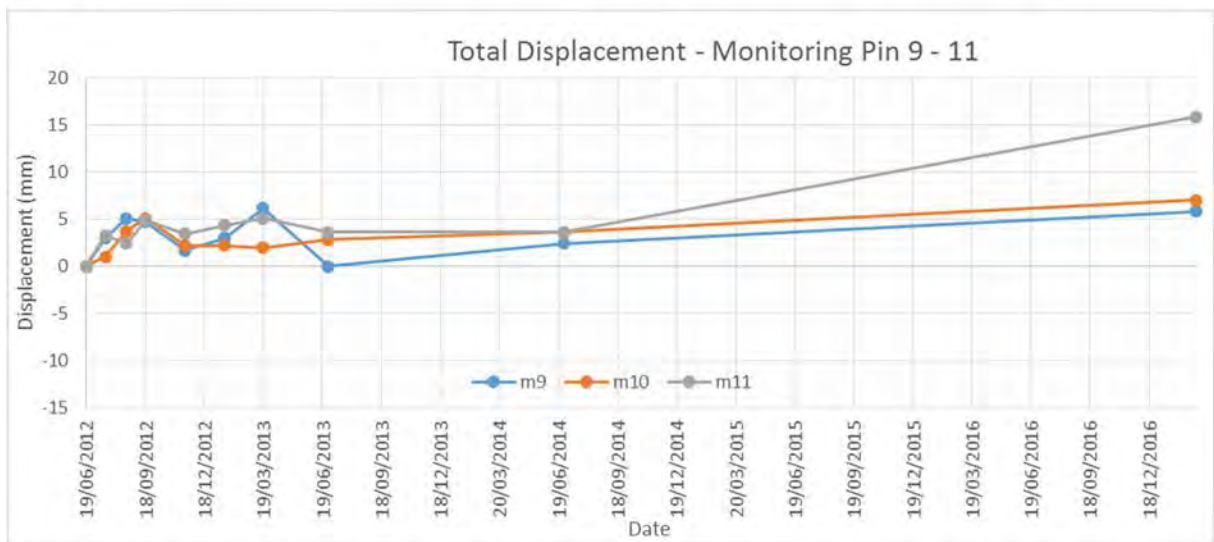
The results of the monitoring for monitoring points 9-11 are presented in Figures 2.9, 2.10, 2.11 and 2.12 below. The full tabulated results are presented in Appendix B.

In summary, the monitoring results are within the accuracy of the survey equipment with the exception of monitoring point 11 on the y axis for which movement of 15 mm was recorded on the final survey. It is unclear what the cause of this movement is, however, it is inferred to be a result of local weathering/damage to the monitoring point given that no other points show similar movement.

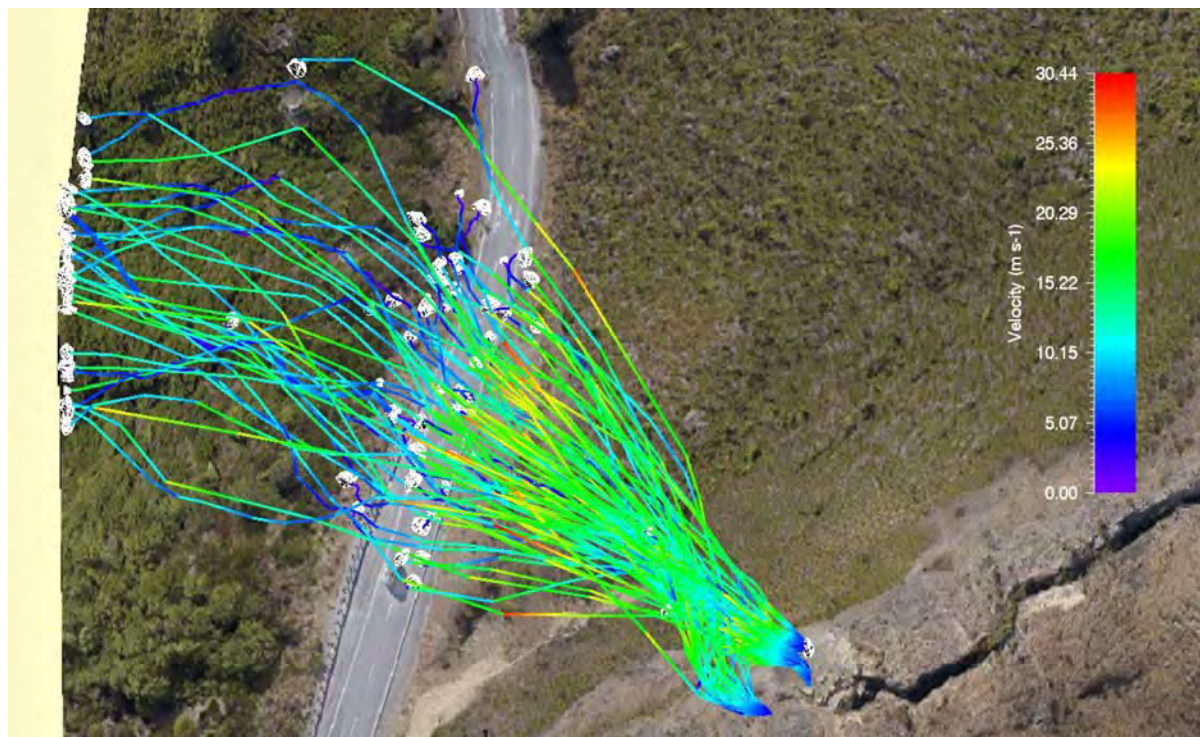
A total of 85 rock fall scenarios were analysed comprising 8 different blocks ranging between 0.5 to 8.0 m<sup>3</sup>. These blocks were released at a number of randomly generated orientations. The trajectories of the rock falls is shown on Figure 4.1 below.

Figure 4.1 – Showing the predicted trajectories of the subject rock falls.

The results of the analysis show that approximately 13% of the blocks did not reach the road, remaining on the slope above. The probability of the rocks impacting the 70 m length of road is assessed to be 87%.

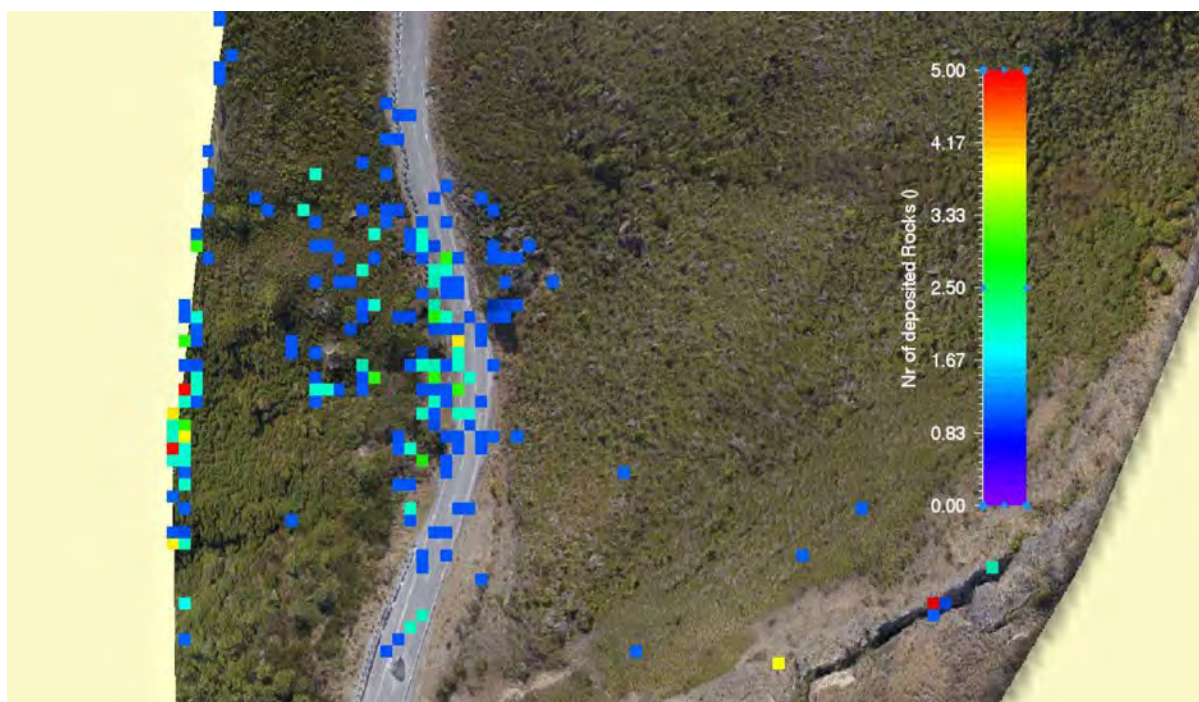
A total of 280 rock fall scenarios were analysed comprising 8 different blocks ranging between 0.5 to 10 m<sup>3</sup>. This assumes the rock will readily break up on the slopes above the road. These blocks were released at a number of randomly generated orientations at points along the bluff for the length of the main tension crack. The final resting location of the blocks and the results of the analysis are presented in Figure 4.2 below.

Figure 4.2 – Showing the final resting locations of the modelled rock fall blocks.

The results indicate an approximately 85% probability of reaching the road at the southern end of the main tension crack reducing to approximately 50% at the northern end.

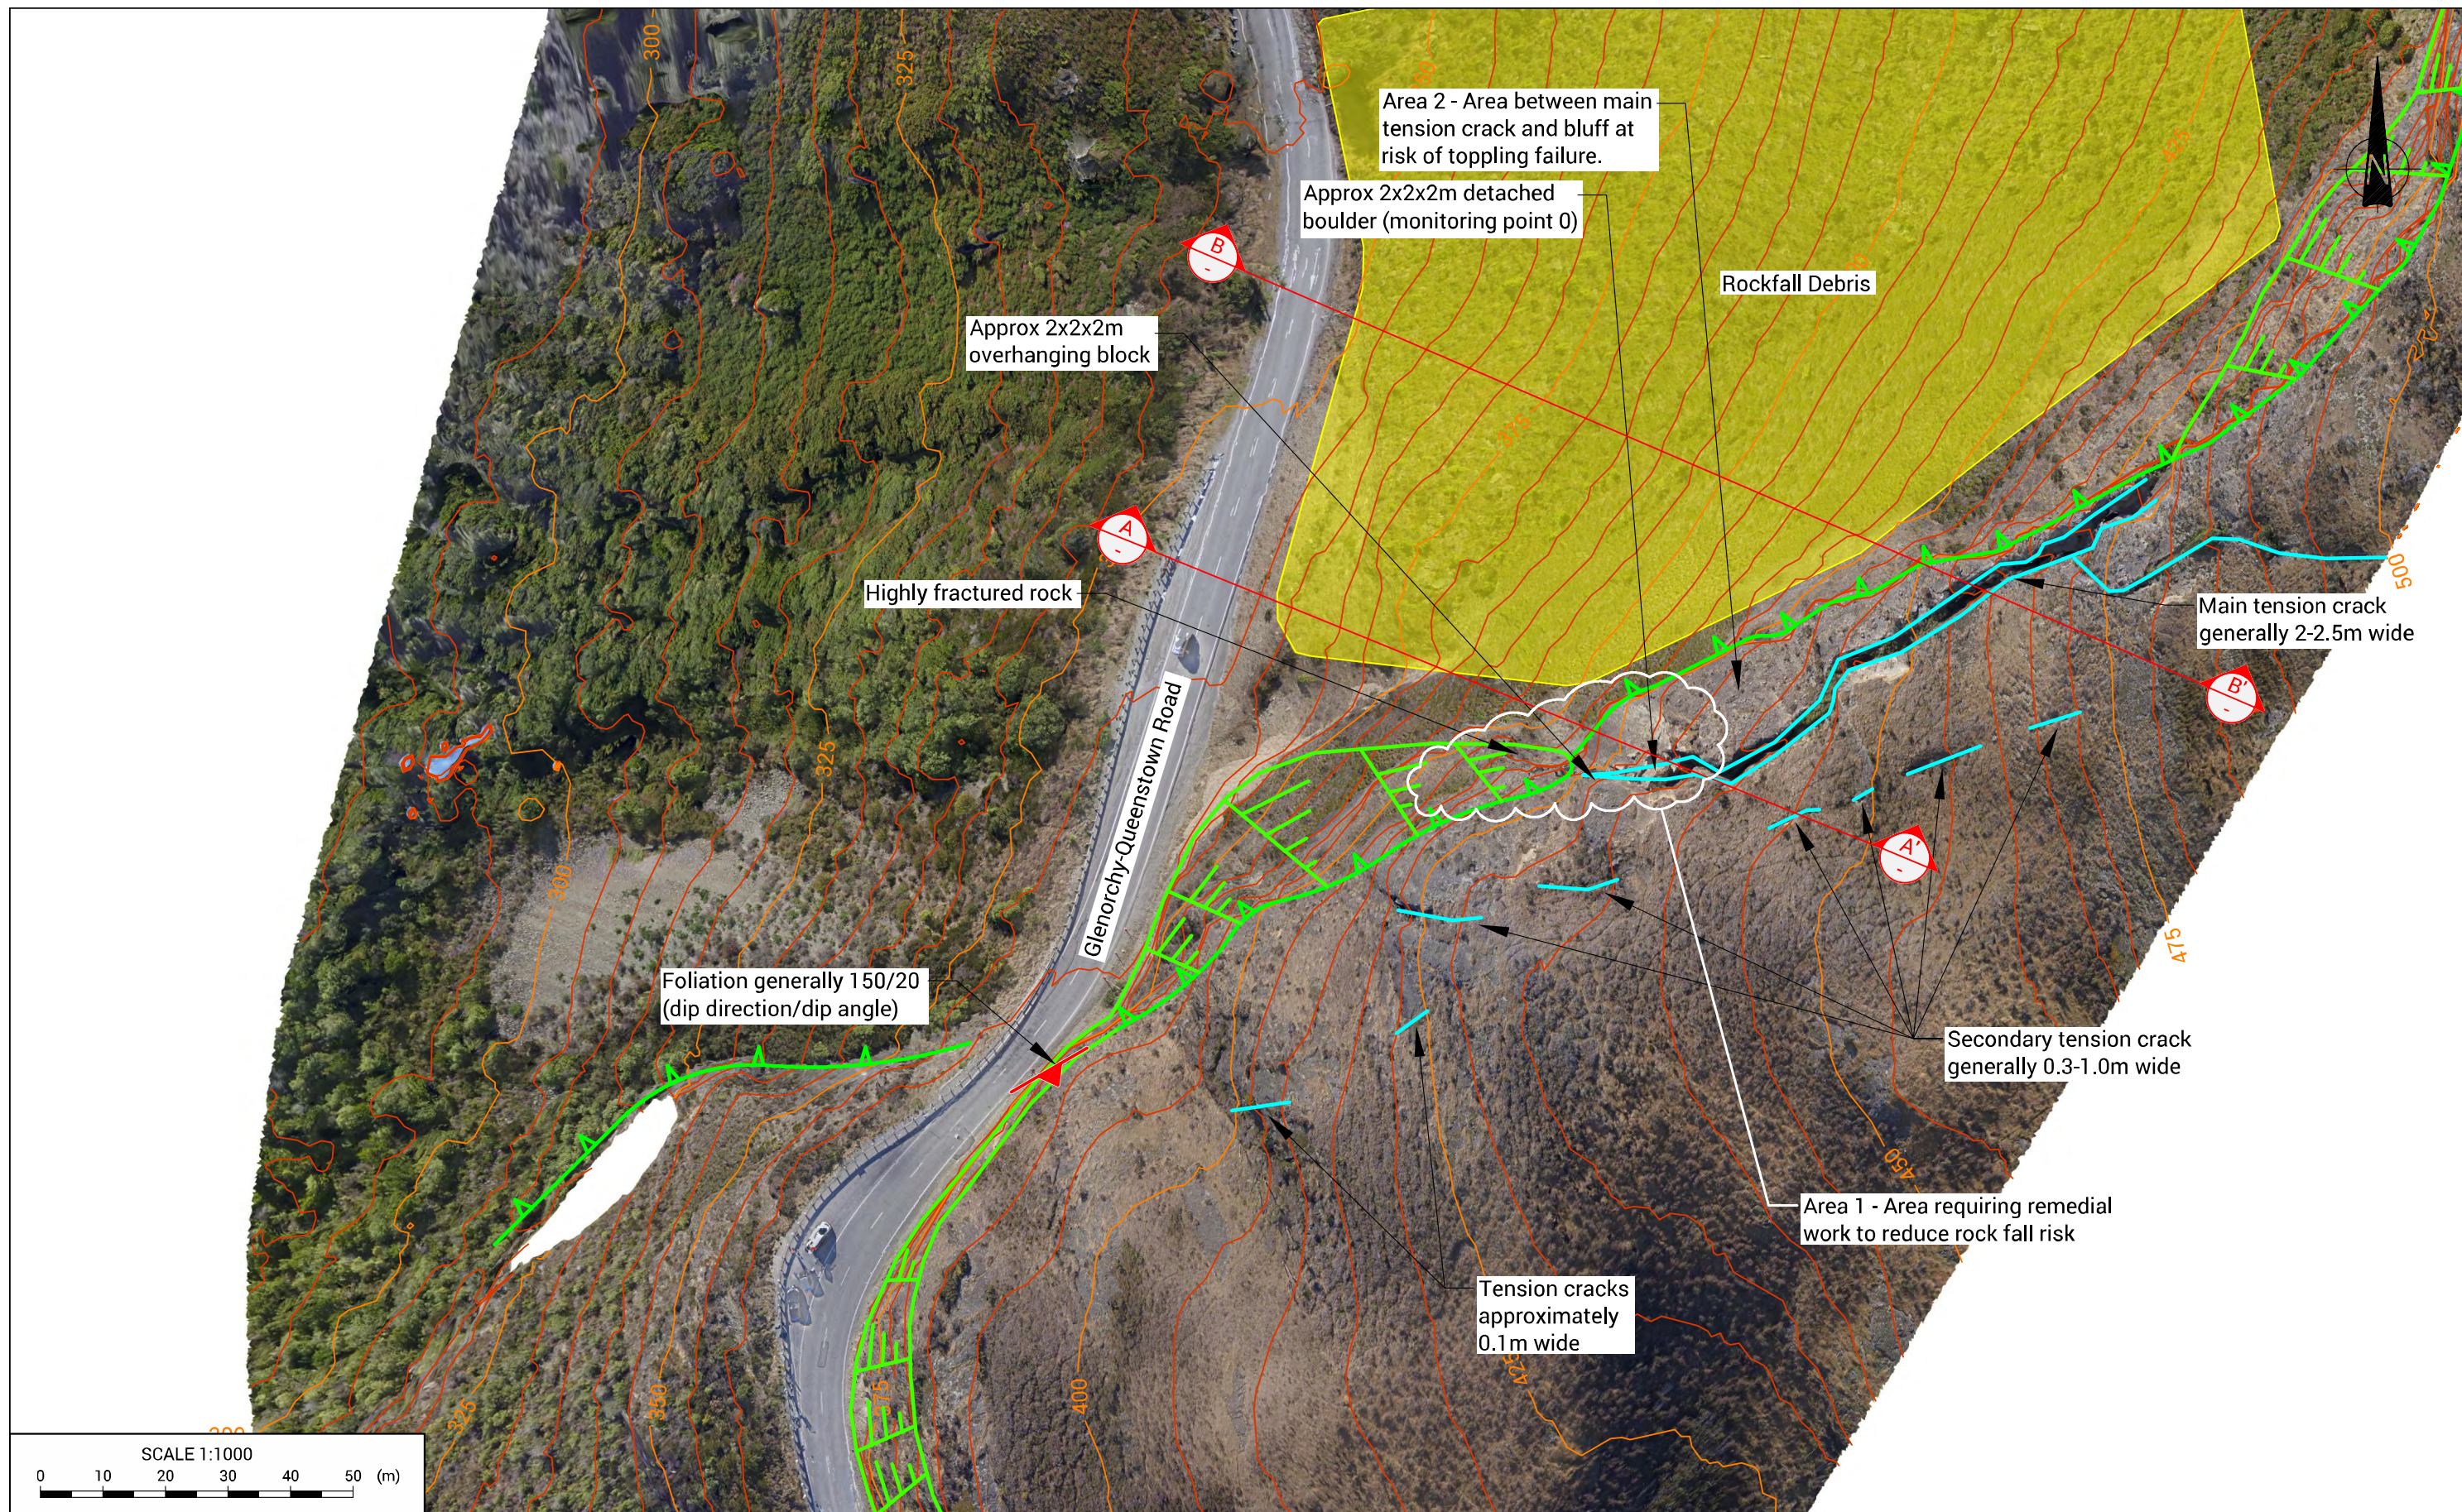
Queenstown Lakes District Council		
Bennetts Bluff, Queenstown-Glenorchy Road		
Geotechnical Assessment		
Site Plan		
FIG No:	Figure 1a	REV. 0

- Two tension cracks are present running parallel to and a short distance up slope of the bluff face. The main tension crack is situated approximately  $< 1.0 - 14$  m behind the bluff, depending on location, and extends for a length of approximately 100 m. This tension crack is predominantly between 2 - 2.5 m wide. The depth of the crack has not been measured directly due to access issues however it is estimated to be several tens of meters. See Figure 1a, 2a and 2 b Appendix A;

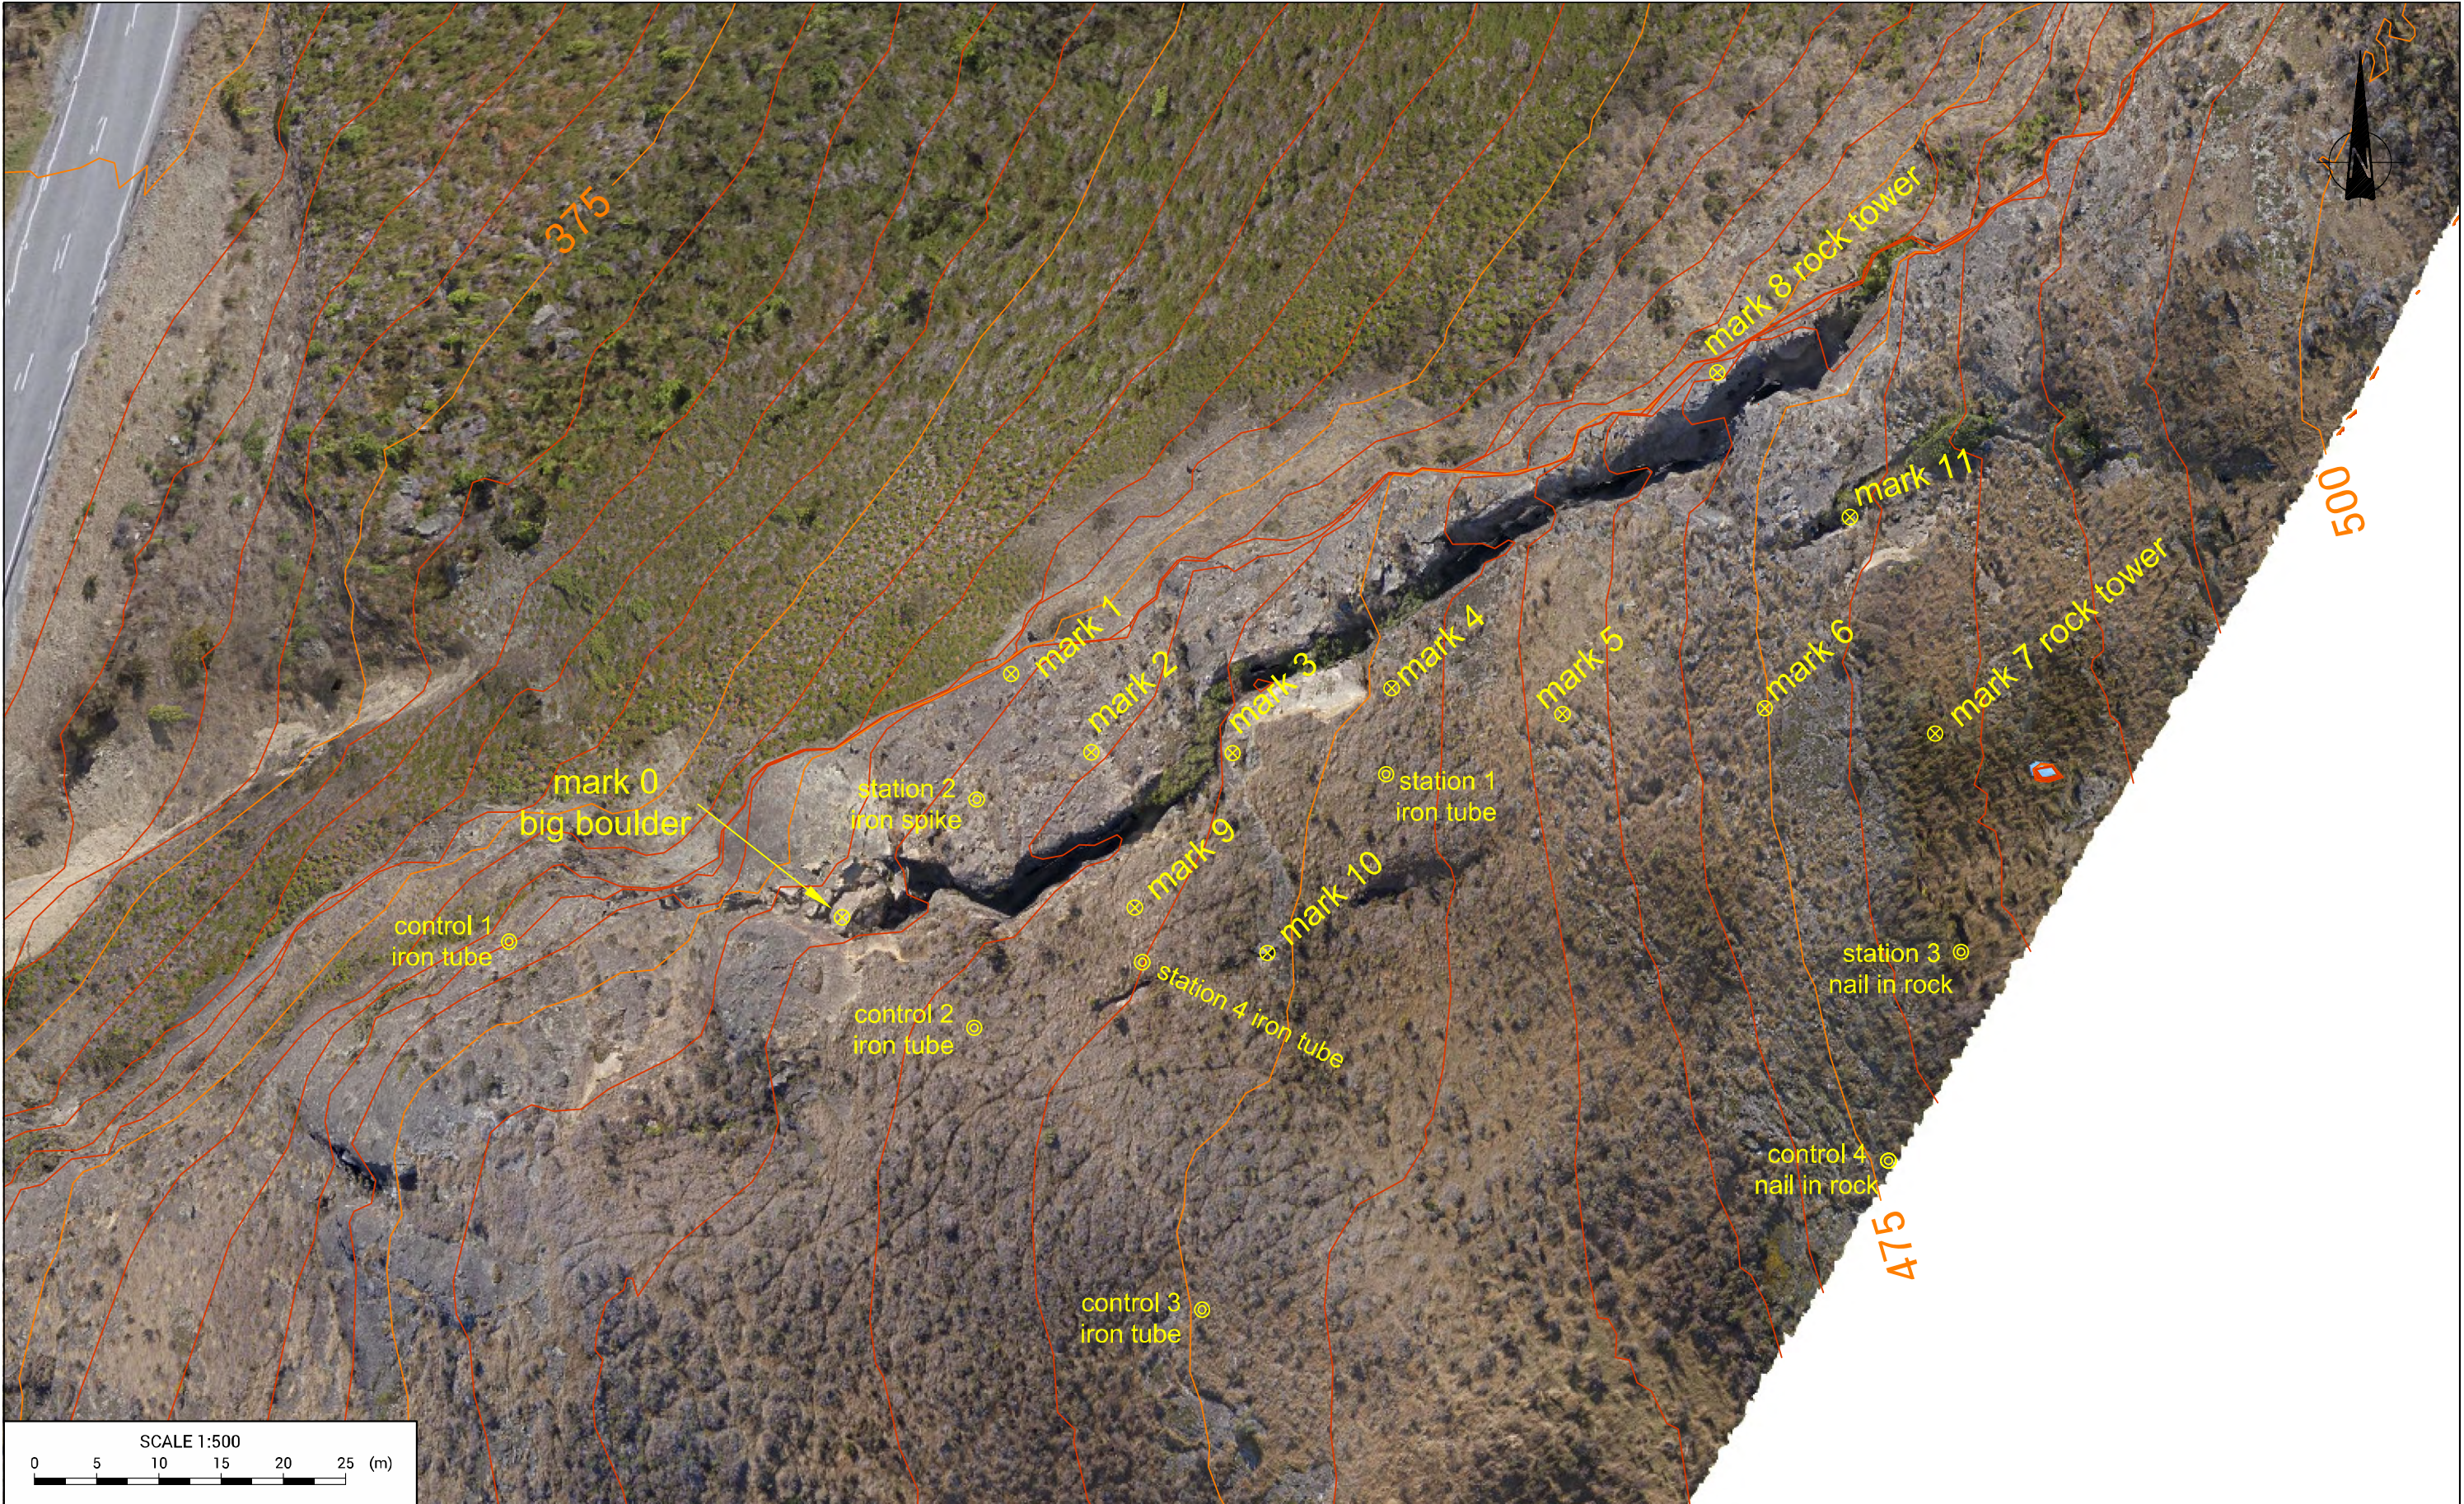
Queenstown Lakes District Council		
Bennetts Bluff, Queenstown-Glenorchy Road		
Geotechnical Assessment		
Monitoring Points Plan		
FIG No: Figure 1b	REV. 0

- The condition of the rock where the main tension crack exits the bluff face is highly fractured (as shown on Figure 1b, Appendix A) and there are several blocks of  $1-8 \text{ m}^3$  considered to be potentially unstable;
