Preliminary Geotechnical Report

Proposed Glenpanel SHA
Ladies Mile
Queenstown

June 2016
GeoSolve Ref: 160403

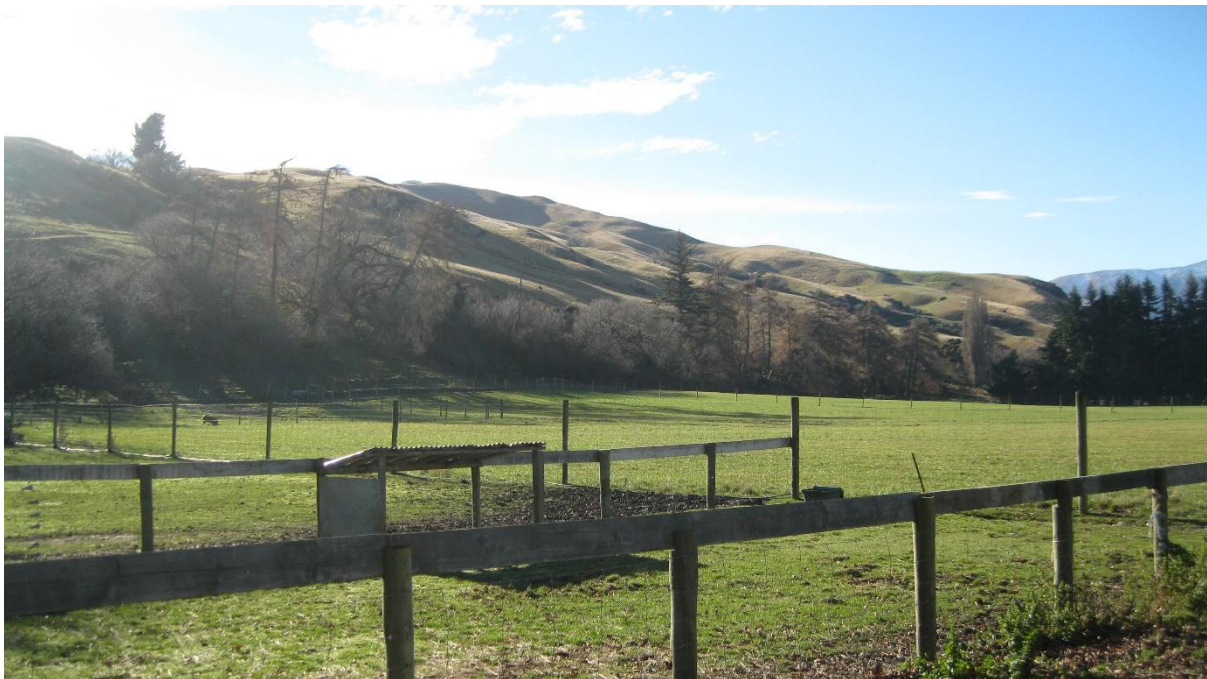
Photo 4: View northeast towards eastern-most alluvial fan feature, northern boundary area. Gully indicated by vegetation extending upslope.

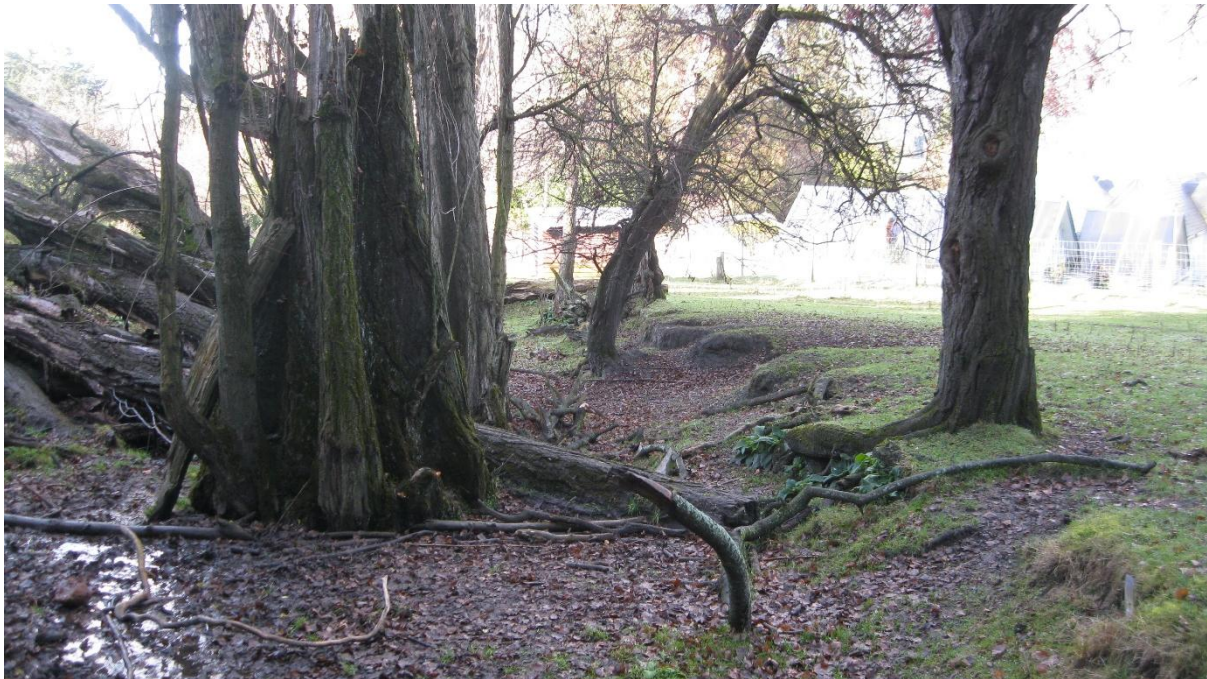
Photo 5: View downstream from mouth of main alluvial fan gully. Weak stream flow evident on left. Glenpanel homestead on downstream part of fan.

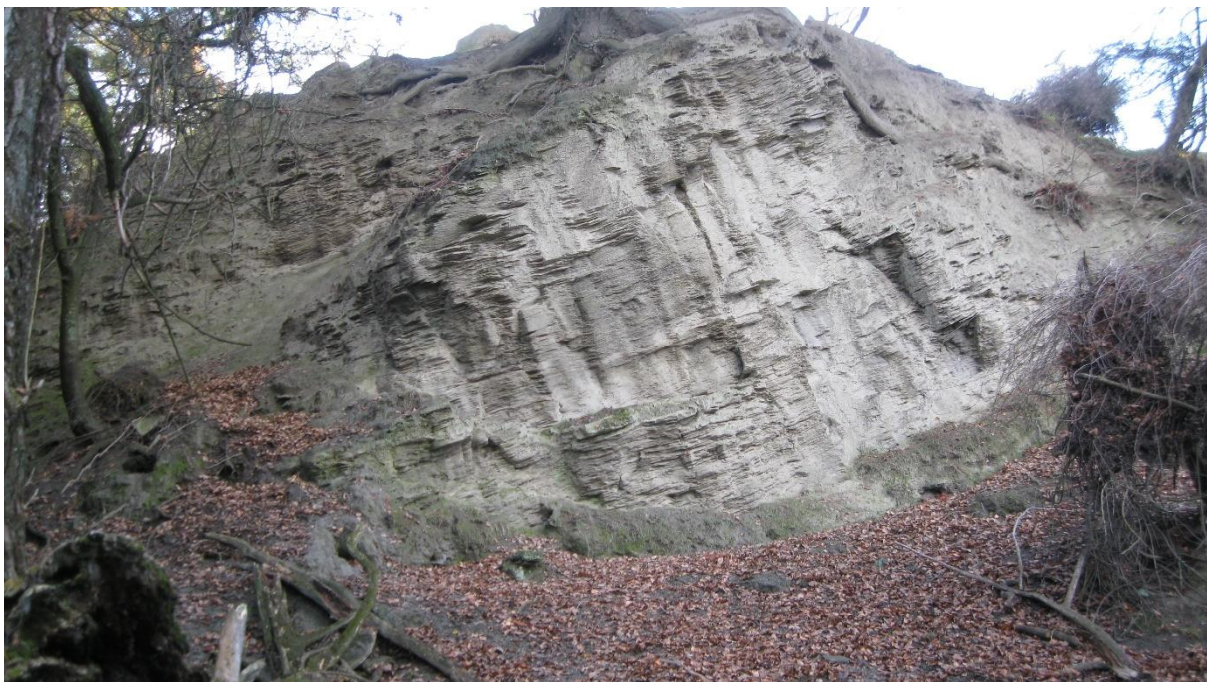
Small scale rock fall associated with localised weathering and gradual fretting of the rock within the incised gullies beyond the northern boundary was observed.

Bluffs and relatively steep slopes are present immediately beyond the northern boundary of the site. Preliminary assessment indicates the risk of rock fall is low. There is some natural weathering and minor fretting of the rock faces observed in some areas in the incised gullies, but these are unlikely to impact on the site.

Photo 6: Schist exposure, main alluvial fan gully.
