Queenstown Country Club

Appendix 5: Preliminary Geotechnical Report

Preliminary Geotechnical Report

Queenstown Country Club,
Lower Shotover, Lake Hayes
Queenstown

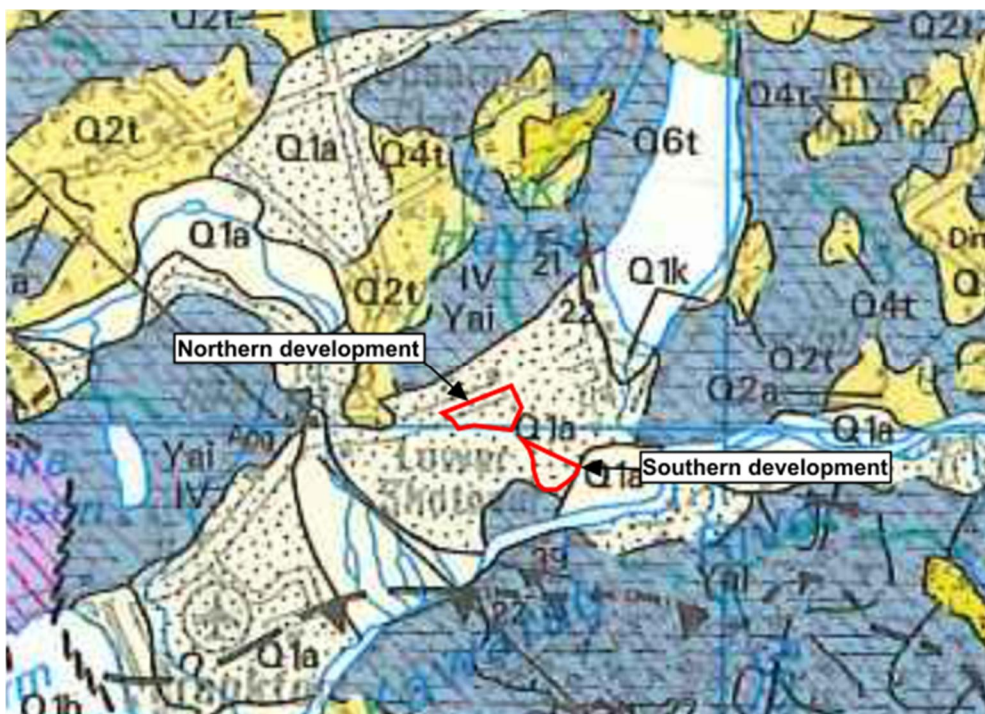
Figure 1a. Excerpt from the Institute of Geological and Nuclear Sciences 1:250,00 Scale Map, 18, Wakatipu.

An excerpt from the regional geological map is provided on Figure 1a. The map indicates the development area is located on Q1a deposits described as 'Gravel and Sands in Alluvial Fans.' The low hill to the south of the southernmost development is shown as a Schist rock exposure.

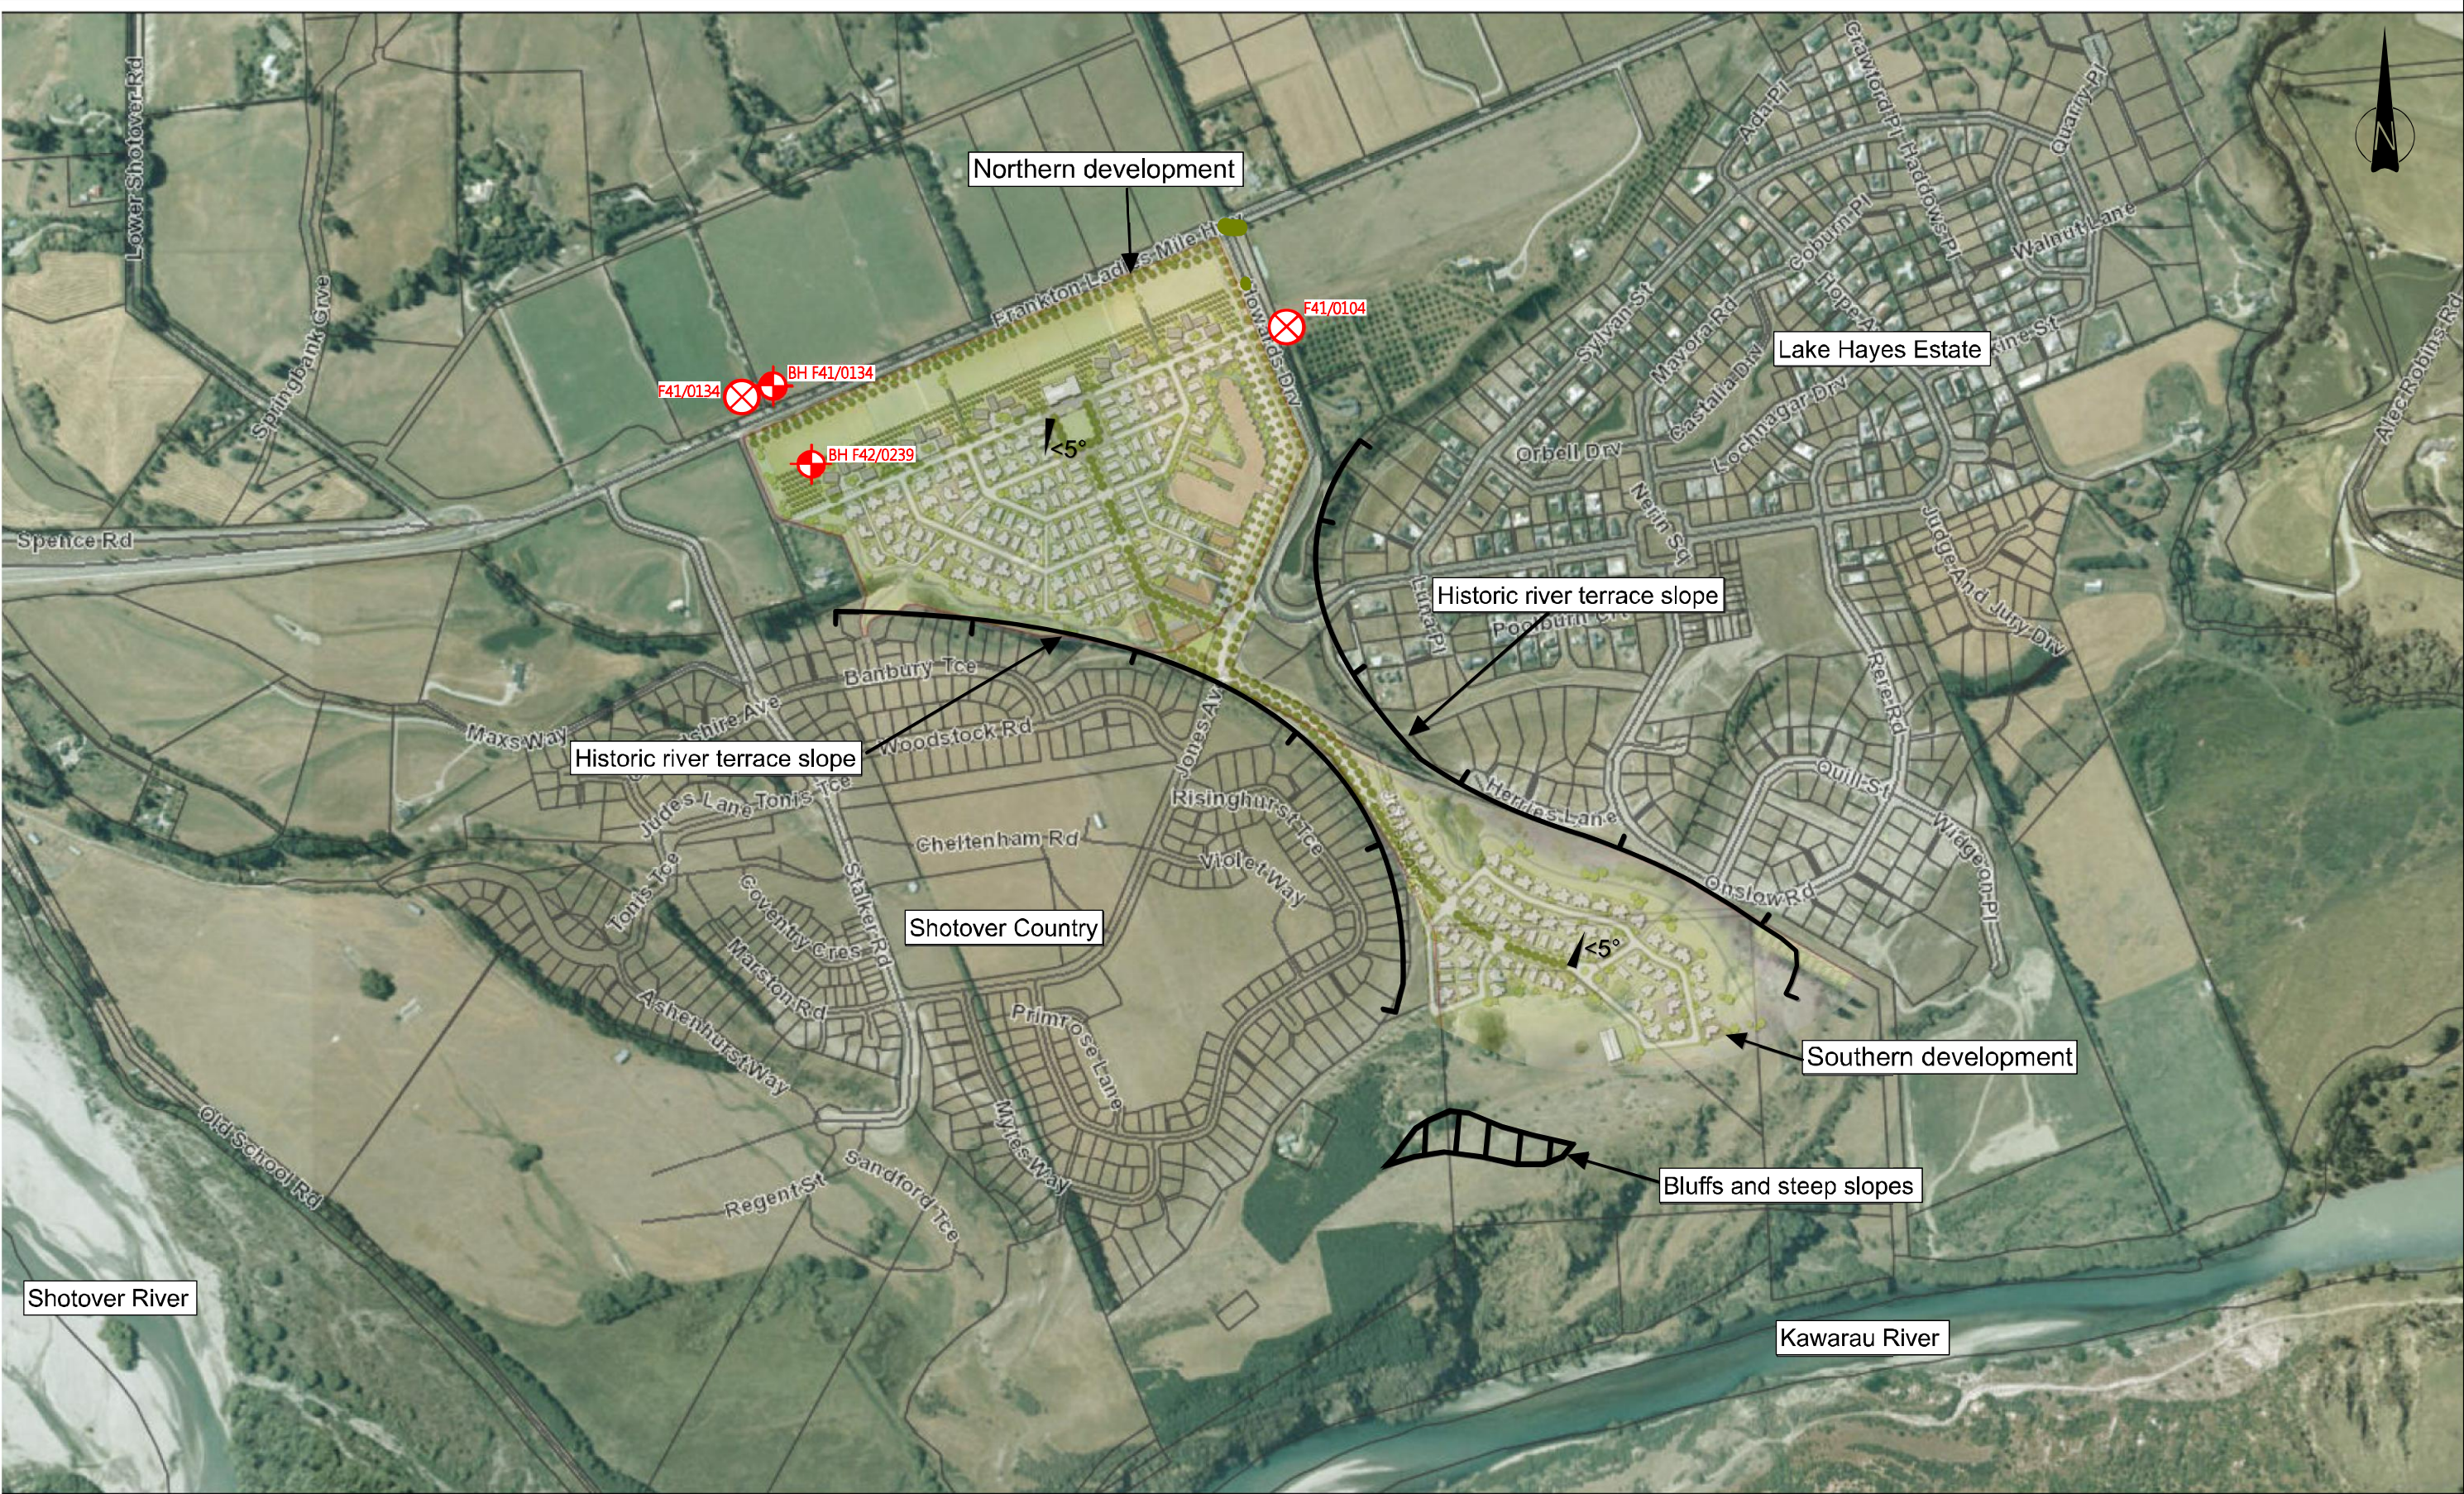
FIG No. Appendix A - Figure 1b

Both northern and southern sites are primarily undeveloped farmland however an existing dwelling is present in the northern area. The location of the sites, and principle observations are shown on Figure 1b, Appendix A. General Views of the site development areas are shown on the Photographs provided in Appendix B.

A review of available Otago Regional Council (ORC) bore data for the northern area of the development indicates the depth of the Deltaic deposits is in excess of 66m. The location of the ORC boreholes (reference F41/0134 and F41/0239) are shown on Figure 1b, Appendix A.

The regional groundwater is expected to lie well below typical foundation and excavation levels. Groundwater levels are expected to rise gently from the Kawarau and Shotover Rivers beneath the development areas. This observation is confirmed by available ORC well data in the northern development area which indicates groundwater to be 51m and 40m below ground level in wells F41/0104 and F41/0134. The location of these wells is shown on Figure 1b, Appendix A.

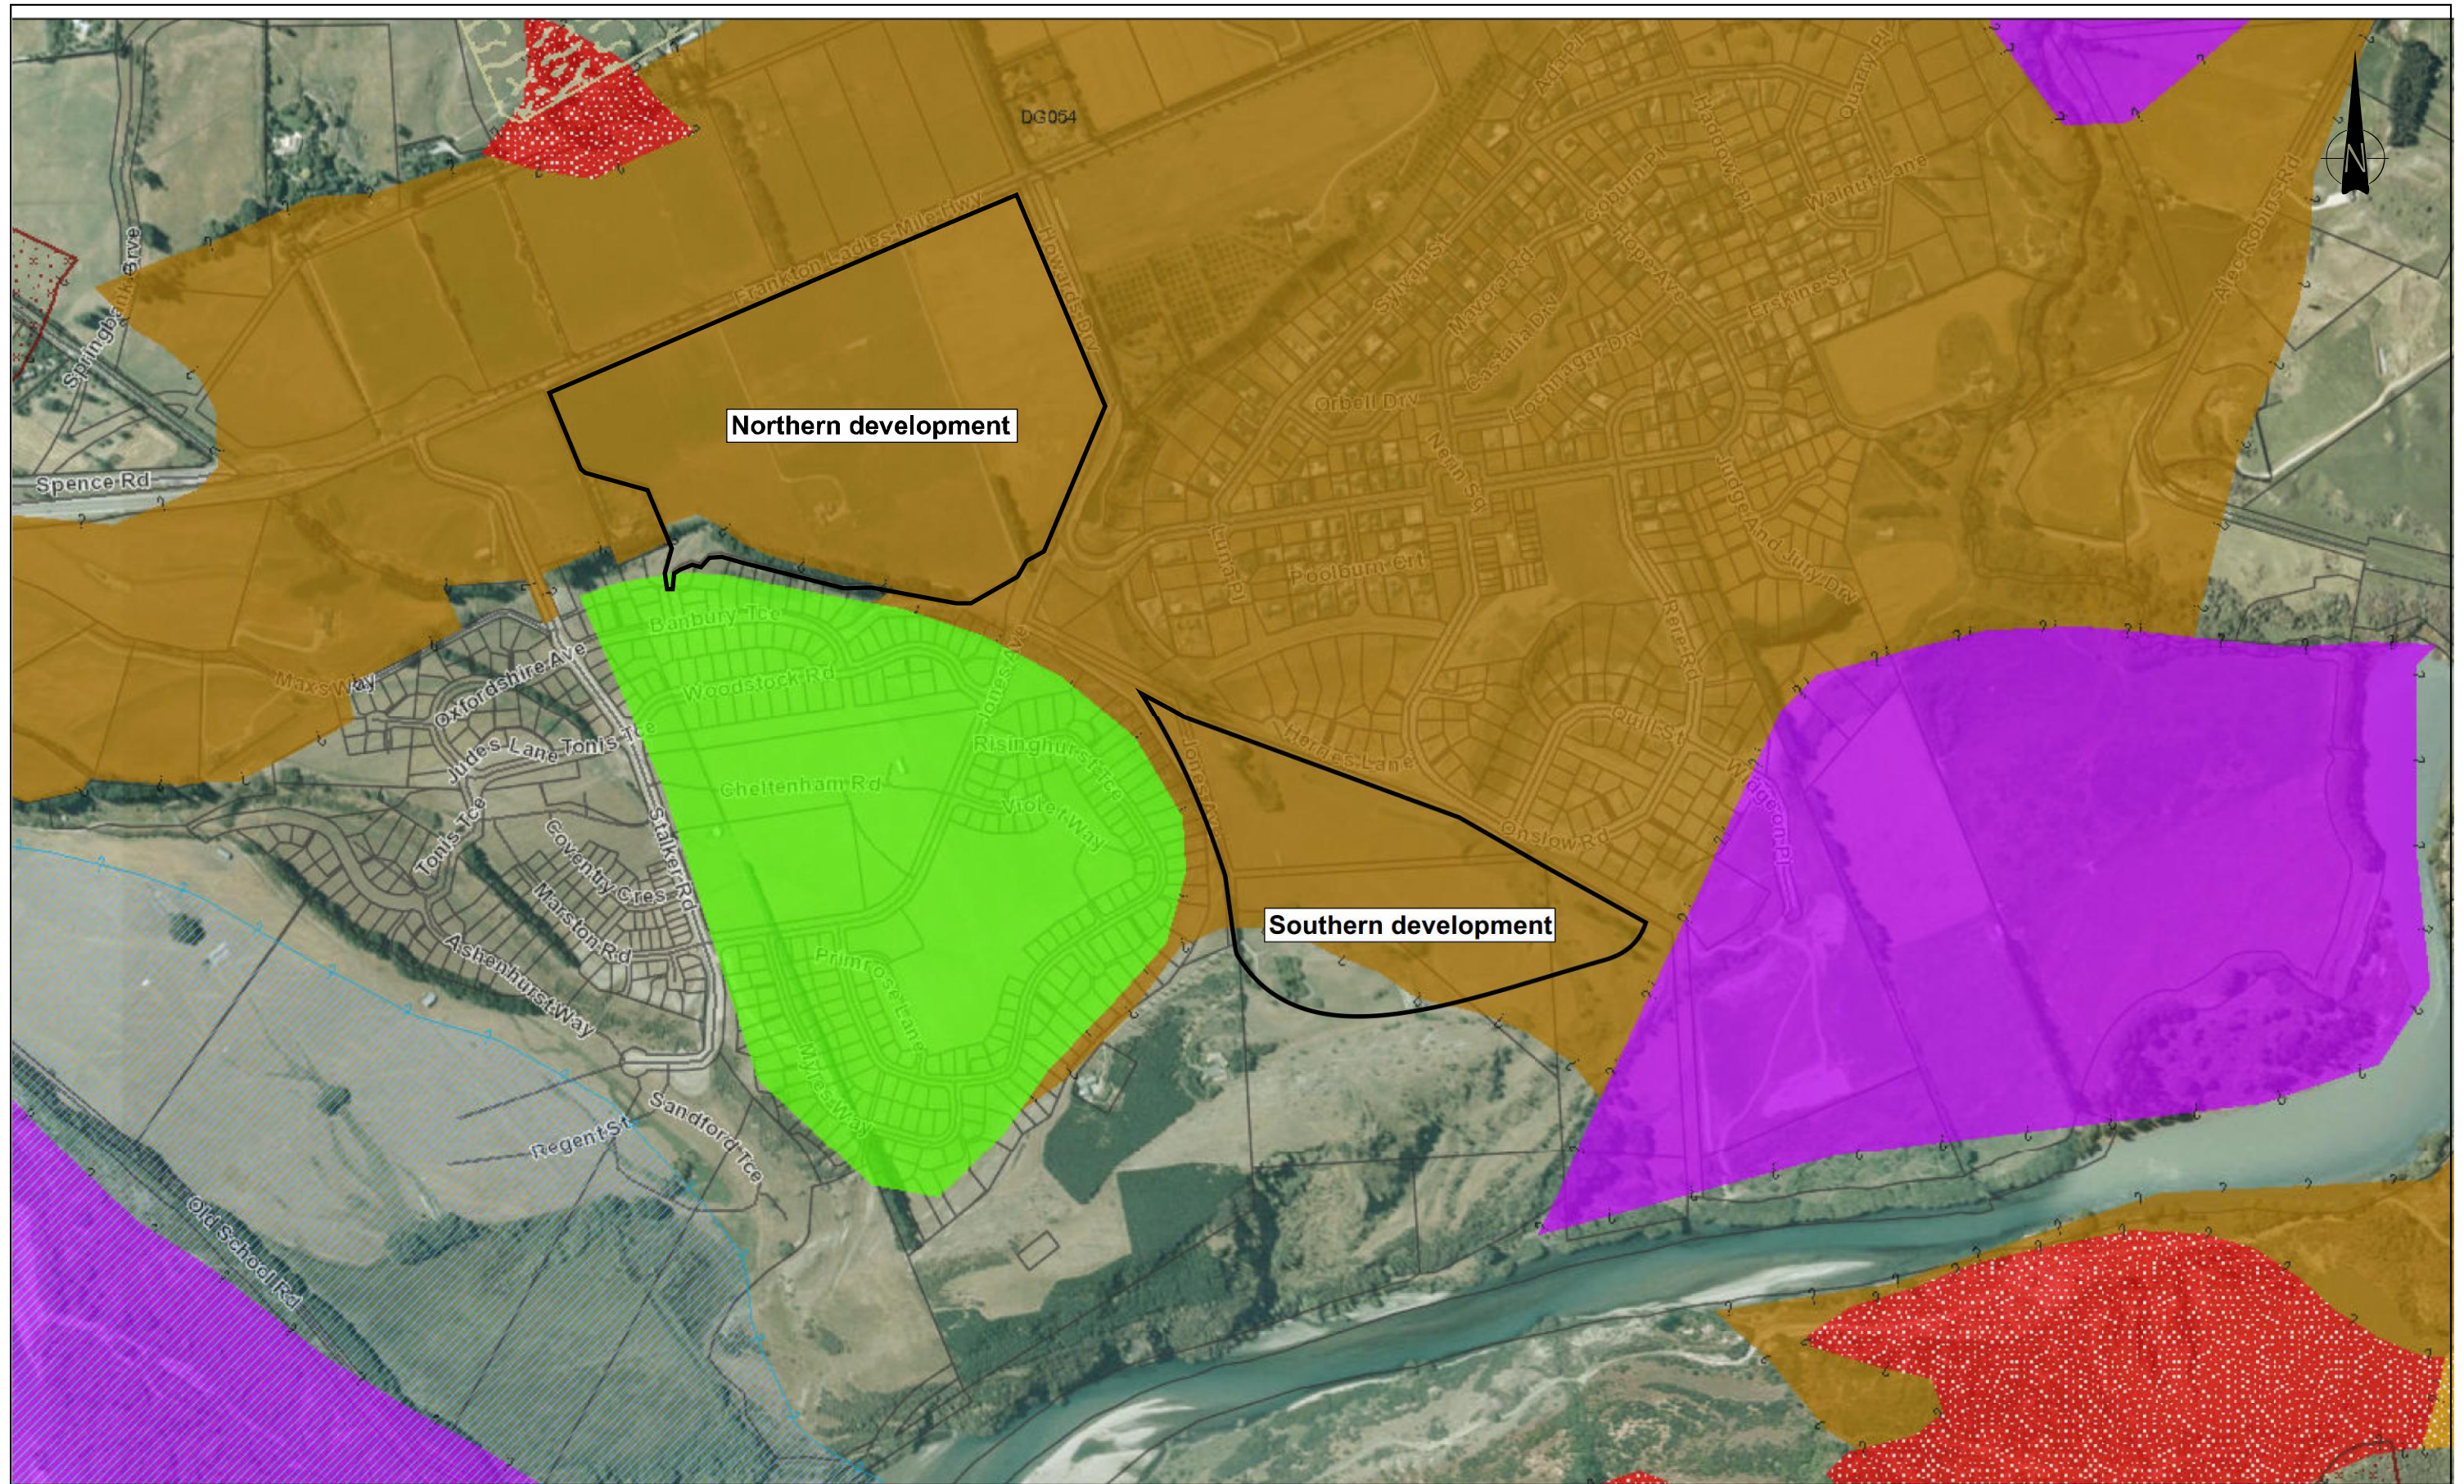
FIG No. Appendix A - Figure 1c

The QLDC GIS mapping system indicates both northern and southern development areas are in an area designated as 'possibly susceptible' to liquefaction. This assessment is based on a regional study completed by Opus Consultants in 2002, see Figure 1c, Appendix A.

The depth to groundwater (40m+), and subsequent studies completed in adjacent areas, indicate liquefaction is nil to low in the development area. This area is considered, by Geosolve, to be the equivalent of LIC1 with respect to liquefaction investigation category.

No alluvial fan hazard has been identified at the site, and none are indicated on the QLDC GIS mapping system, see Figure 1c, Appendix A.

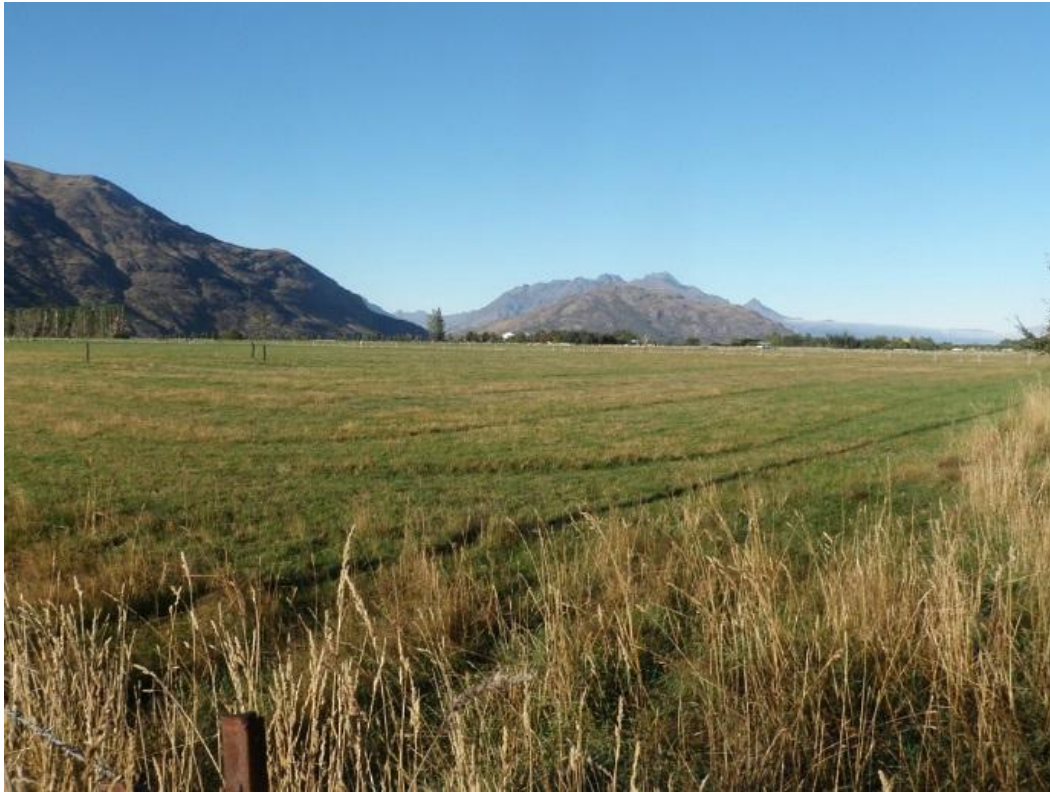
Northern Area: The ground surface is sub-horizontal to gently sloping ($<5^\circ$) in a southern direction with an approximate RL of 360m. Surface water flows will be in a southerly direction. Along the southern boundary the ground falls 15m down a historic river terrace slope (see Photographs 3, Appendix B) which has typical slope of 25-35°.

Photograph 1. General view looking south west across the gently sloping farmland of the northern development area.

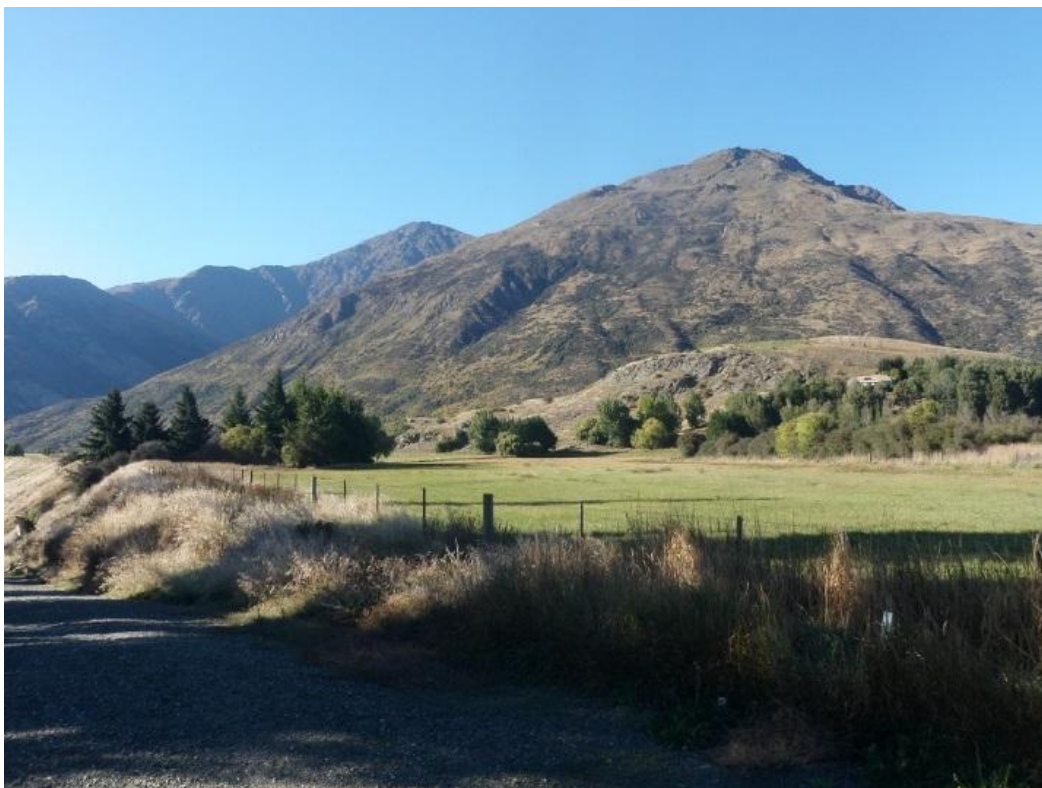
Southern Area: This area of the development is located on the northern side of a low hill which falls at various grades in a north/north east direction towards Lake Hayes estate. Much of the site area is a gently sloping historic river terrace (approx. RL 360) however steep ground climbs immediately south of the property, with the summit of the low hill being 250m south and 80m higher than the terrace area. On the north eastern boundary of the property a historic river terrace slope is present which falls approximately 20m at 25-35° to Lake Hayes Estate. The portion of the development accessed from Onslow Road is at the base of this slope. The low hill is shown on Photograph 2 and the north eastern river terrace slope on Photograph 4, Appendix B.

Bluffs are present in the southern area of the proposed development. Preliminary assessment indicates the risk of rock fall is low, however some weathering and minor fretting of the rock face was observed in some areas. Detailed inspection and assessment of these areas should be completed. If adverse instability is identified measures such as fences, scaling, removal, rock fall mesh, spot bolts and anchoring will be appropriate to address any identified stability concerns.

Photograph 2. General view looking south across the southern development area. Steep ground and rock bluffs are present in the distance, the gently sloping areas in the foreground and river terrace slope on the left.

- An inspection of rock fall/bluff instability and any requirements in the southern area of the site.
 - Other geotechnical inputs as required for detailed design e.g. Pavement CBR values for roadway construction, safe temporary and permanent batter angles.

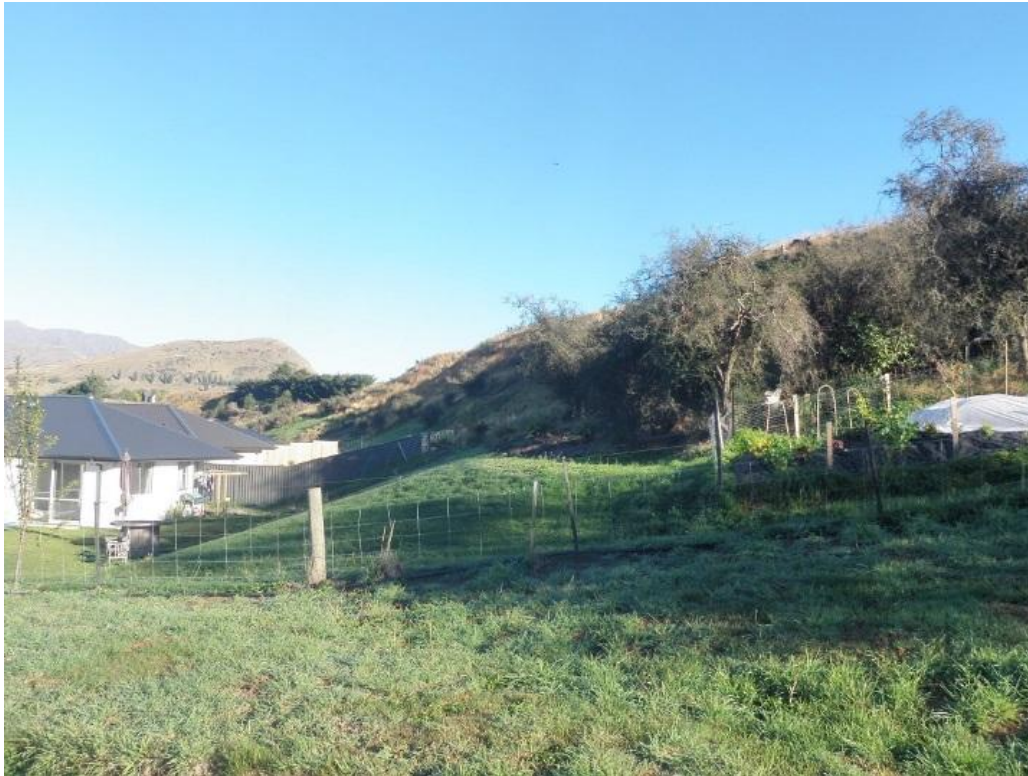
Development plans indicate buildings will be located close to slope crests. During the detailed design phase slope stability analysis for static and seismic (serviceability and ultimate limit state) cases should be completed. The analysis should determine the factors of safety against failure, and the location and magnitude of any surface displacement expected. Building set-back distances and/or specific foundation design requirements can then be incorporated into the detailed design.

Photograph 3. River terrace slope on the south western boundary of the northern development (to be located at the crest), with the Shotover Country sub-division at the slope toe.

- Confirmation of the near surface soil stratigraphy and foundation bearing capacities;
 - Stability/ set back and foundation options for buildings located close to river terrace slope crests;

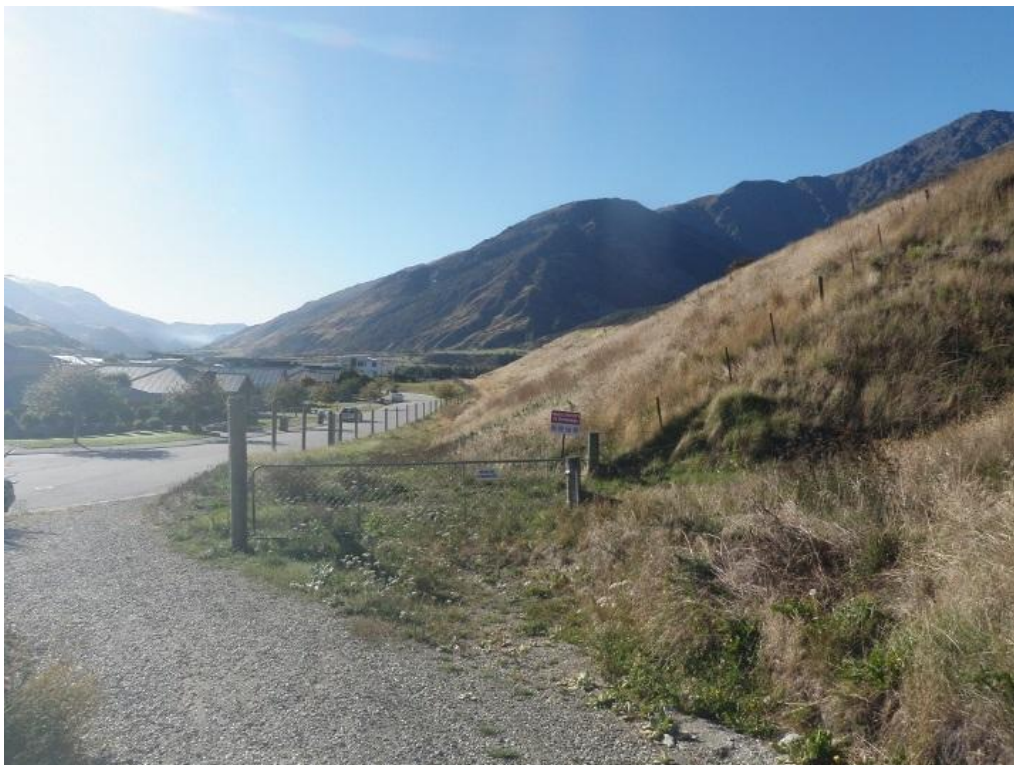
Photograph 4. The river terrace slope along the northern eastern boundary of the southern development, with Lake Hayes Estate and Herries Lane at the slope toe.
