Luggate Hall Initial Seismic Assessment

51 Main Road
Luggate

Luggate Hall ISA

Prepared For:
Queenstown Lakes District Council

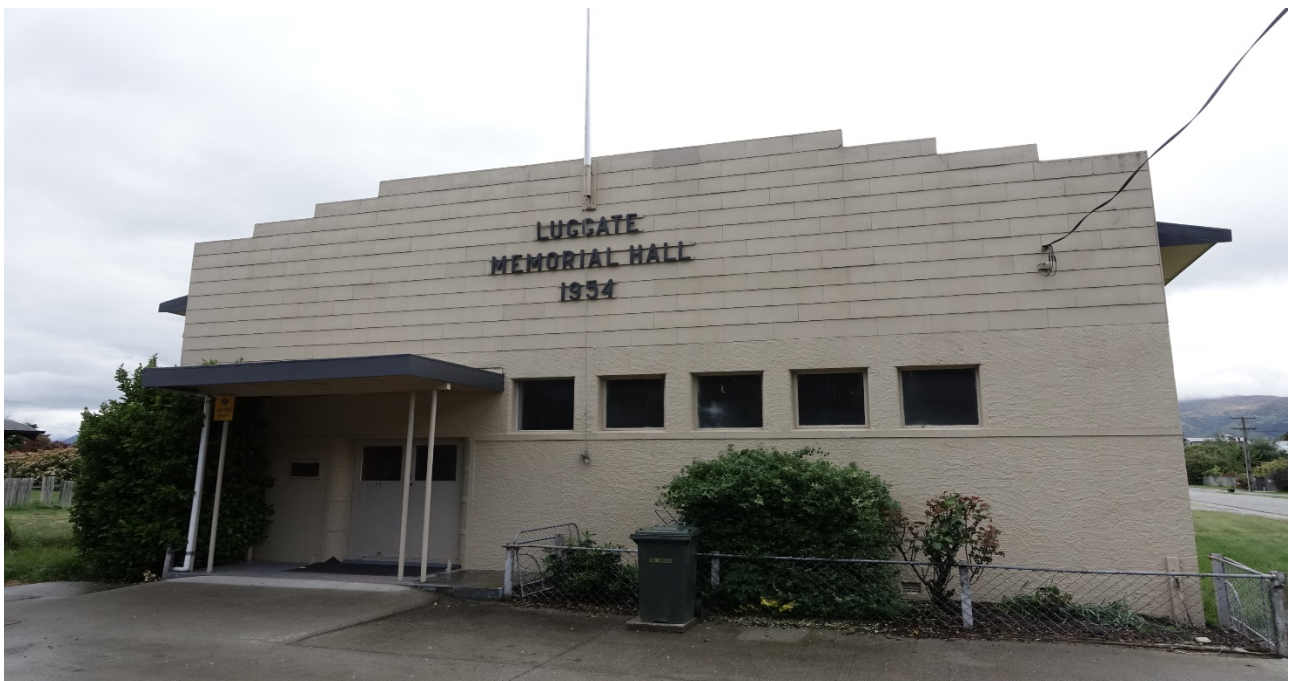
Figure 3-3: Exterior Photo of Luggate Memorial Hall

The walls are made up of a double mudbrick cladding with cavity that spans between the foundation and concrete bond beam. Timber framing infills between the bond beam and the underside of the roof. It is unclear if the double mudbrick has cavity ties between the two layers. The overall thickness appears to be 300mm.
