Davis Consulting Group Preliminary Site Investigation

Peninsula Bay North End  
Proposed Plan Change,  
Wanaka  
Preliminary Site Investigation

Peninsula Bay Joint Venture

*May 2015*

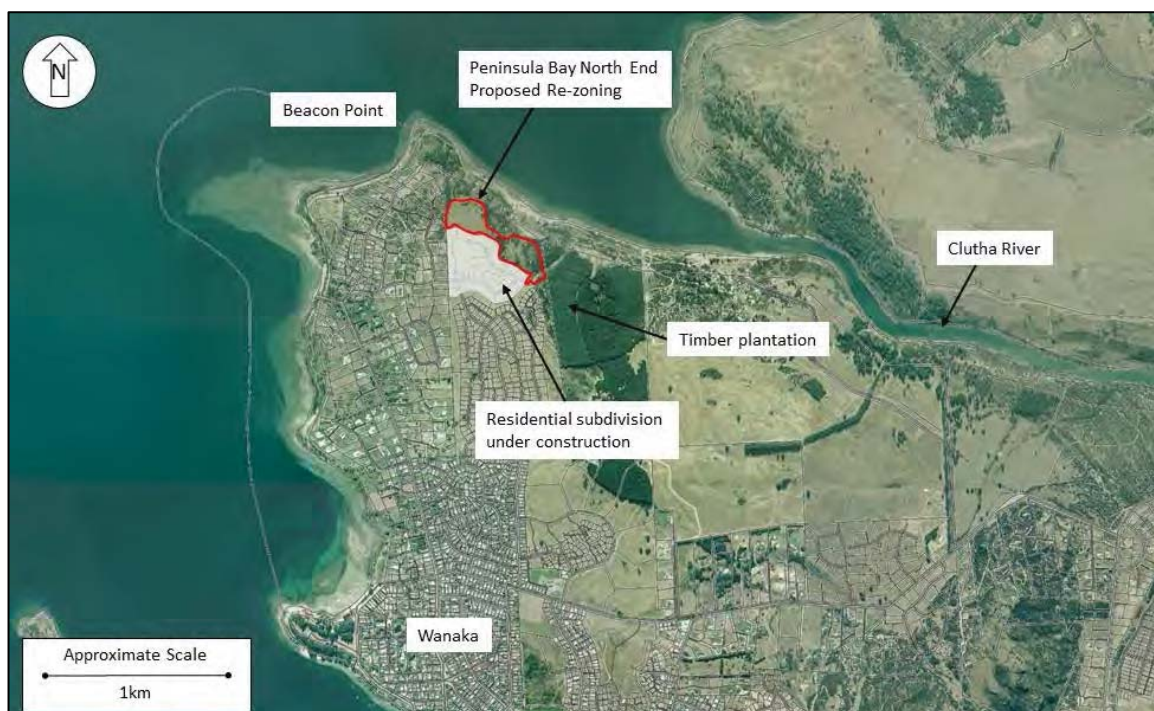
**Figure 1: Site Location Plan**

The site under investigation is located to the north of Wanaka, north of Infinity Drive and the Peninsula Bay housing development (Figure 1) within land zoned Open Space.

The site is surrounded by recent residential subdivisions to the west and south, plantation forest to the east and the southern shores of Lake Wanaka to the north (see Figure 1).

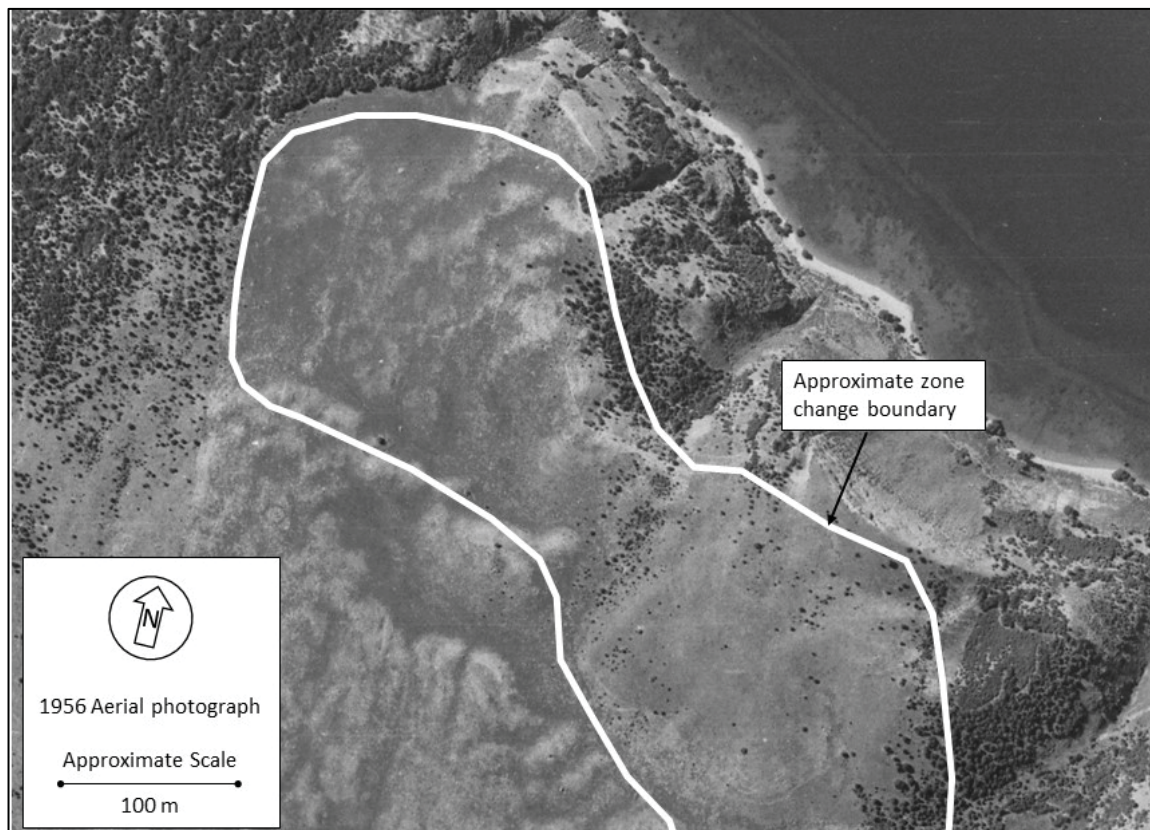
**Figure 2:** 1956 aerial photograph

Farming activities are observed in aerial imagery dating back to 1956 (see Figures 2 to 4).

No farming infrastructure such as sheds or yards were observed within or in the immediate vicinity of the site in aerial photography from 1956 to present (see Figure 2 to 4).

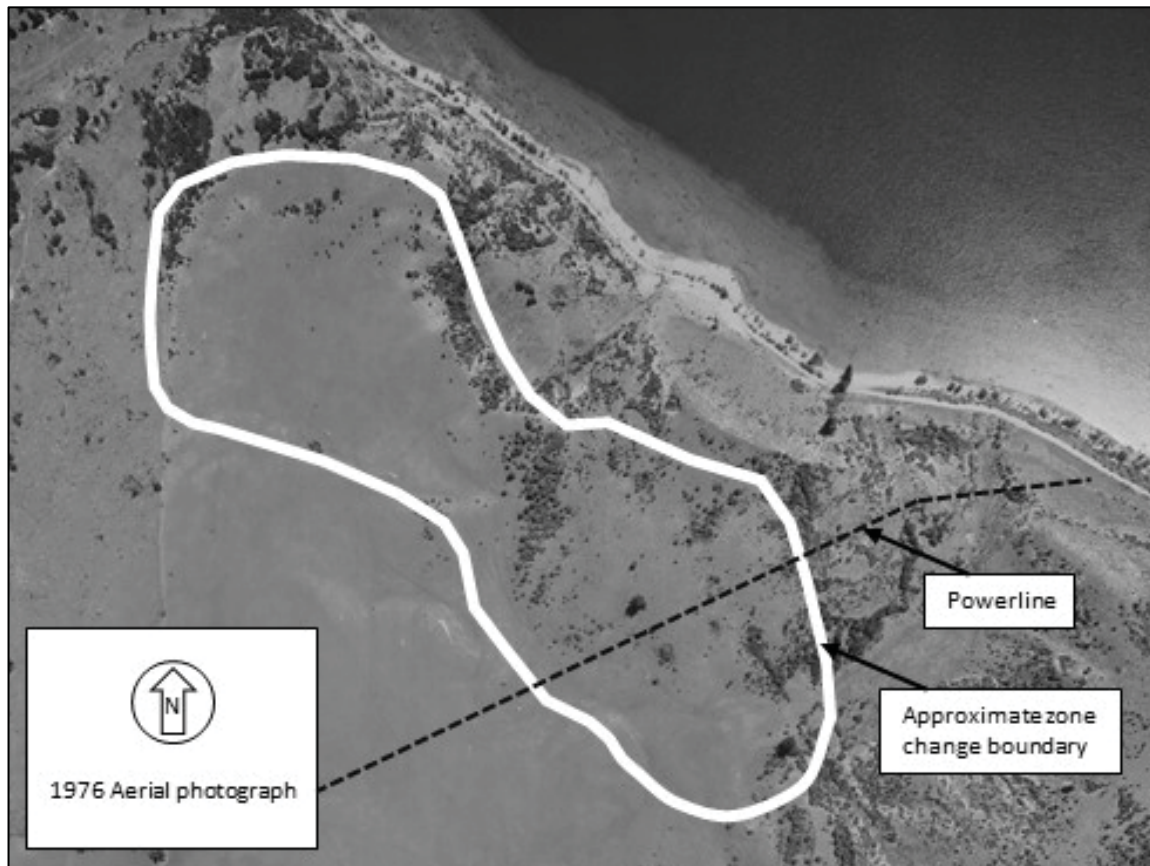
**Figure 3:** 1976 aerial photograph

A powerline is observed in 1976 aerial photograph (see Figure 3). No transformers were observed in aerial images. Powerlines were present in 2005 aerial imagery (see Figure 5) and removed prior to the 2015 site inspection. There was only 1 remaining power pole at the time of assessment. This was located in the eastern perimeter of the site.

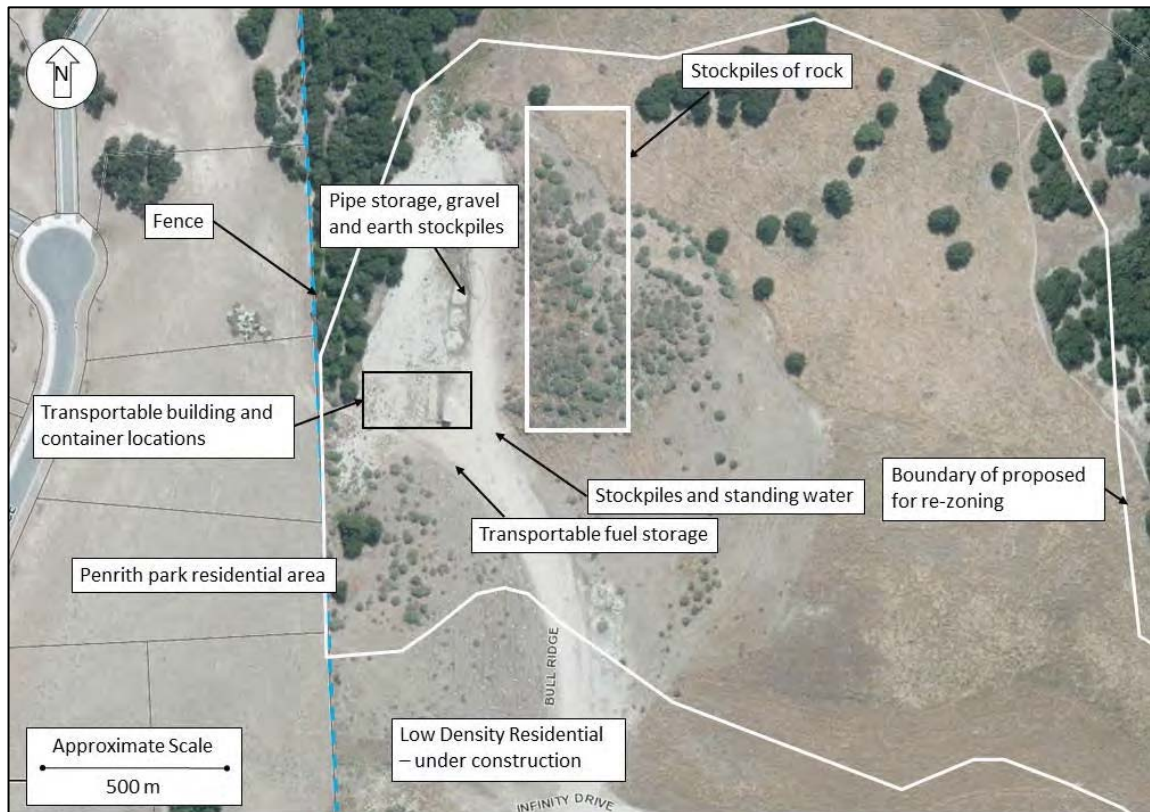
**Figure 5:** Layout of groundworks laydown area and rock stockpiles

At the time of the site visit an earth and groundworks crew were working from a laydown area located in the north western corner of the area under investigation. The laydown area was approximately 300 m<sup>2</sup> and was sheeted with grey gravel/sand regolith. Within this area there was a transportable building, shipping container, portable self-contained toilet, mobile trailer mounted fuel storage, and a transportable rubbish bin (see Figure 5 and Plate 1-2). Several stockpiles of gravel and earth were located on the eastern perimeter of the yard. Water was pooling within a low lying area in-between stockpiles of earth and gravel (see Plate 3). There was no evidence of surface staining from hydrocarbon leaks and no odours observed during the site walk over. Surface soil from sample 11 had a slight hydrocarbon odour.

To the west of the groundworks area there is a wooden fence bordering the Penrith Park residential area (see Figure 5 and Plate 5).

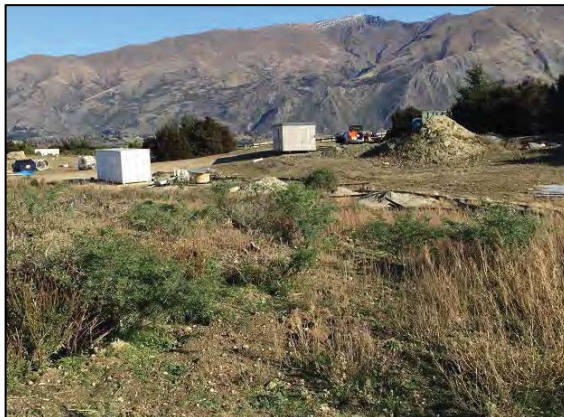
**Plate 1:** Groundworks yard

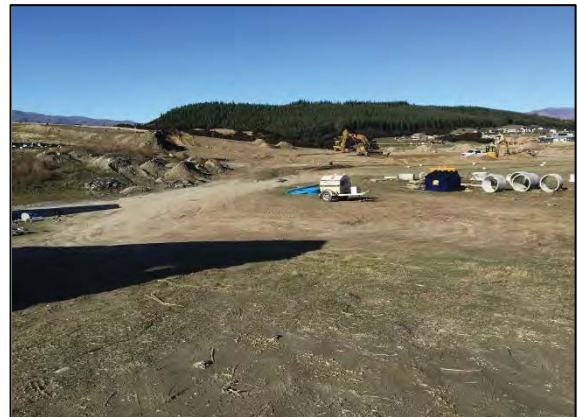
At the time of the site visit, residential subdivisions were under construction south of the study site, with road construction underway and several building foundations in preparation (see Figure 1 and 5 and Plate 2).

**Plate 2:** Groundworks yard showing fuel storage, general waste bin and subdivision under construction in background

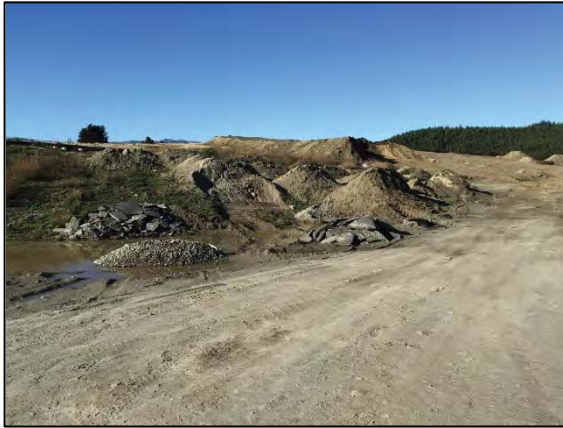
**Plate 3:** Southern portion of groundworks yard. Stockpiles of gravel and earth. Pooled water from recent rain

- Surface Water Quality – The only surface water observed on site was a small puddle within the groundworks area. This water was turbid due to the frequent trafficking.

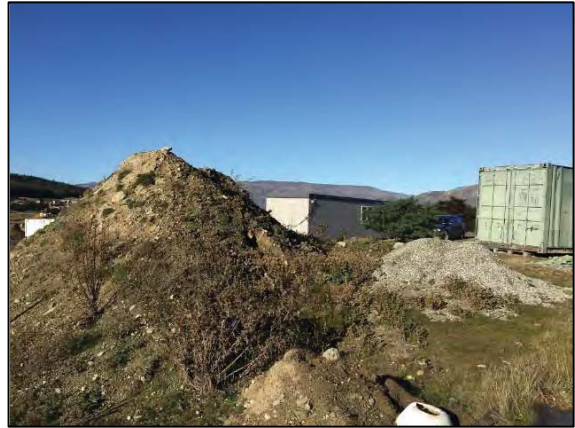
**Plate 4:** Gravel and earth stockpiles east of groundworks yard

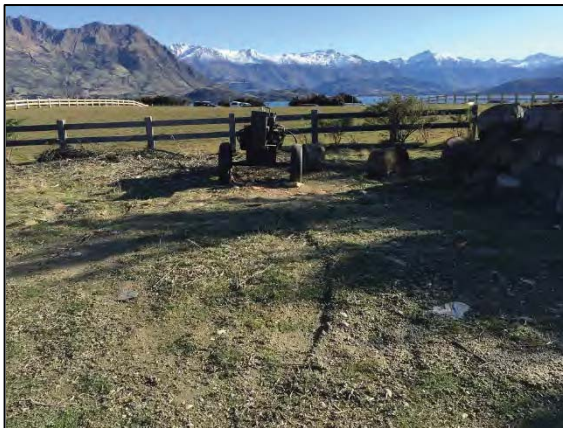
**Plate 5:** Neighbouring property to the north of groundworks yard

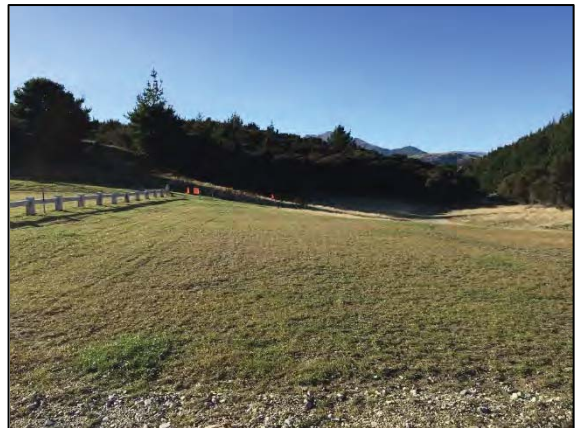
To the south east of the study site there is a grassed area, manuka/kanuka shrubland and a pine timber plantation further east beyond Infinity Drive (see Figure 1 and Plate 6).

**Plate 6:** Southern portion of proposed zone change area. Access track and timber plantation on right. Shrubland in centre

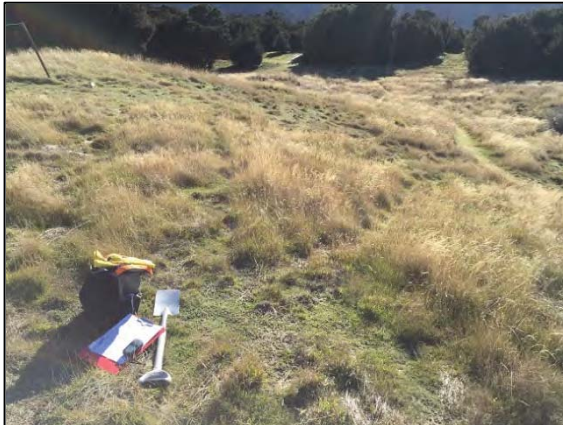
**Plate 7:** Typical grassed areas and shrubland within site

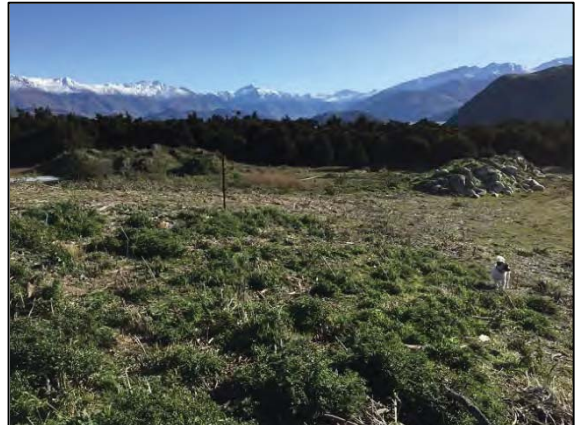
**Plate 8:** Stockpile of rock and soil near WPSS08

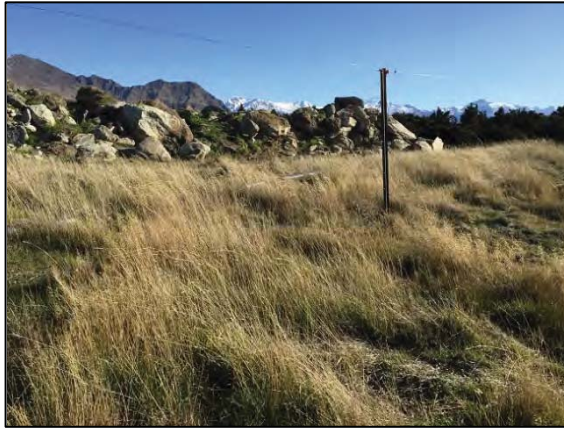
**Plate 9:** Stockpile of soil near WPSS09

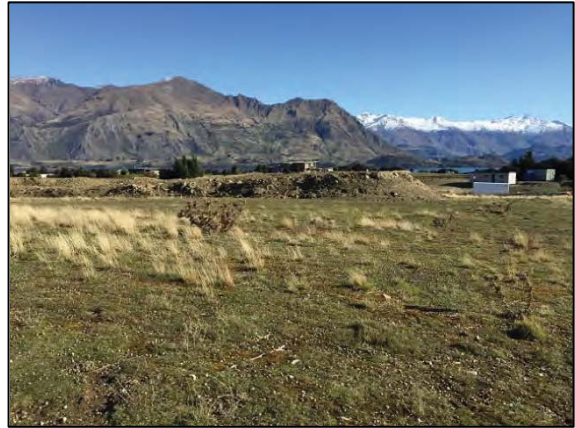
**Plate 10:** Stockpile of soil near WPSS06

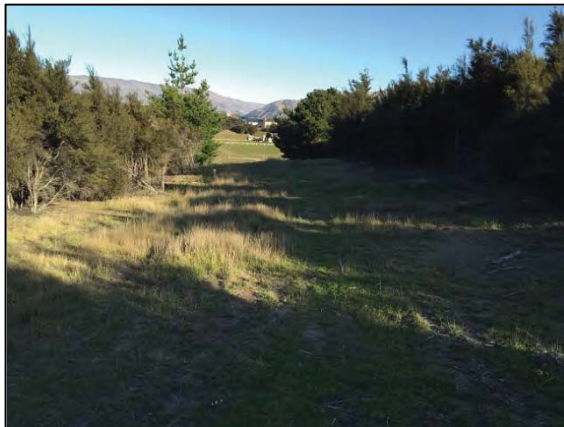
Access to the site was limited to the groundworks area in the northwest, and a gravel access track extending northeast of Infinity Drive in the south-eastern portion of the site and a trafficked track up the hill through the south eastern portion of the study area (see Plate 11 and 12).

**Plate 11** Access track in south-eastern portion of proposed re-zoning study area

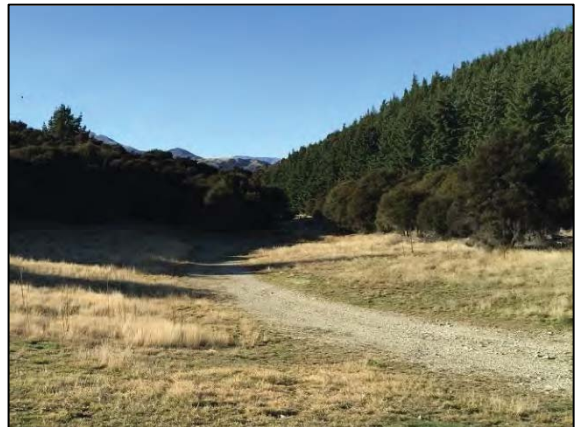
**Plate 12:** Gravel track extension of Infinity Drive in south-eastern portion of the proposed re-zoning study area

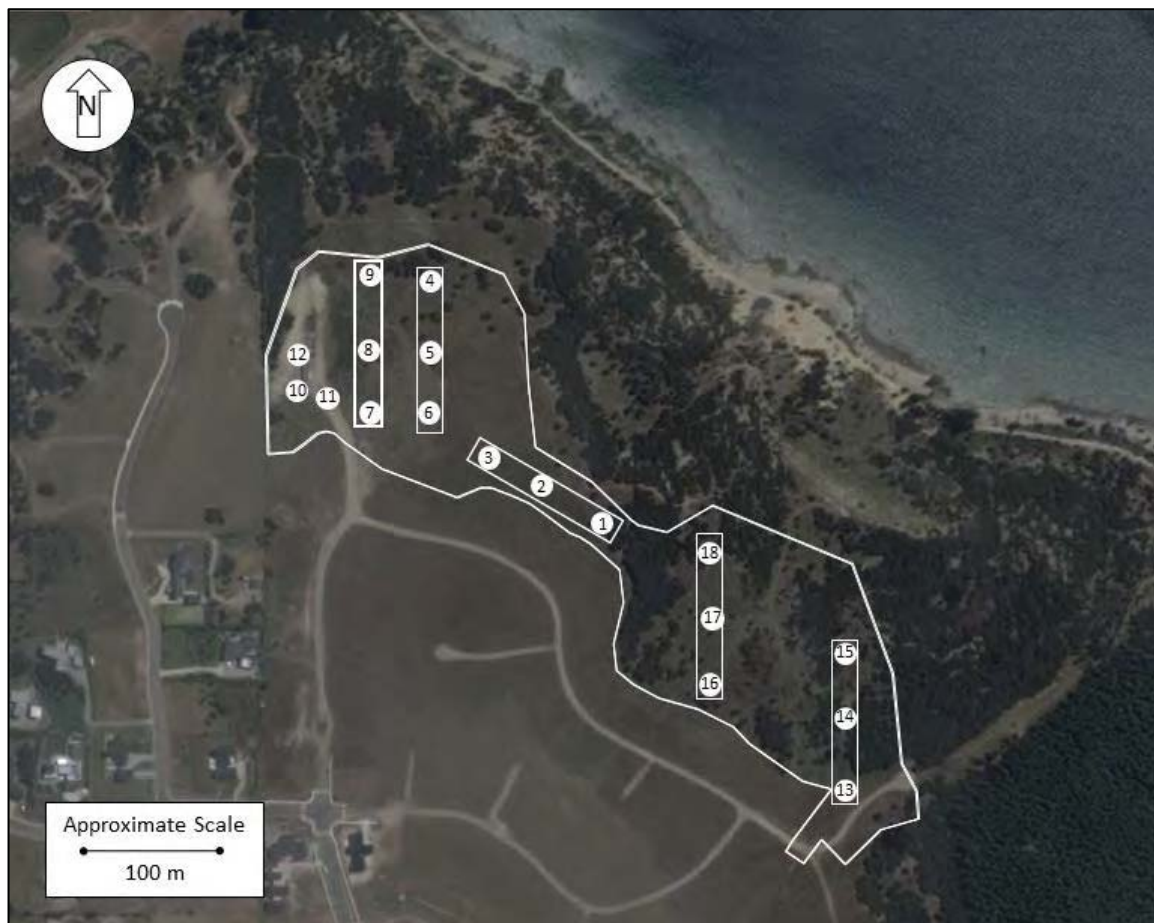
**Figure 6:** Soil sample location plan

The soil sample locations and analysis are provided in Figure 6 and summarised in Table 1 below. The laboratory certificates are provided in Appendix E. Samples were analysed for heavy metals, organochlorine pesticides and hydrocarbons.

Arsenic and pesticides were assessed throughout the study area to investigate the impact of historical agricultural activities. The relevant sample sites 1 to 9 and 13 to 18 are marked in Figure 6. Surface sampling was considered appropriate for the assessment of pesticides for two

Hydrocarbon contamination was investigated within the groundworks laydown after hydrocarbon storage activities were observed in the area during the site inspection. The relevant sample sites 10 to 12 are marked in Figure 6. Surface sampling was considered appropriate for the assessment of hydrocarbons for two reasons. First, contamination is most likely limited to small drips and spills on surface. Second, people living on the site will predominantly be exposed to surface soils.
