NAME: Stone Cottage

LOCATION: 253 Centennial Avenue, Arrowtown

NAME:	Kawarau Falls Dairy & Meat Store
LOCATION:	2, Kingston Road, Kawarau Falls, Frankton
GPS Point:	45°01'45"S, 168°43'43"E
Constructed:	circa.1864
Building Type/Use:	Agricultural
Materials:	Timber/stacked Schist/ corrugated iron
Style:	Vernacular
Architect:	None
Builder:	Unknown
NZHPT Register:	N/A
Valuation number:	290990108
Legal Description:	Lot 1 DP395546
Condition:	Moderate

NAME: Threepwood stables

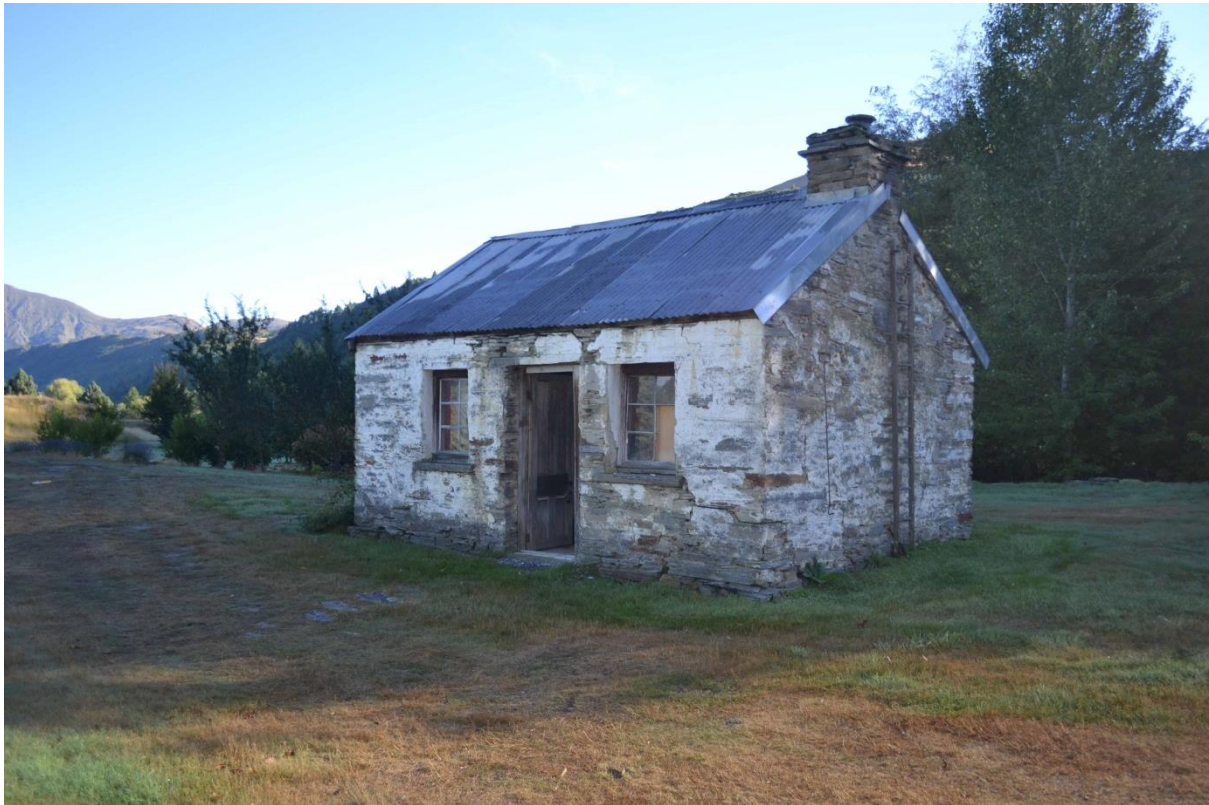
Condition: Fair – some repair required

The cottage is a simple, vernacular building of stacked/rubble Schist and a gabled roof clad with corrugated iron. It has a high degree of originality/authenticity remaining, including to the interior. The latter is of great interest as limewashed plaster remains on the walls and the original timber floor, fireplace and a partly-dismantled timber partition dividing the interior into two rooms still exist. External architectural features of interest include the stone walls with weathered plaster/render finish, rectangular stone chimney, flat stone lintels and sills, 6 light casement windows and centrally-placed entrance door.

The building has significance for its traditional rubble/stacked Schist masonry, which has the weathered remains of a render/plaster and limewash finish. Long flat stones have been used for lintels to the front elevation and for sills. The methods of construction of the structures, including the remaining interior features and finishes to the cottage potentially aid understanding of traditional building crafts in the District.

The cottage has a central entrance with timber, four-panel door and windows on either side. All these openings have flat, stone lintels with the windows and door deeply recessed. The windows also have flat stone sills and there is a flat threshold stone to the door.

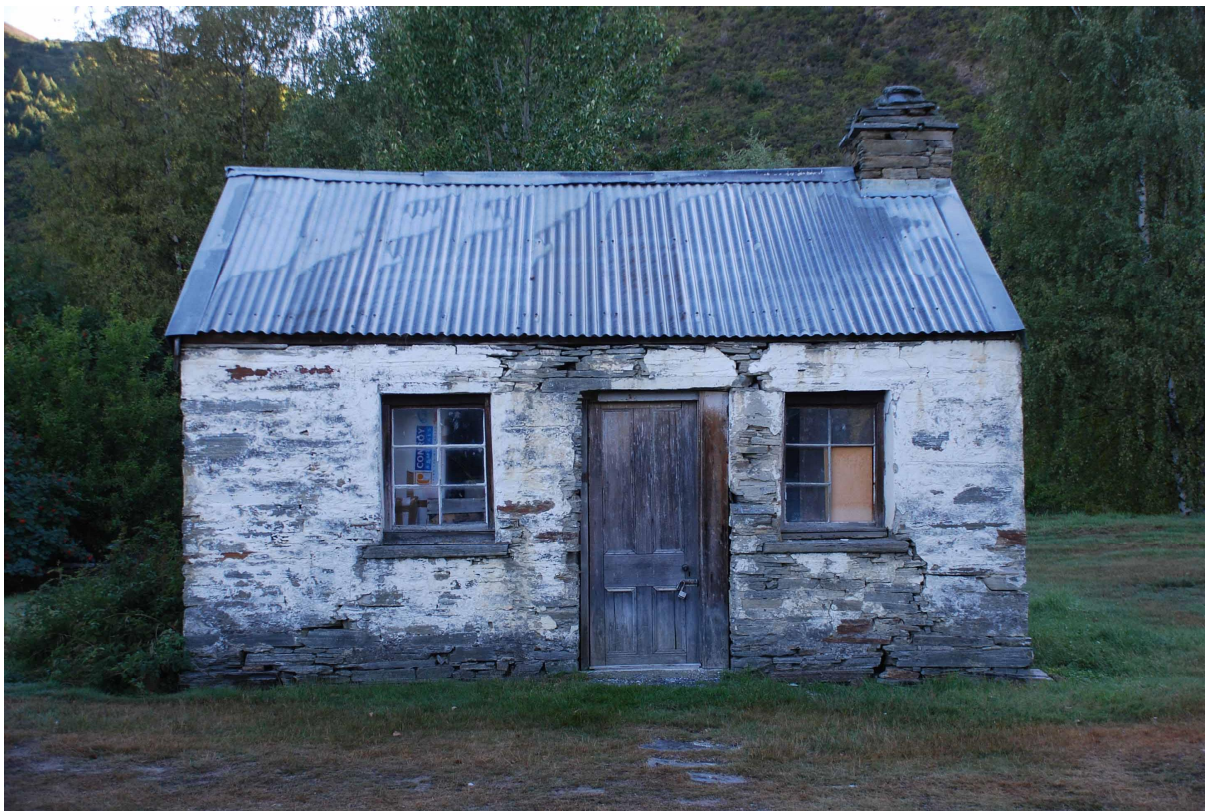
South-west (front) elevation

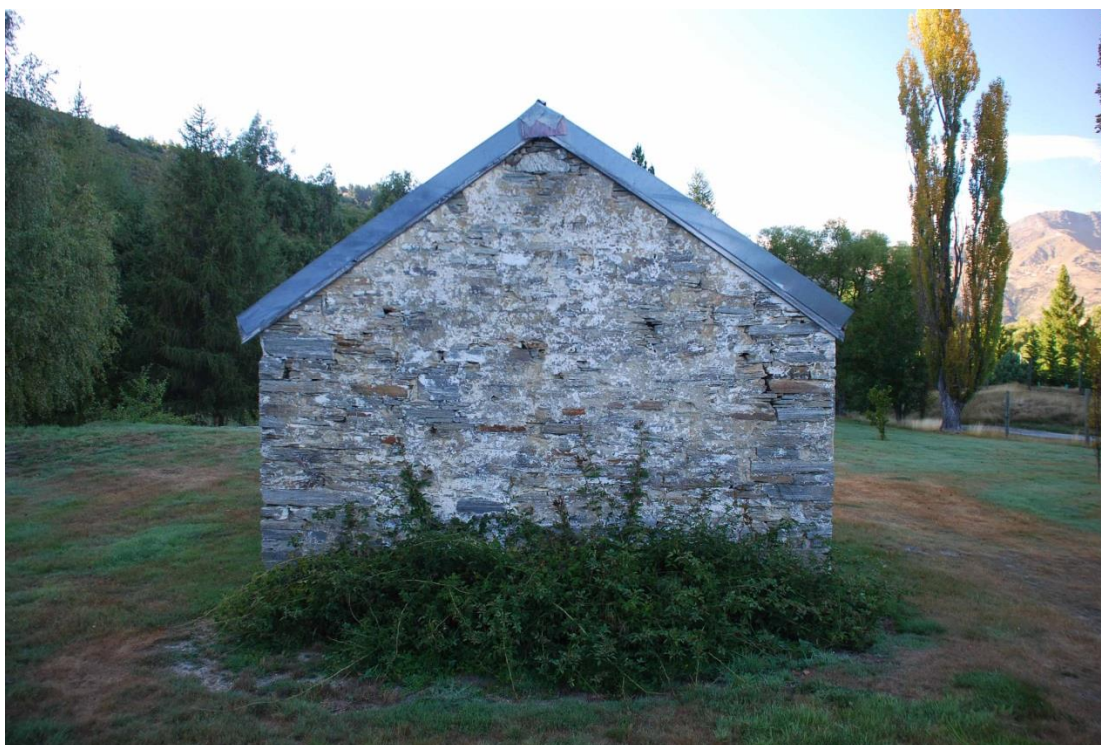
North-west elevation

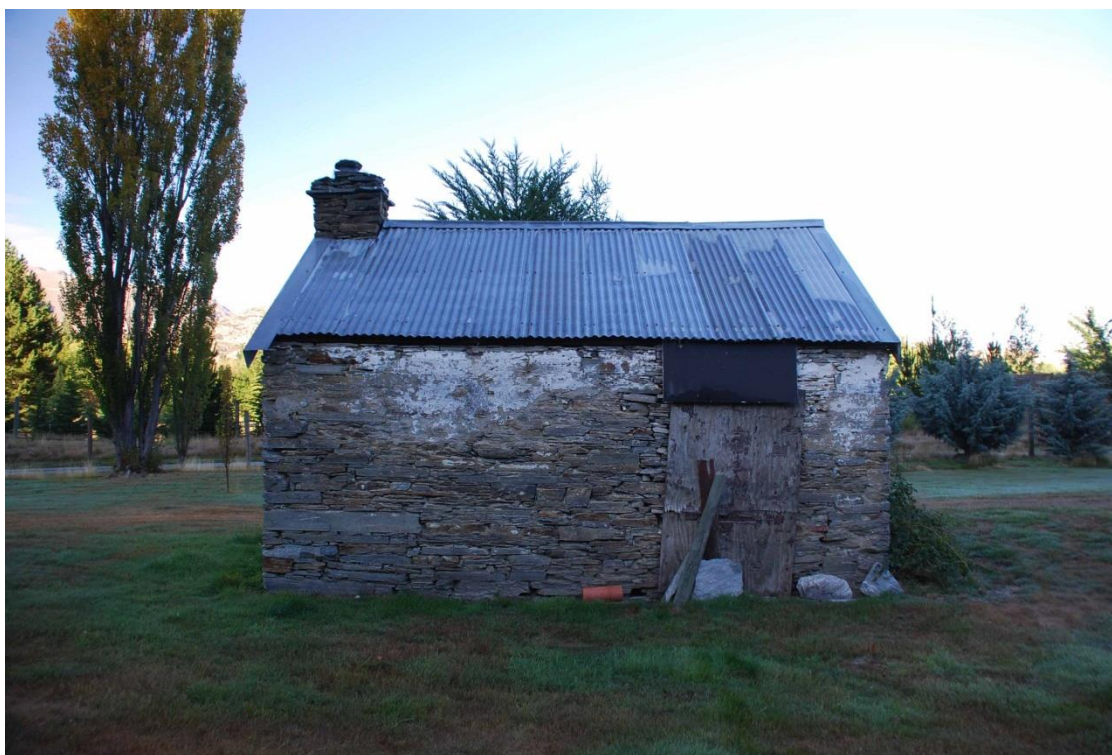
An opening in the rear wall of the cottage has been boarded over and it could not be seen whether this is a doorway into a rear lean-to that has been demolished.

North-east elevation with boarded-over opening

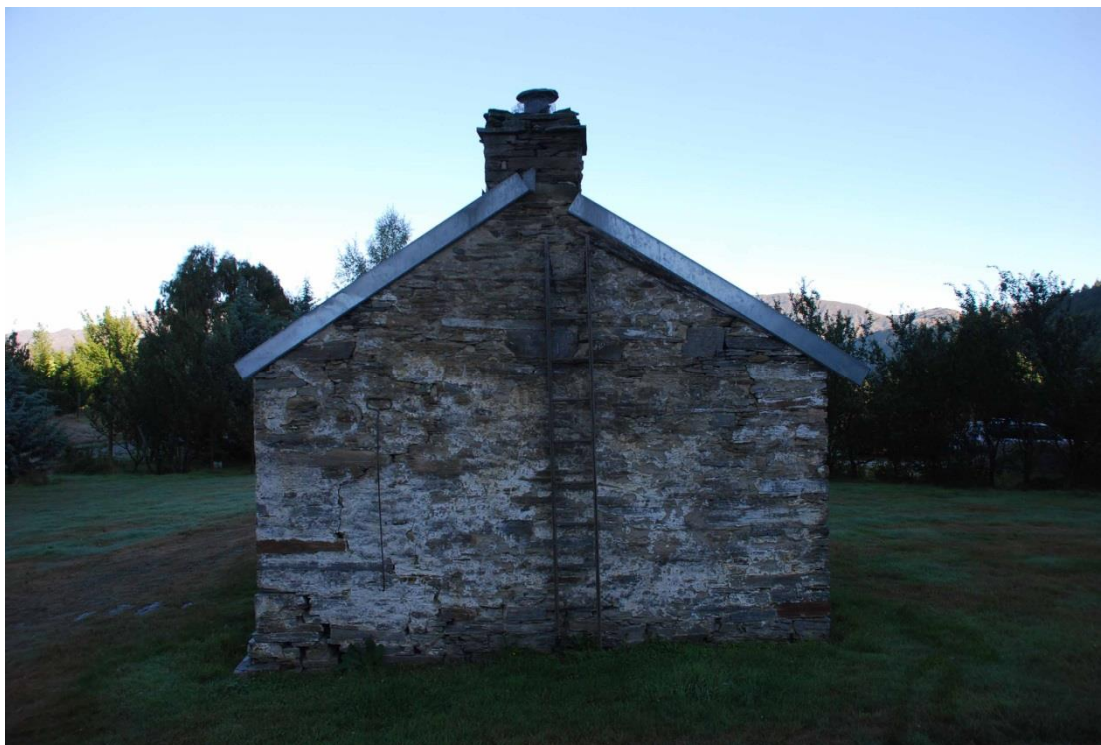
South-east elevation

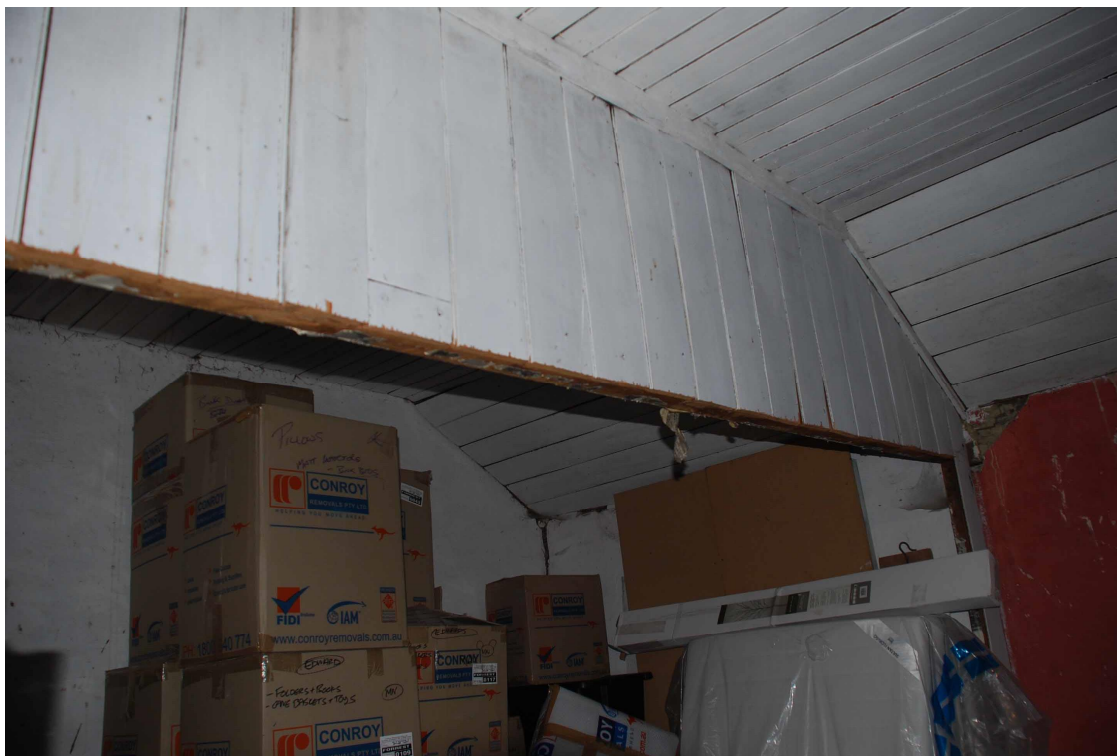
At the time of inspection, the interior of the cottage was full of storage which meant that parts could not be seen. However, it is clear that it retains much of its historic fabric and finishes, including a timber floor, timber-boarded ceiling, plastered and limewashed walls, a fireplace and a timber partition which divides the interior in to two rooms. Some time ago the partition has been cut through just below ceiling level, but the timber lining boards remain stacked in the cottage and could be reinstated as they have been decorated with 20th century newspapers, which would give a guide to the partitions earlier form.

Interior with timber-lined ceiling and remains of a timber-lined partition

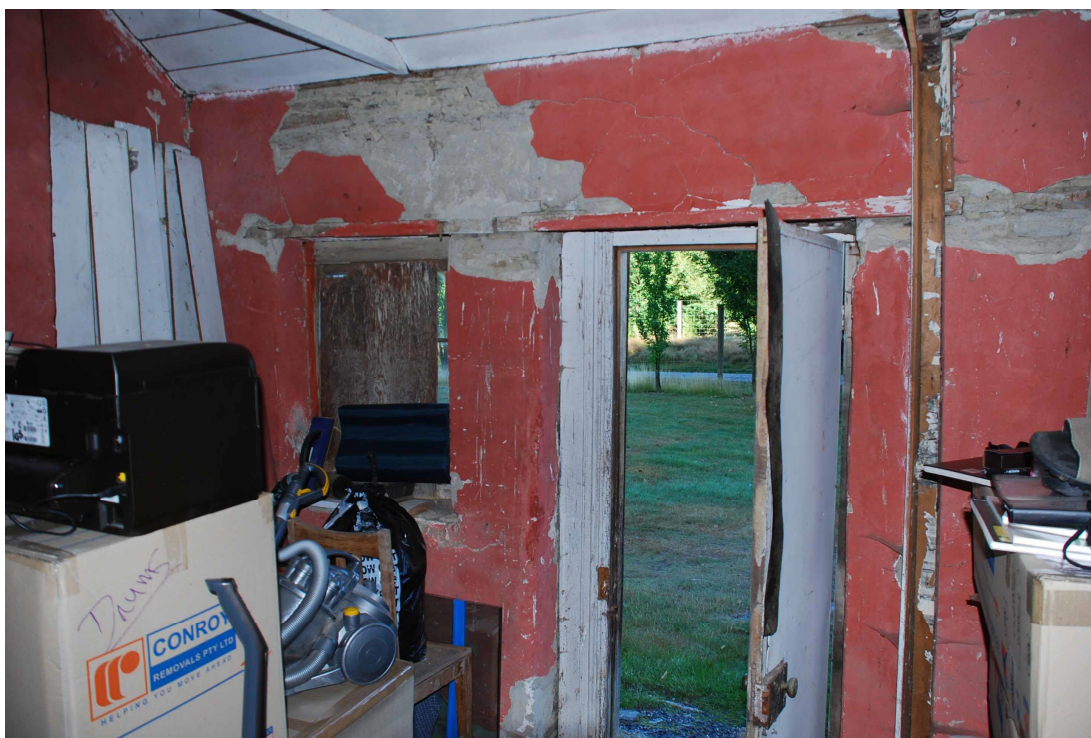
Interior with plastered and limewashed walls

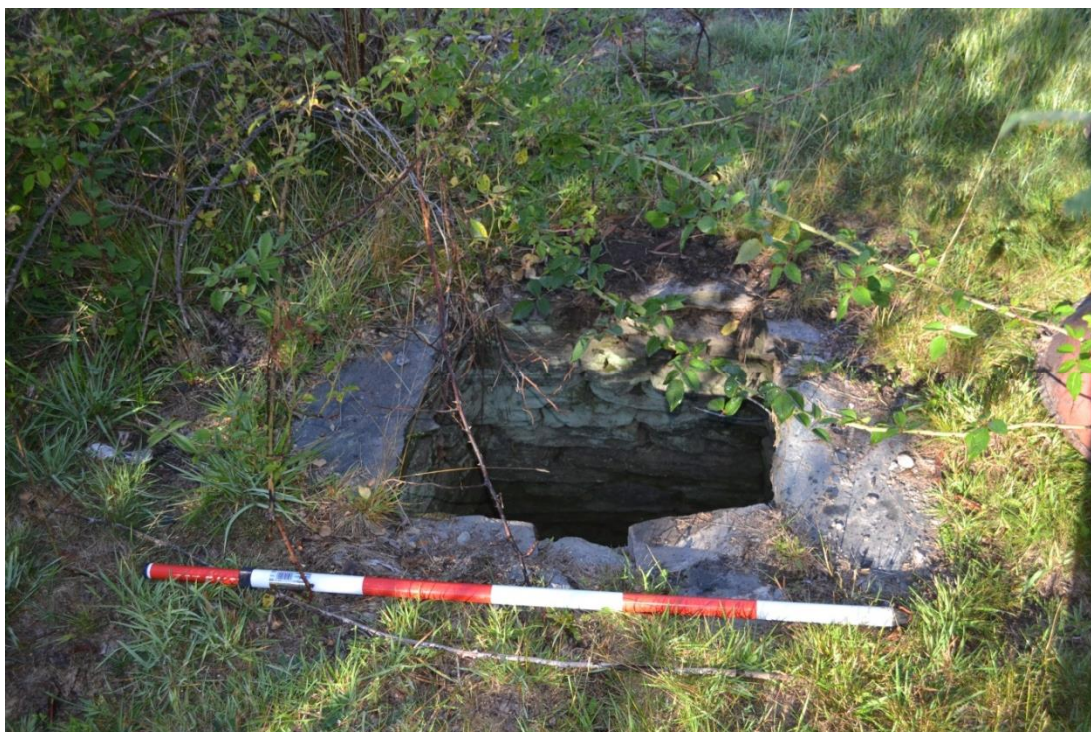
Stone-lined well to the west of the cottage

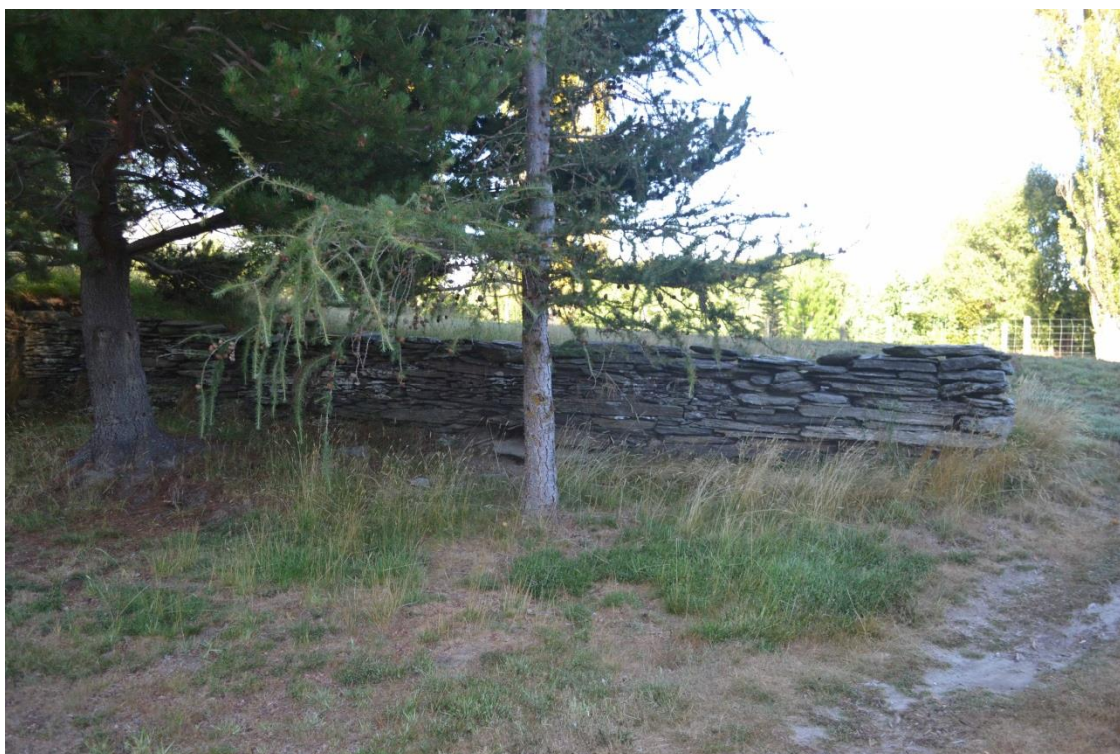
Part of the revetted stone wall

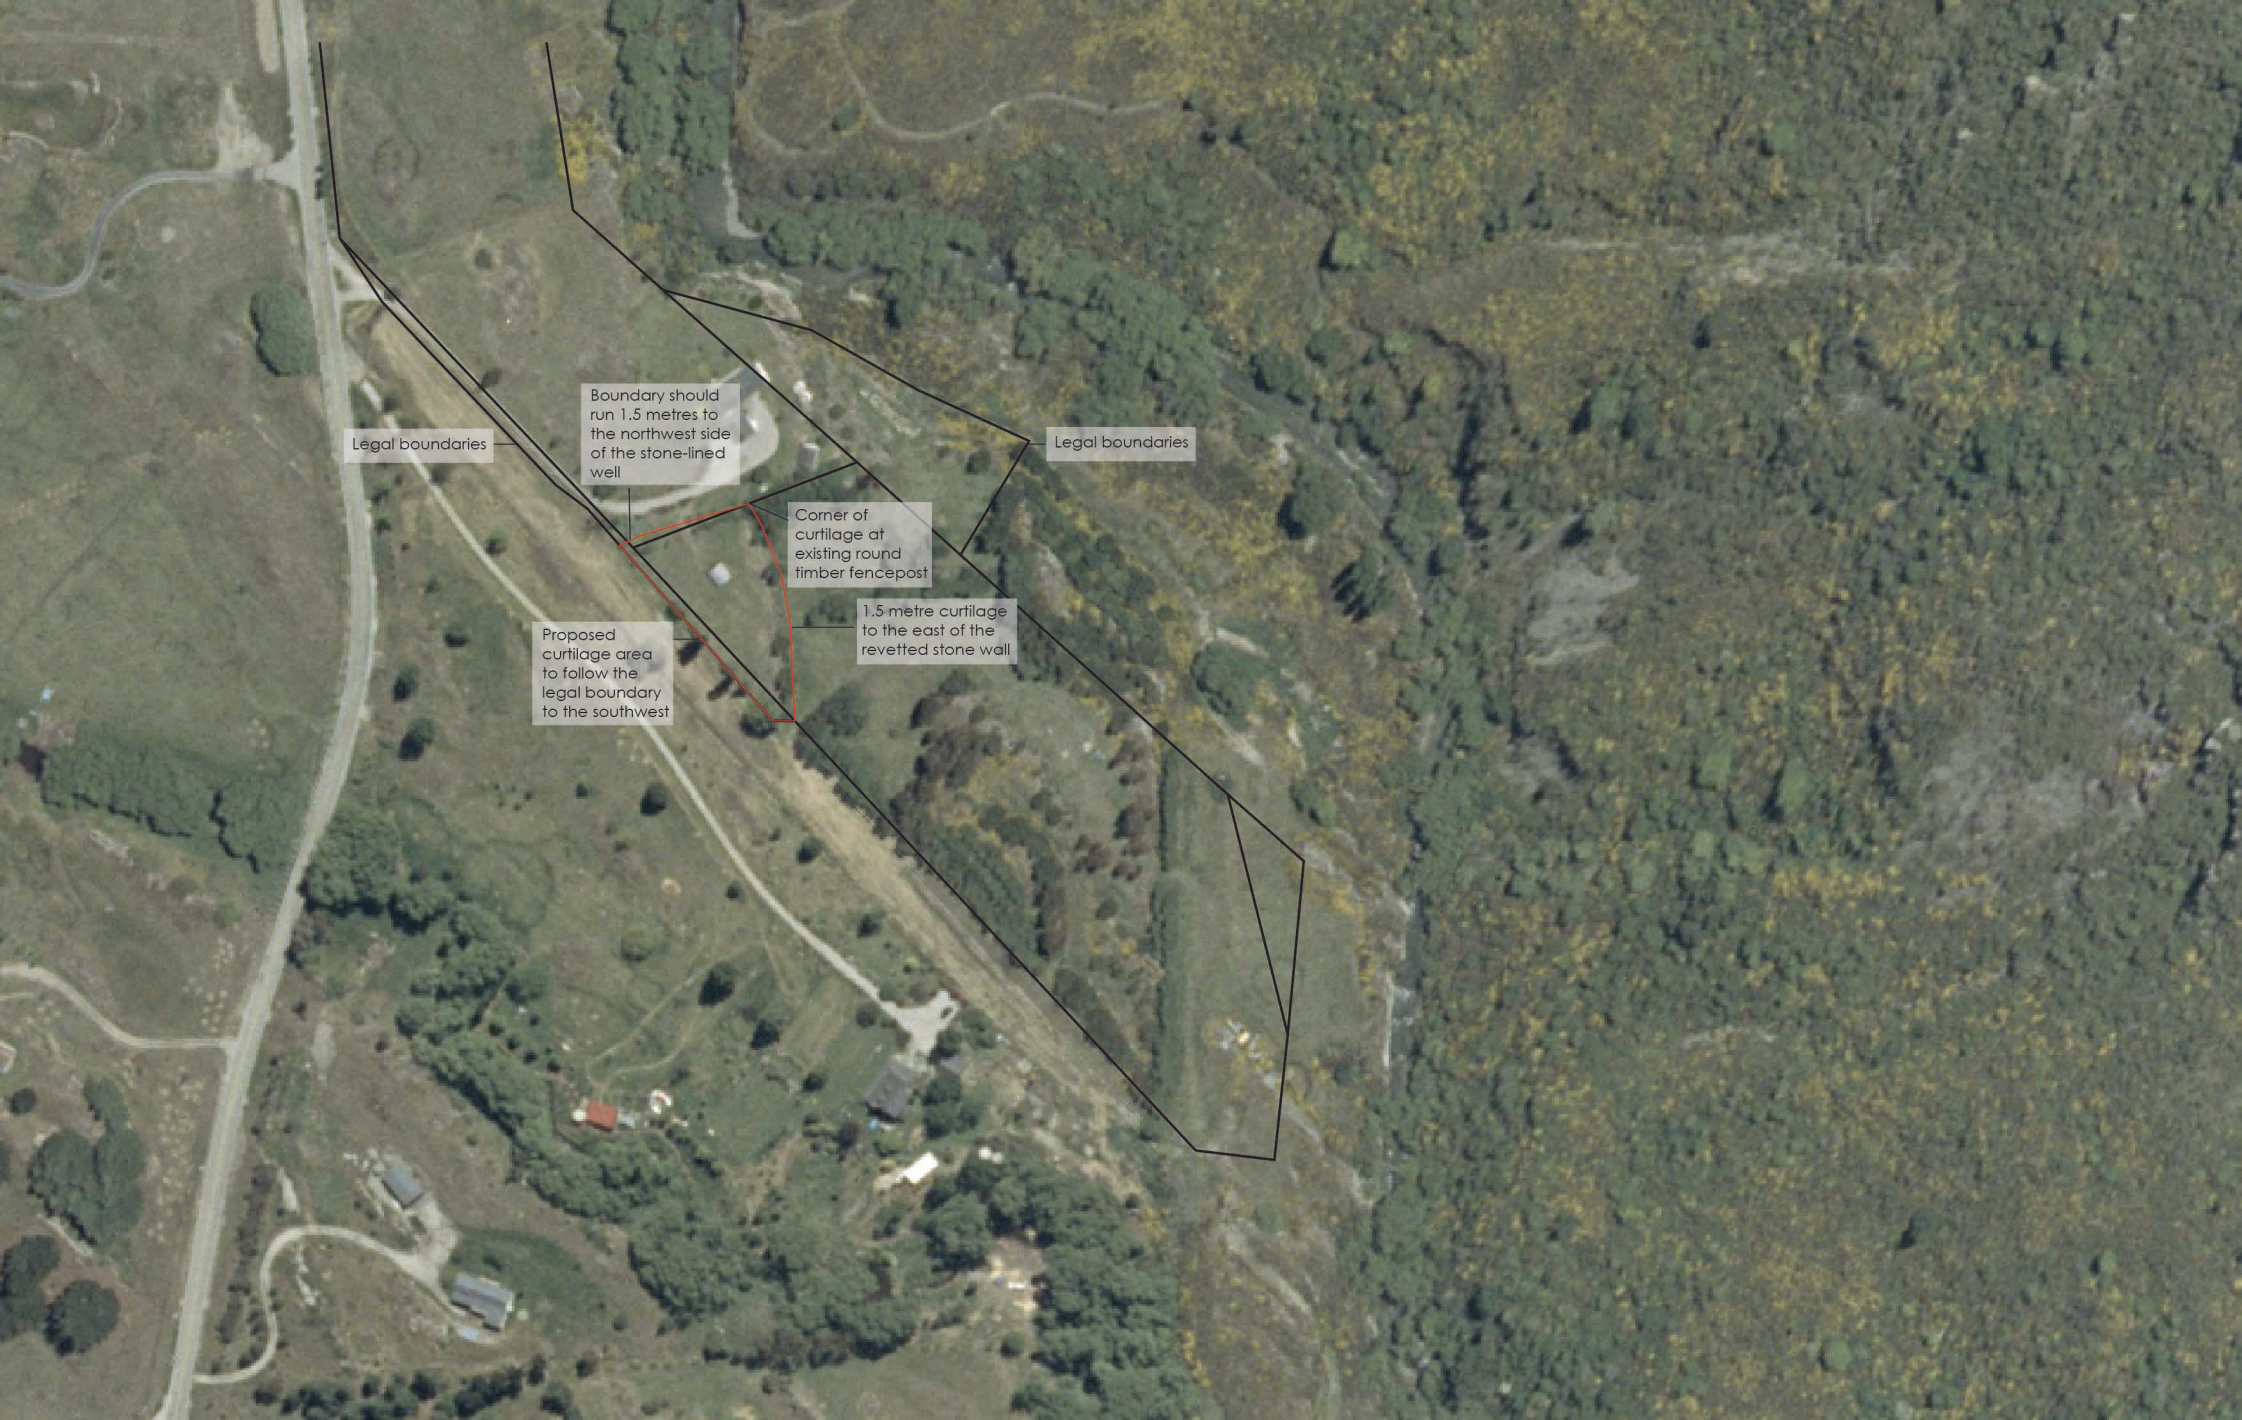
Boundary should run 1.5 metres to the northwest side of the stone-lined well

Corner of curtilage at existing round timber fencepost

Proposed curtilage area to follow the legal boundary to the southwest

1.5 metre curtilage to the east of the revetted stone wall

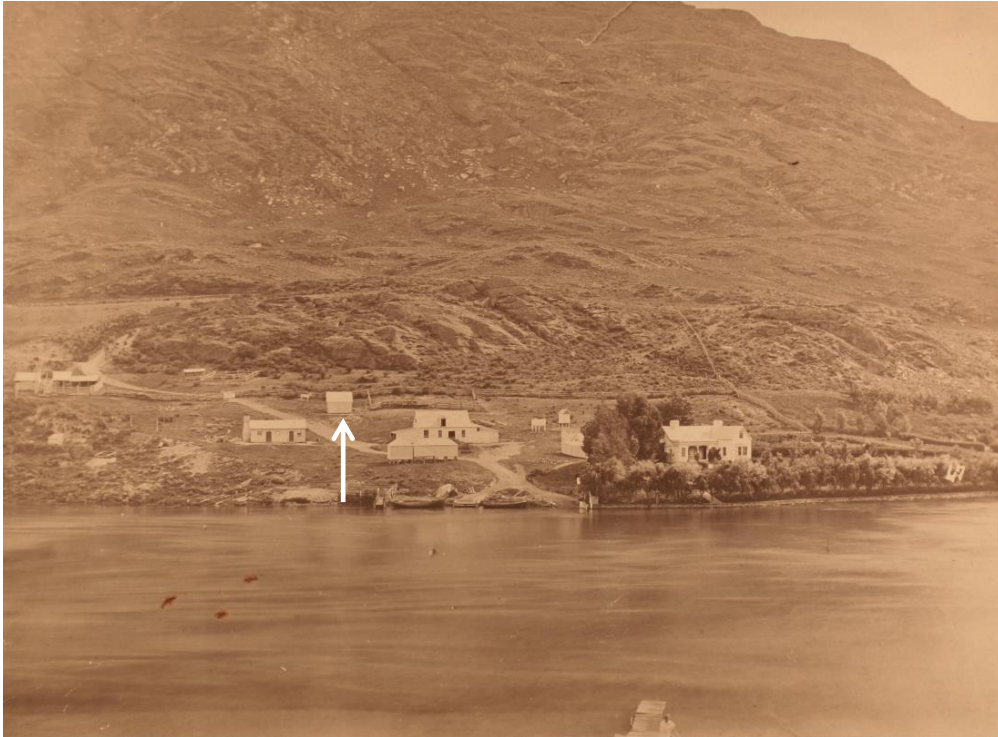
This photograph shows the farm station with many of its buildings. Note the meat store (arrowed) and the large house to the right. The dairy is hidden by the trees to the left of the house. *Photo – Lakes District Museum, EL1392B*

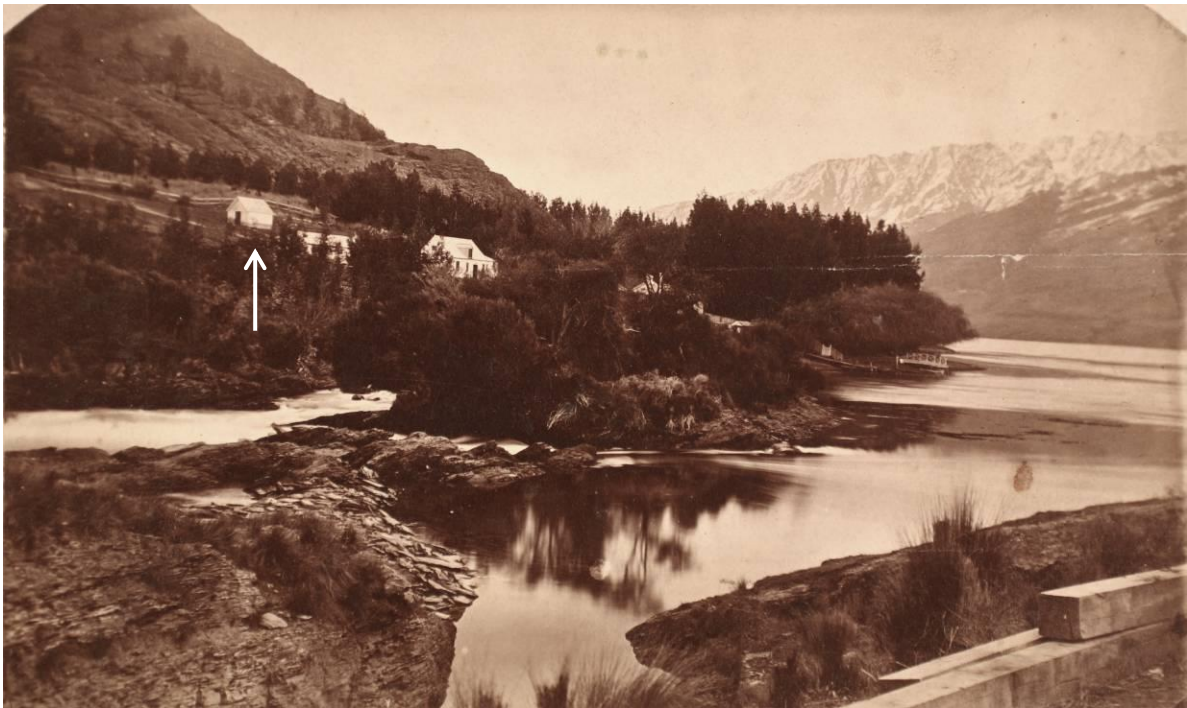
Showing the Meat Store (arrowed) and some of the other farm buildings. The Dairy is concealed by vegetation. *Photo – Lakes District Museum, EL 0892.*

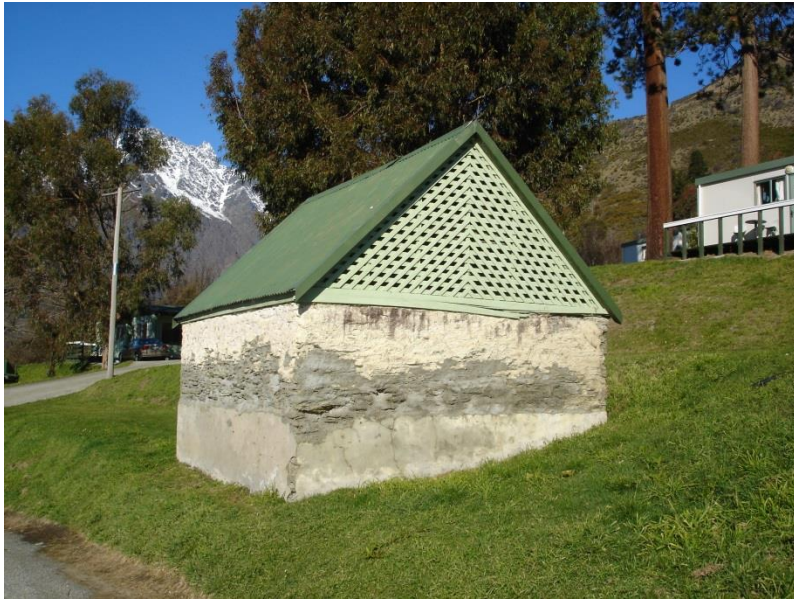
The Meat Store (this description relates to the building before it was relocated from its original site) is 4 metres wide and 4.6 metres long. It too has a single door in its (original) east elevation but the gables of this building are constructed in timber frame, not stone. The timber frame has a lattice of diagonal slats in timber with remnants of hessian sacking still fixed on the internal face. The main door is in two leaves and is vertical t&g with ledged framing internally and wrought iron strap hinges. The door is set into a timber frame and this is held on the stone wall by timber grounds built into the stonework.

Meat Store (2005) looking southeast.

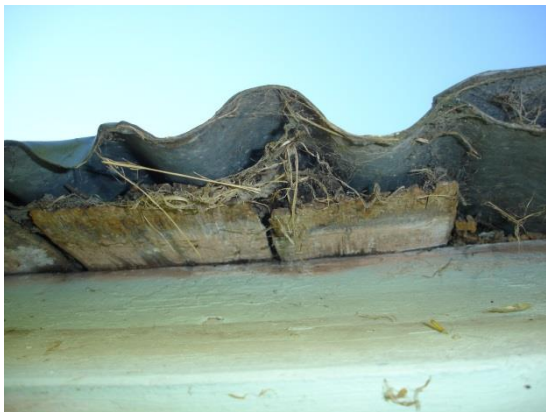
The stacked stone walls are typical of local vernacular construction. The split timber shingles covering both roofs, possibly Mountain Beech from the head of the lake, and the diamond pattern ventilation lattice of the Meat Store are more unusual. Very few buildings remain with timber shingles on the roof and where they do, they are usually concealed under corrugated iron cladding. The use of timber shingles on early buildings indicates the shortage of more common and more durable roofing materials in the early years, but timber was in plentiful supply and was therefore adopted until it became clear that it was unsuitable and other materials such as corrugated iron began to arrive in the country.

Detail of timber shingles visible under the corrugated iron at the eaves.

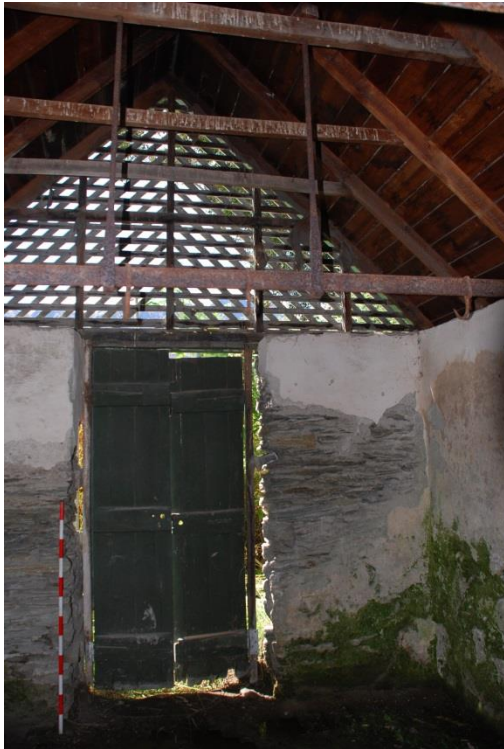
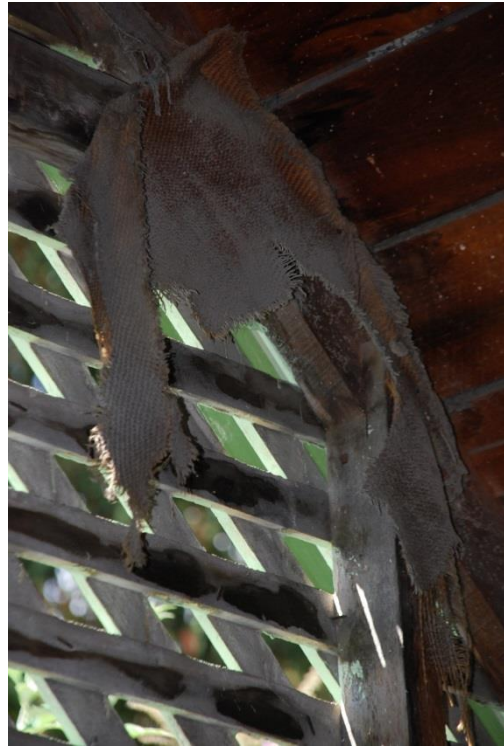
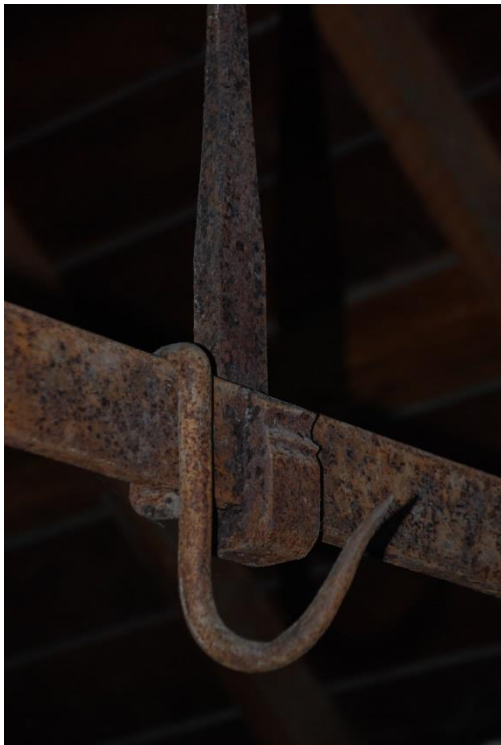
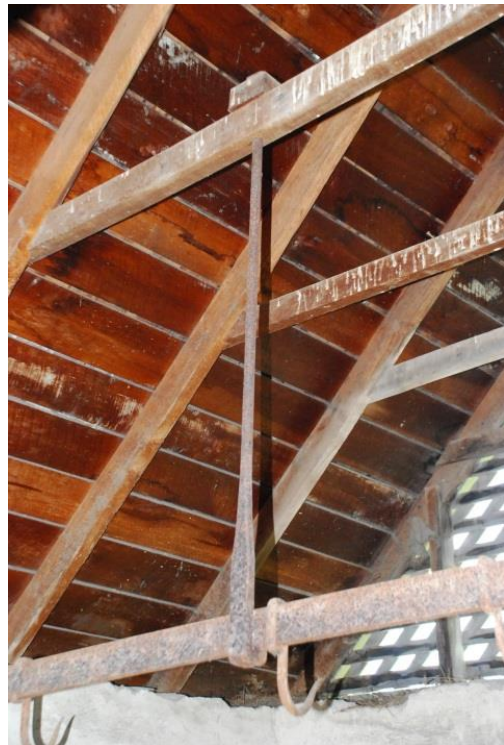
Internally, the walls are plastered with soft lime plaster. The floor is paved in brick laid on edge but with no mortar. The roof is made up of timber rafters (probably Rimu) which are half-housed at the ridge. There is no ridge beam or ridge board. A collar tie spans between the rafters at mid pitch. Above the rafters the roof is lined with butted Rimu boards and the original timber shingle roof is visible through some of the gaps in these boards. The shingles are also visible at the eaves, where they protrude below the corrugated iron.

Two wrought iron bars span across the building at eaves height and these are suspended from the collar tie above by smaller wrought iron hangers. A number of substantial iron meat hooks slide along on the lower bars and it is from these that the carcasses were hung until required. These, together with the ventilated eaves and brick floor are highly emotive of the function of the building as a cool store for large quantities of meat.

Interior of Meat store showing plastered stone walls, double doors, lattice gables with hessian covering and roof showing timber sarking, rafters & collar ties and wrought iron meat hooks.

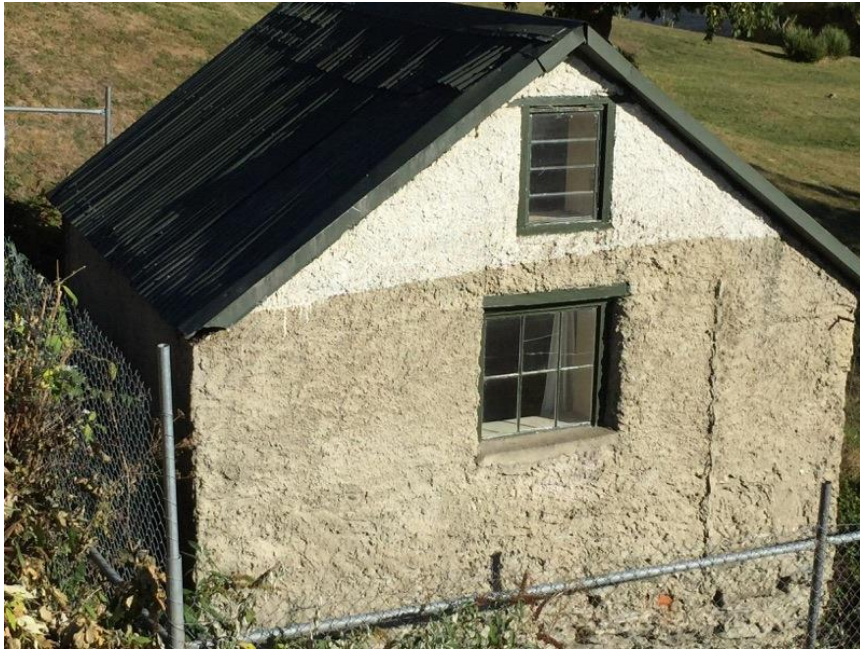
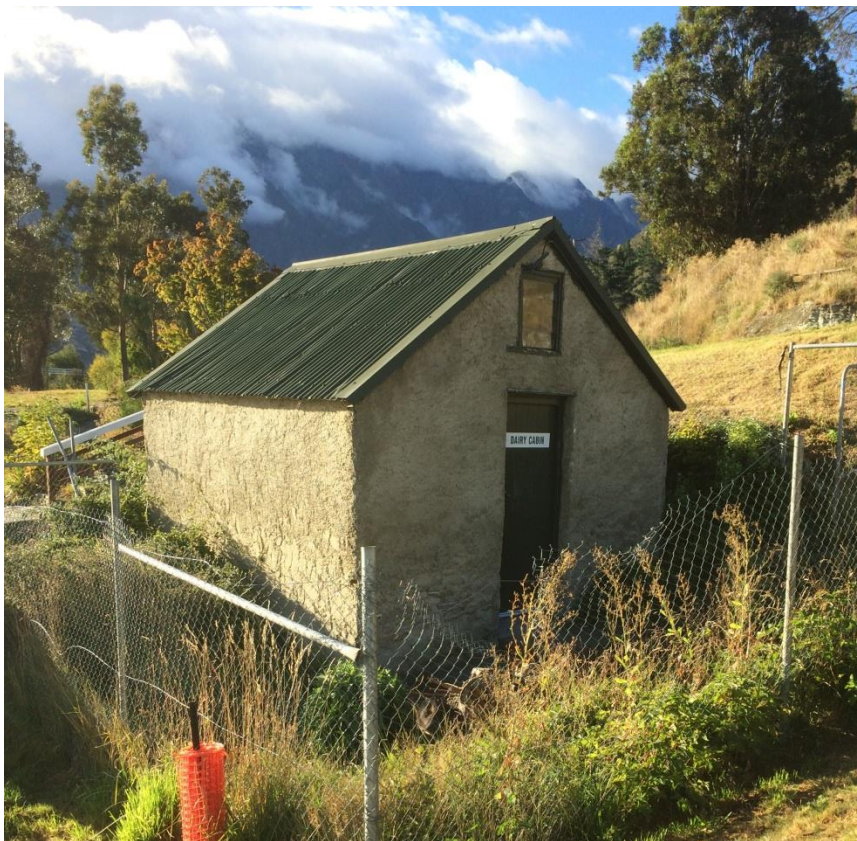
The Dairy is 4.15 metre long and 4.05 metres wide. The roof form is gabled with a roof pitch of approximately 45 degrees. It has a t&g door in the western gable end. High in the gable on the same elevation is another small window now fitted with an aluminium glazed louvred window. The eastern gable has two windows, another matching one at high level in the gable, which probably dates from its construction, and another lower down which is presumed to be more recent and consists of a recycled 6-pane window sash. The side walls are only approximately 2 metres high above floor level and on the south are partially built into the bank behind. The ground slopes from south down to the north and therefore the northern wall appears higher. This form (apart from the additional window on the eastern elevation) is typical of historic small farm dairies in the Wakatipu and Central Otago, which

Dairy (2015), east elevation (top) and north & west elevations (bottom).

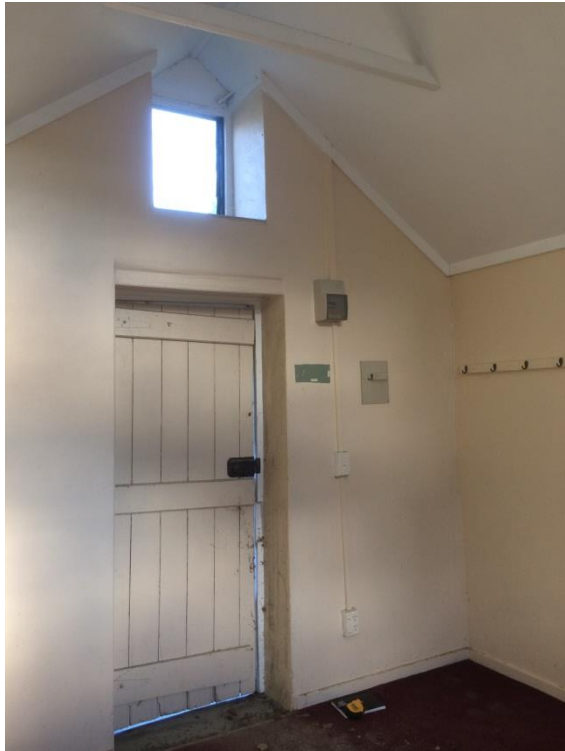
Internally, the dairy has cement plastered walls and a concrete floor. The ceiling has been underlined in hardboard, leaving the collar ties at mid height in the gable exposed.

Interior of Dairy (2015)

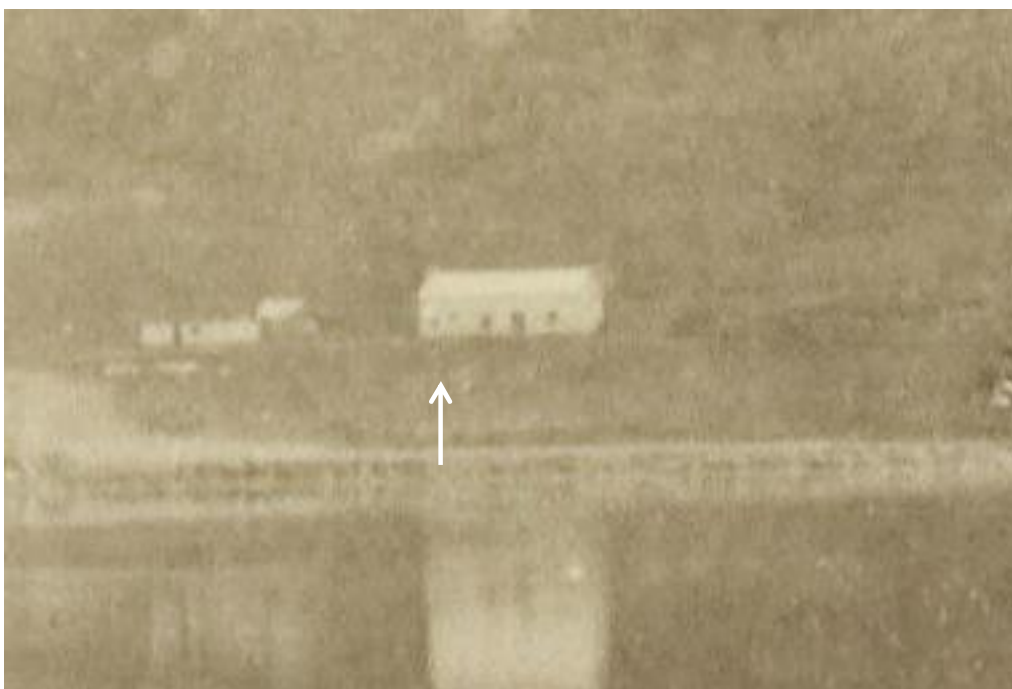
Dating to c. 1885, this photograph was taken from the other side of Lake Hayes. It shows the stables with another building (to the left) where the implement shed stands today. (photograph: Te Papa Archives O.004714)
