## Maxwell Place & Panorama Terrace Intersection – Tree Safety Assessment

Queenstown Lakes District Council, Parks Division, requested that Opus International Consultants complete a safety assessment of the trees near the intersection of Panorama Terrace and Maxwell Place.

A site visit was completed on 15 March 2017.

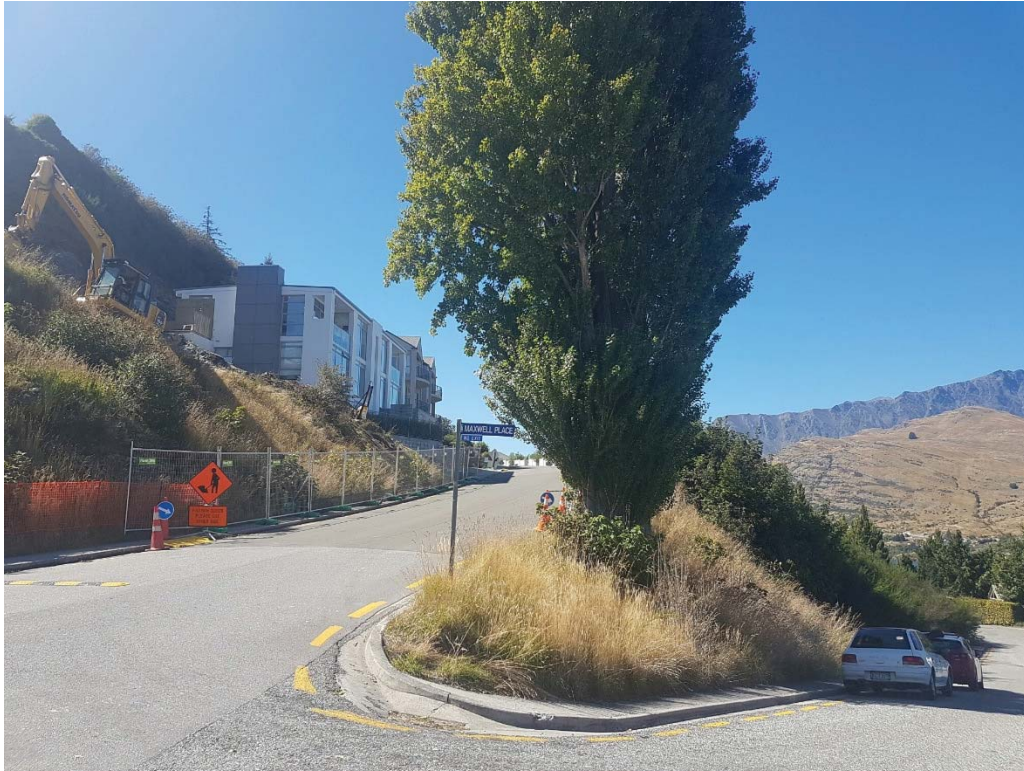
*Figure 2: Trees inside corner of intersection*

The trees currently pose a safety hazard by restricting sight lines at the intersection. In particular vehicles exiting Maxwell Place have poor sight distance to their right due to the trees blocking vision. This is of particular concern to cyclists as their smaller width and positioning on the road is likely to further reduce sight distance. Figure 2 shows the affected sightline, while Figure 3 shows the reverse angle.

It is recommended to remove both trees from the road reserve. The removal of the trees would be beneficial to user safety by improving sight distances, reducing the chance of icy surfaces, and removing the possibility of collision with the trees.

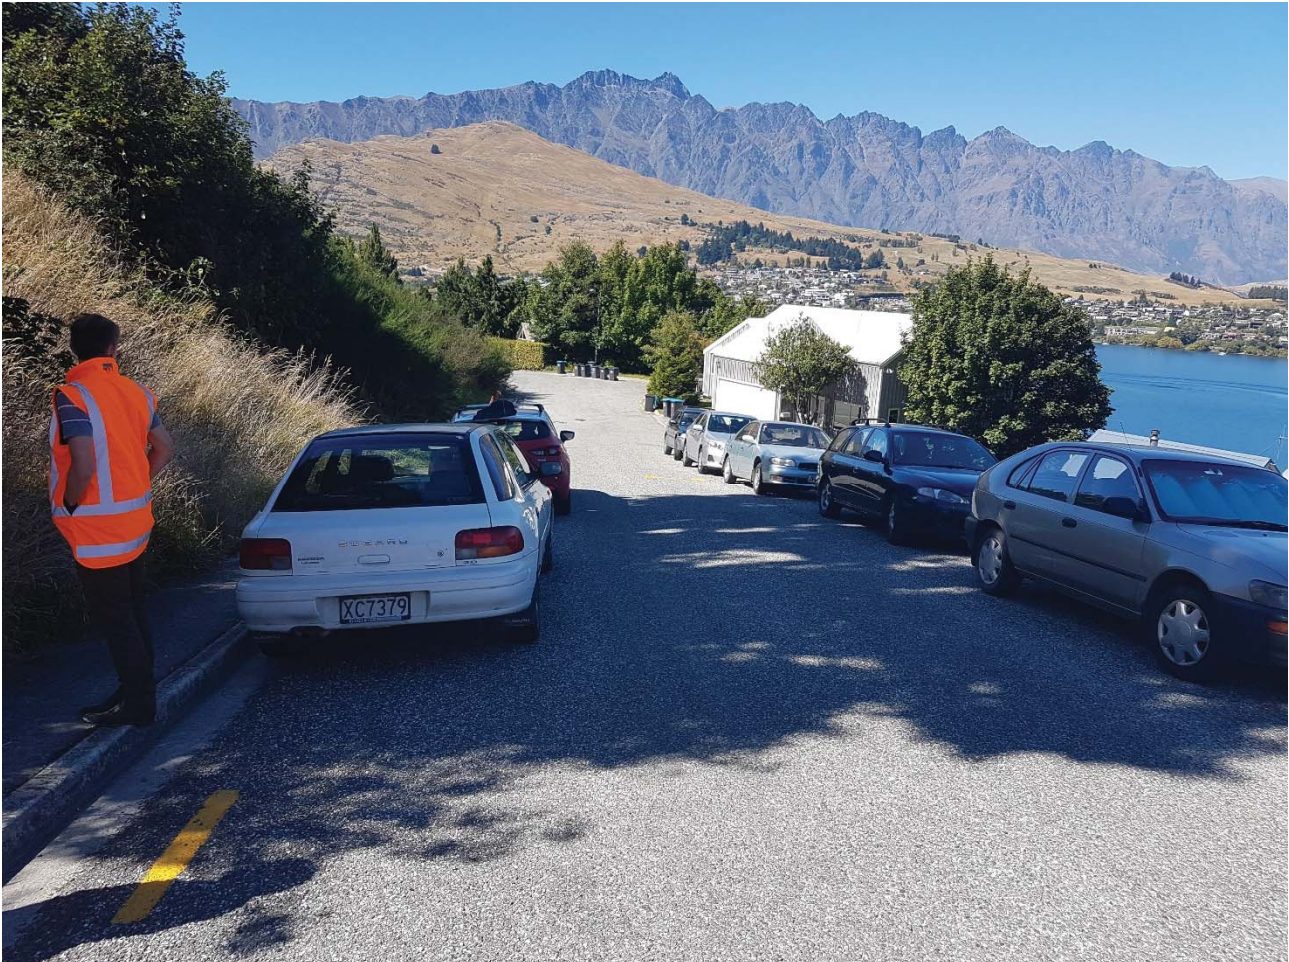
During the winter period, temperatures often reach below freezing. The shade created by the trees, figure 4, is likely to result in a dangerous icy surface near the intersection and partway down Maxwell Place as the sun cannot effectively warm the road surface.

*Figure 4: Shaded area on Maxwell Place*
