# Preliminary Geotechnical Report

Proposed Glenpanel SHA  
Ladies Mile  
Queenstown

**Report prepared by:**  
GeoSolve Ltd

**June 2016**  
**GeoSolve Ref: 160403**

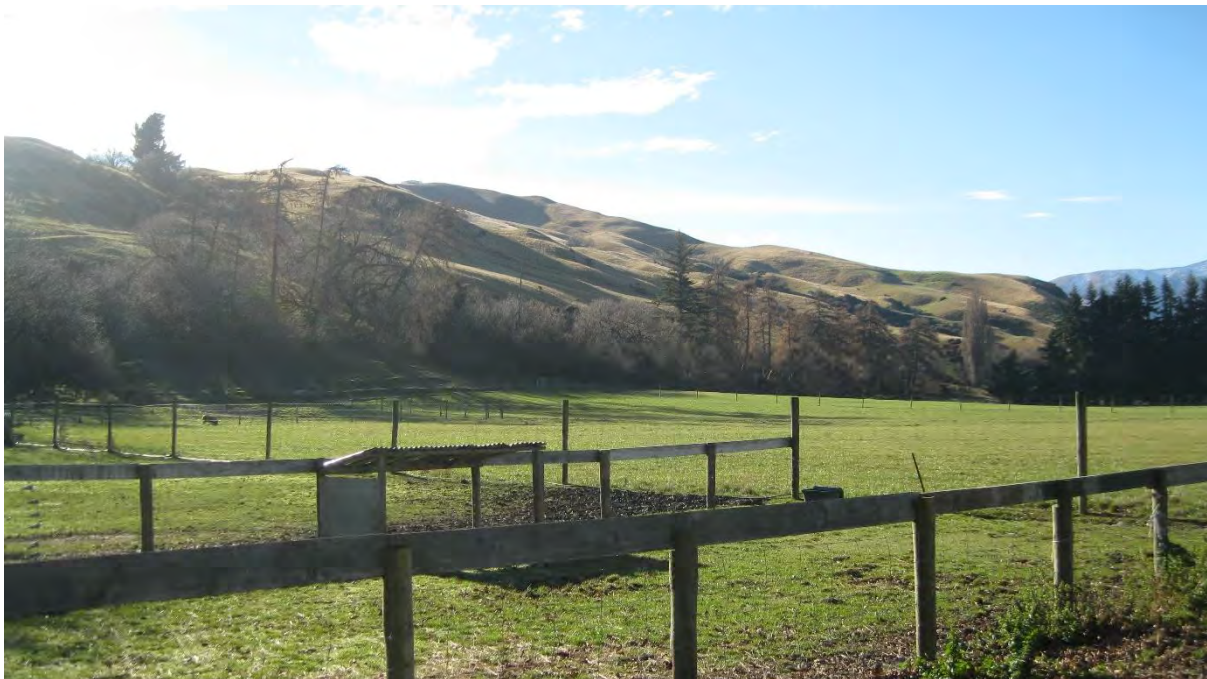
Photo 4: View northeast towards eastern-most alluvial fan feature, northern boundary area. Gully indicated by vegetation extending upslope.

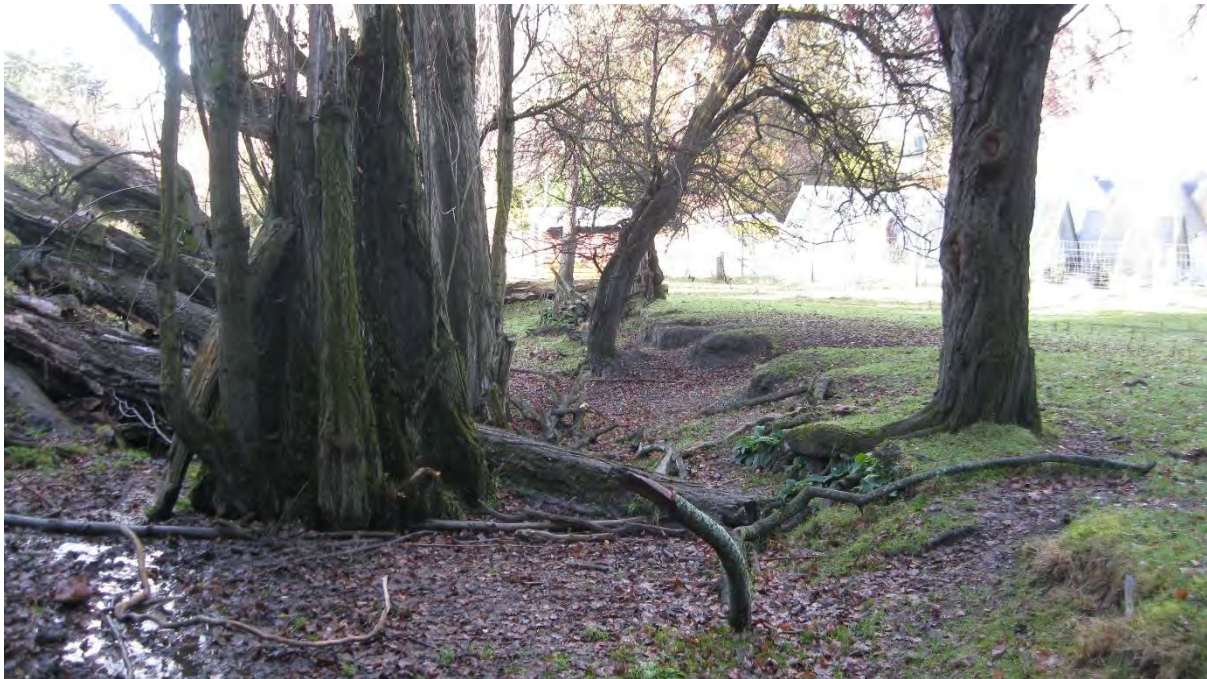
Photo 5: View downstream from mouth of main alluvial fan gully. Weak stream flow evident on left. Glenpanel homestead on downstream part of fan.

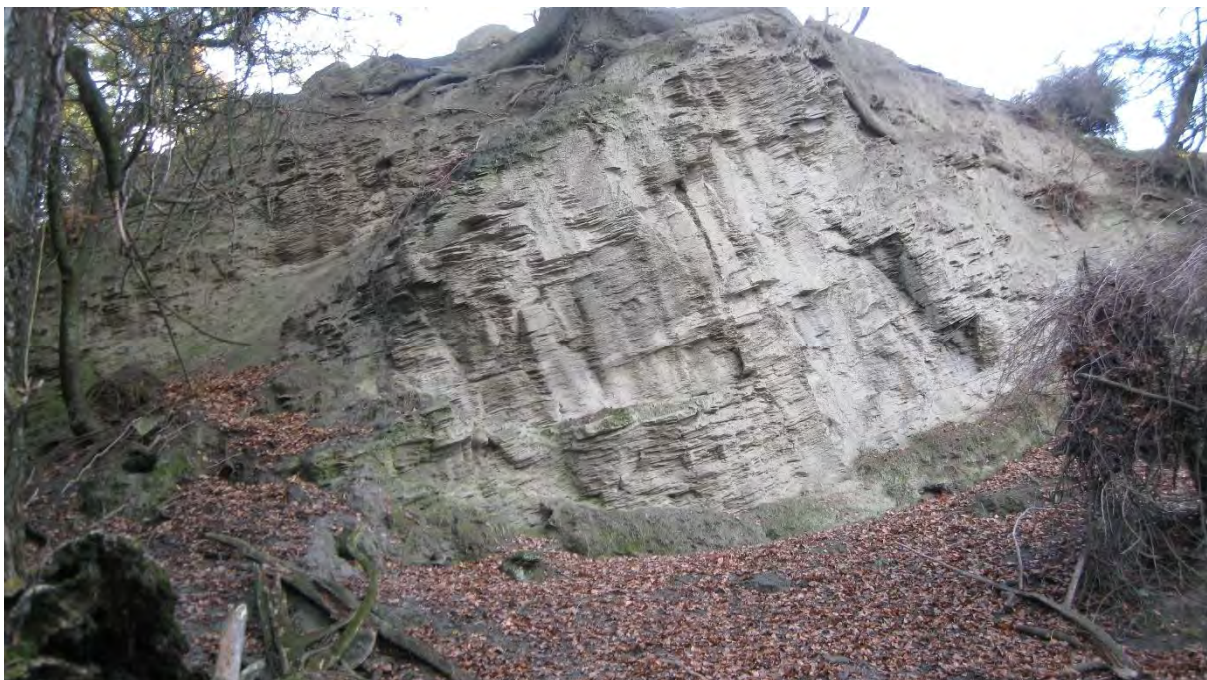
Photo 6: Schist exposure, main alluvial fan gully.

Small scale rock fall associated with localised weathering and gradual fretting of the rock within the incised gullies beyond the northern boundary was observed.

Bluffs and relatively steep slopes are present immediately beyond the northern boundary of the site. Preliminary assessment indicates the risk of rock fall is low. There is some natural weathering and minor fretting of the rock faces observed in some areas in the incised gullies, but these are unlikely to impact on the site.
