The condition of the Greenstone-Kinloch Road has been examined, locals interviewed and recommendations for improvement proposed, in response to a request from Queenstown Lakes District Council (QLDC).

INTRODUCTION

1 HISTORY OF GREENSTONE-KINLOCH ROAD

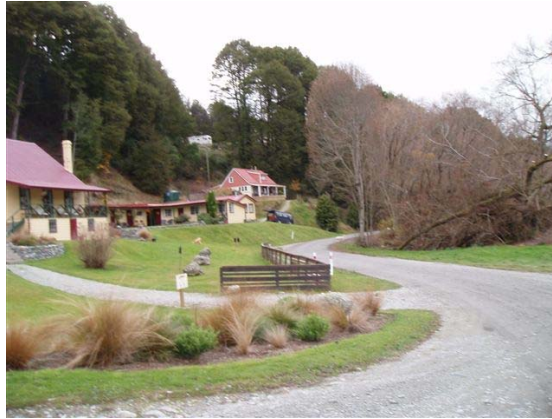
Figure 2: Kinloch Lodge

An effect of completion of the road was that the Kinloch Lodge, established in 1865, was now able to receive guests by road, as well as by boat. The Lodge, extended since the opening of the road, is shown in the picture below.
