QLDC OFFICES AND LIBRARY

DETAILED SEISMIC ASSESSMENT

PHASES 1 & 2

QUEENSTOWN LAKES DISTRICT COUNCIL

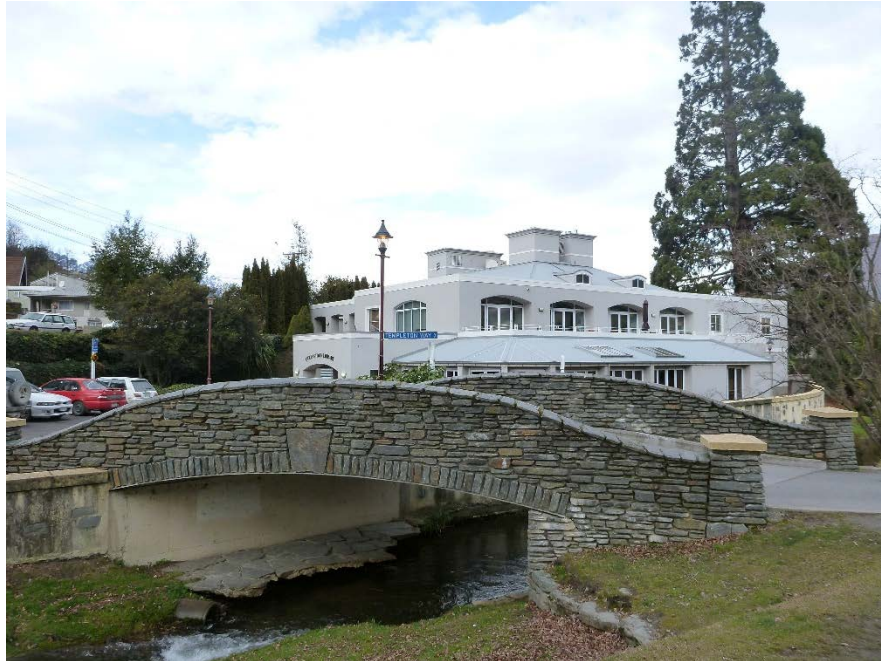
Figure 3-1: 8-10 Gorge Road

The site at 8-10 Gorge Road is sloping from Gorge Road down towards Horne Creek which runs along the western boundary of the site. The level difference is currently addressed by the building which acts as a retaining structure over the lower level, and a crib wall running away to the east. The photo taken in Figure 3-1 is looking south towards the building from the western bank of Horne Creek.

Queenstown Lakes District 2012 Liquefaction Hazard Assessment, September 2012). Noting the presence of Horne Creek to the north, there was also considered to be a potential for lateral spreading. The site is also identified as flood prone (Otago Regional Council Horne Creek Flood Risk Study 2006) due to swelling of Horne Creek.

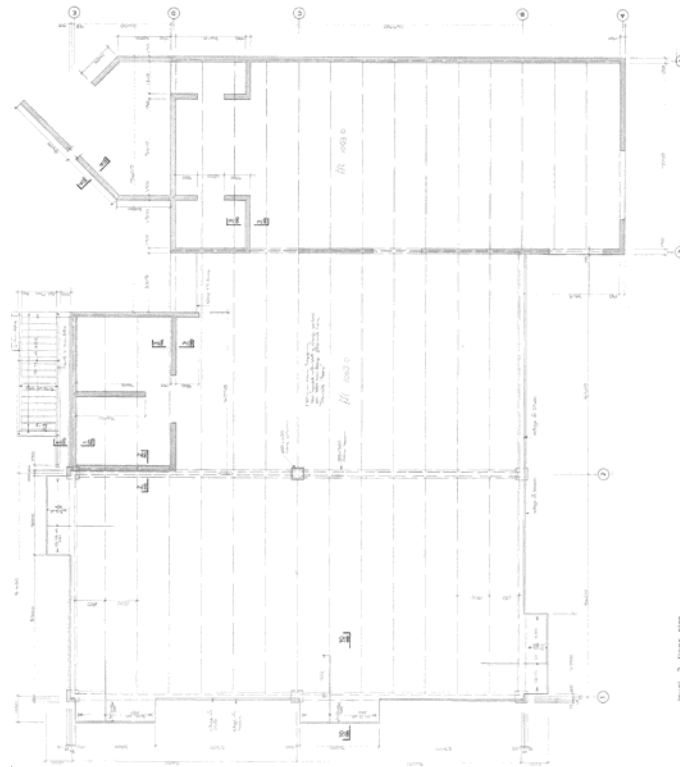
Figure 3-2: New Building for the Wakatipu Club (1976) – First Floor Plan

The building was designed by Holmes Wood Poole and Johnston in 1976 and the full structural drawings and specification were available for review. Figure 3-2 shows the general layout of the first floor plan from the original structural drawings.

The suspended floors were constructed of 350mm deep precast concrete double tee flooring units with a 50mm topping. The precast flooring units were supported by the blockwork walls and concrete beams in a manner referred to as 'flange hung' – a type of detail not commonly used until the 1980's. Records show that the double tee units were designed and constructed by Stresscrete but details of the units and flange hung supports have not been able to be found at this time.

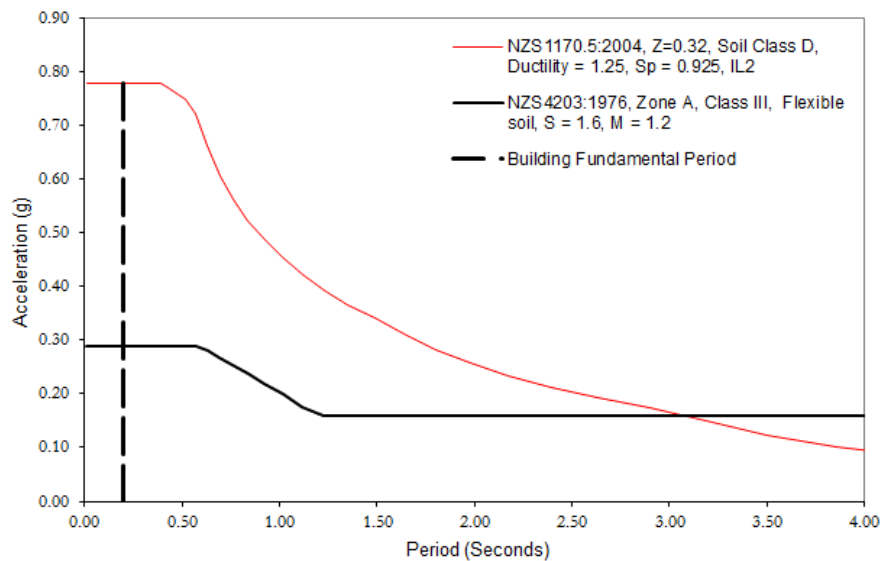
Figure 4-1: Comparison of Design Codes

The building was originally designed in 1976 and review of the original calculations shows that it adopted the loadings standard NZS4203:1976 which was released that year. The seismic design load used for the original design was 0.29g. The loadings standard NZS4203:1976 has since been superseded by NZS1170.5:2004. As such, the seismic design load for an IL2 building on the site today would be 0.78g. Therefore, based on a direct code comparison, the original building would be expected to have a capacity of just 37% of current code requirements.

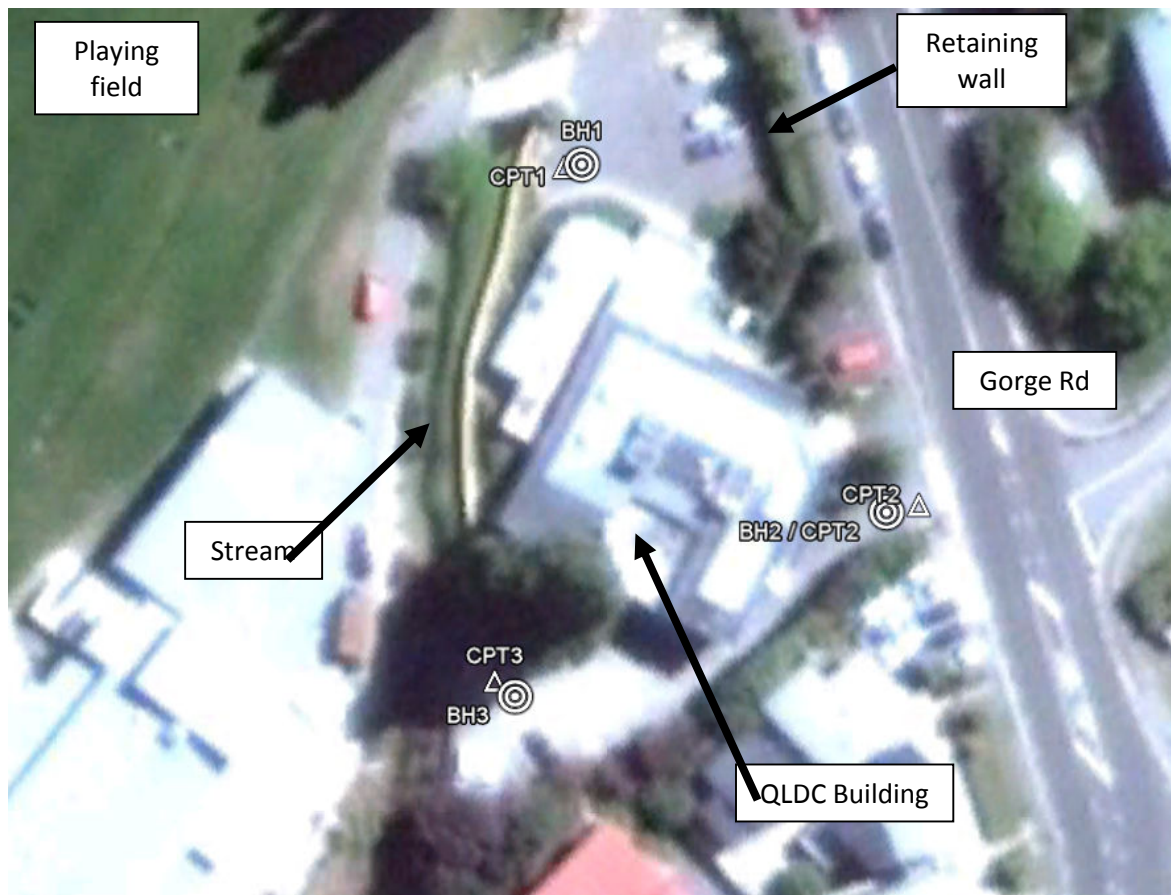
Figure 1 – Site investigation location plan

- Three machine drilled boreholes to a maximum depth of 20m with Standard Penetration Tests (SPT) testing at 1.5m centres.
- Three Cone Penetration Tests (CPTs) to a maximum depth of 12m. The CPTs were all predrilled for the upper 1.5m, and CPT02 was also predrilled from 3 to 5.2m depth to push through a gravel layer.
