## Maxwell Place & Panorama Terrace Intersection – Tree Safety Assessment

Queenstown Lakes District Council, Parks Division, requested that Opus International Consultants complete a safety assessment of the trees near the intersection of Panorama Terrace and Maxwell Place.

A site visit was completed on 15 March 2017.

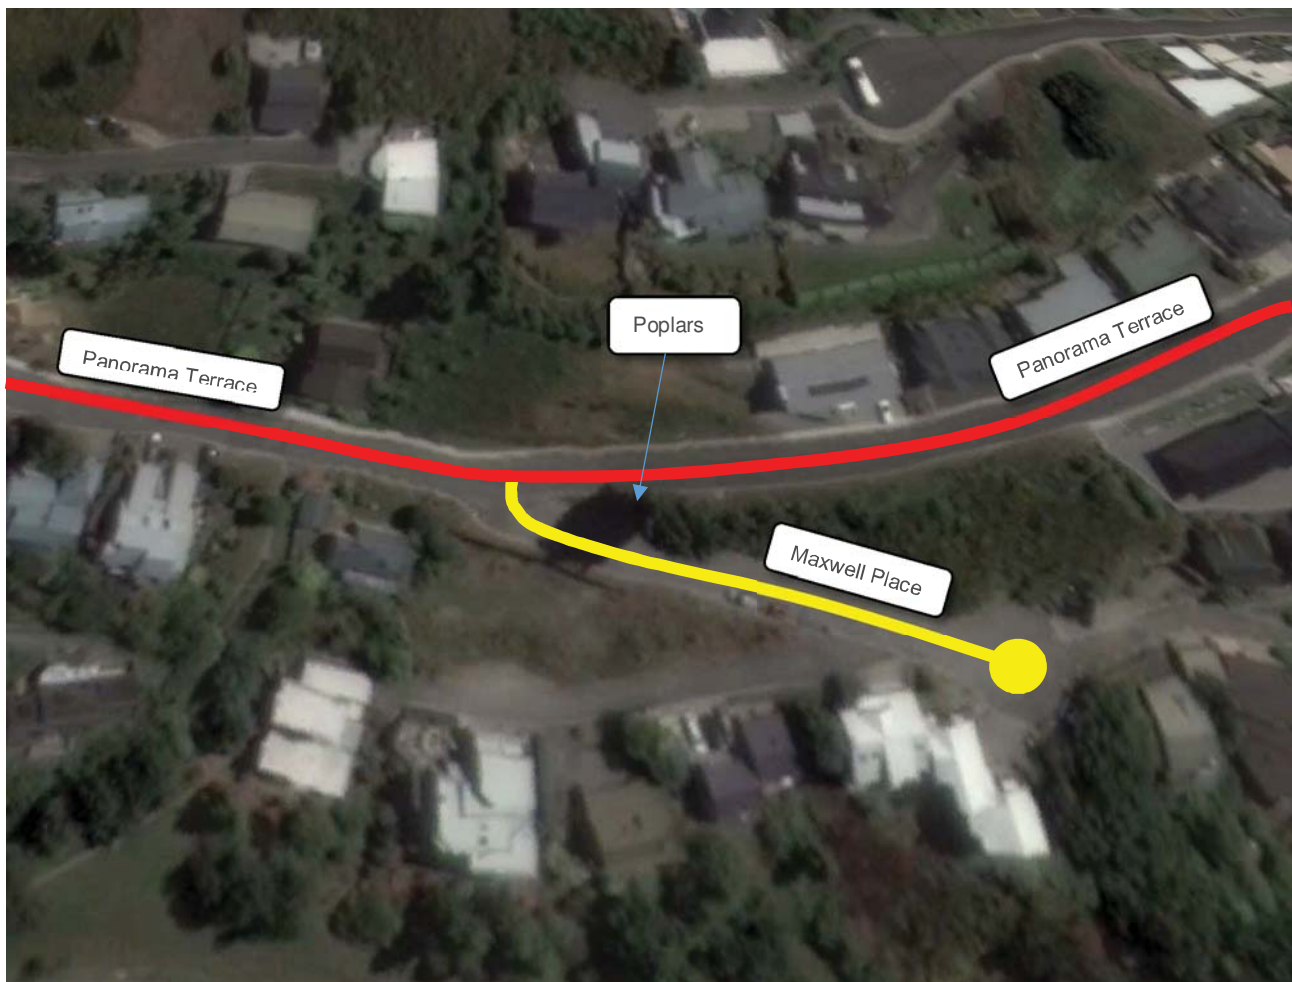
The intersection is located in a hillside residential area. The posted speed limit is 50km/hr. Panorama Terrace is a residential road providing access to many private properties, while Maxwell Place is a cul-d-sac, also providing access to further private properties. The intersection between these two roads is an angled “T” intersection, the layout of which is displayed in figure 1. There are two large poplar trees inside the acute angle created by this intersection, as shown in figure 2.

Figure 1: Panorama Terrace & Maxwell Place intersection

It is recommended to remove both trees from the road reserve. The removal of the trees would be beneficial to user safety by improving sight distances, reducing the chance of icy surfaces, and removing the possibility of collision with the trees.
